dsPIC33EPXXGS50X Family Silicon Errata and Data Sheet Clarification

The dsPIC33EPXXGS50X family devices that you have received conform functionally to the current Device Data Sheet (DS70005127D), except for the anomalies described in this document.

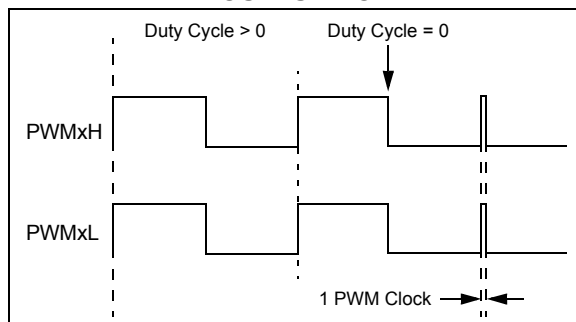
FIGURE 1: EXAMPLE FOR REDUNDANT OUTPUT MODE

In the Redundant Output mode (IOCONx[11:10] = 0b01) and Push-Pull Output mode (IOCONx[11:10] = 0b10), with the Immediate Update Enable bit disabled (PWMCONx[0] = 0), when the Duty Cycle register is updated from a non-zero value to zero, a glitch pulse of a width equal to one PWM clock will appear at the next PWM period boundary, as shown in Figure 1 (for the Redundant Output mode). The Duty Cycle register refers to the PDCx register if PWMCONx[8] = 0 or the MDC register if PWMCONx[8] = 1.

Work around

If the application requires a zero duty cycle output, there are two possible work around methods:

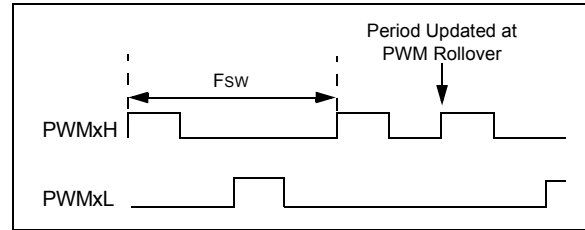
FIGURE 2:

When the PWM module is configured for Push-Pull mode (IOCONx[11:10] = 0b10) with the Enable Immediate Period Update bit enabled (PTCON[10] = 1), a write to the Period register that coincides with the period rollover event may cause the push-pull output logic to produce back-to-back pulses on the PWMx pins (Figure 2).

Ensure that the update to the PWM Period register occurs away from the PWM rollover event by setting the EIPU bit (PTCON[10] = 1). Use either the PWM Special Event Trigger (SEVTCMP) or the PWM Primary Trigger (TRIGx) to generate a PWM Interrupt Service Routine (ISR) near the start of the PWM cycle. This ISR will ensure that period writes do not occur near the PWM period rollover event.

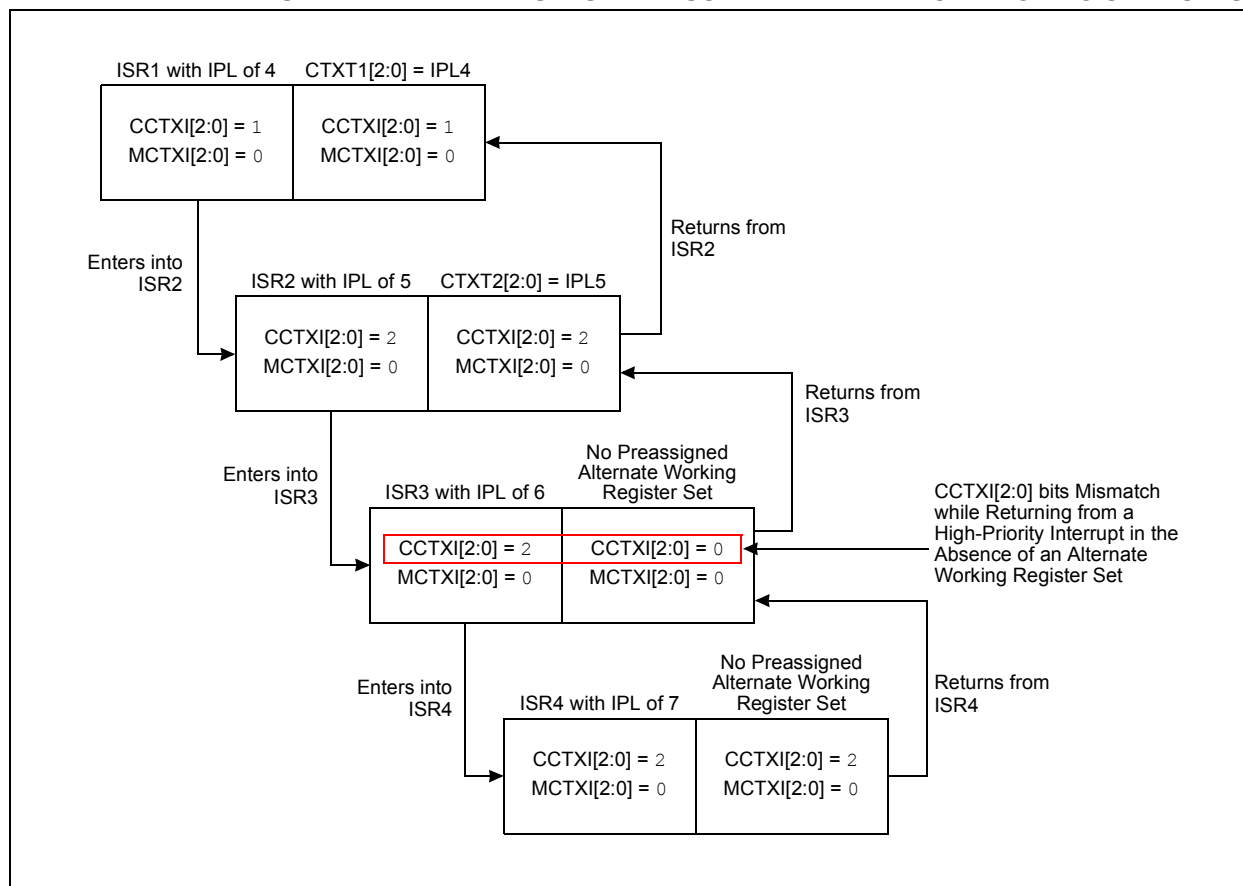
FIGURE 3: MISMATCH OF WORKING REGISTER SET WHEN NESTING MORE THAN ONE INTERRUPT WITHIN INTERRUPTS THAT USE ALTERNATE WORKING REGISTER SETS

Issue and work around are illustrated in [Figure 3](#) and [Figure 4](#), respectively. The figures show the status bits, `CCTXI[2:0]` and `MCTXI[2:0]`, after entering into an ISR from a lower priority ISR (left pane), and after returning to the same ISR from a higher priority ISR (right pane).

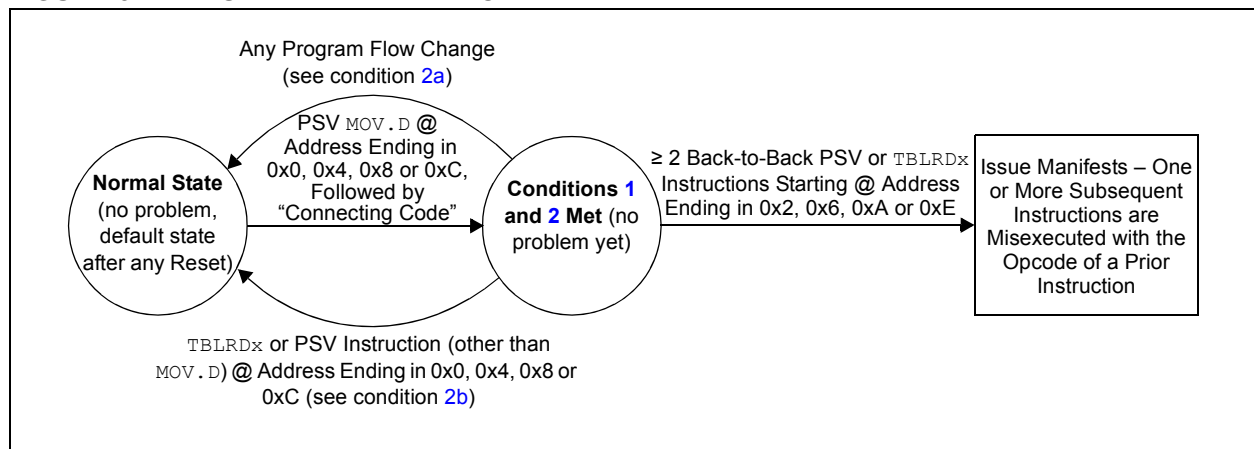
FIGURE 5: SIMPLIFIED BEHAVIOR

When two or more data Flash read instructions (via Program Space Visibility (PSV) read or table read) are executed back-to-back, one or more subsequent instructions can be misexecuted when all of the conditions in [Table 5](#) occur.

| 3. | ≥ 2 back-to-back PSV or <code>TBLRDx</code> instructions are executed (following the code of condition 2), where the first of the back-to-back instructions is located at an address ending in 0x2, 0x6, 0xA or 0xE. |

1. All instances of PSV `MOV.D` can be replaced with two PSV `MOV` instructions instead. Non-PSV `MOV.D` instructions acting on RAM/SFRs do not need to be modified; or
2. If not already present, a program flow change instruction (such as `BRA $+2`) can be inserted above back-to-back data Flash read sequences; or
3. Back-to-back data Flash read instruction sequences can be broken up by inserting a non-Flash read instruction (such as a `NOP`), in between the Flash read instructions; or
4. The alignment of the code can be shifted to avoid the required opcode location addresses.

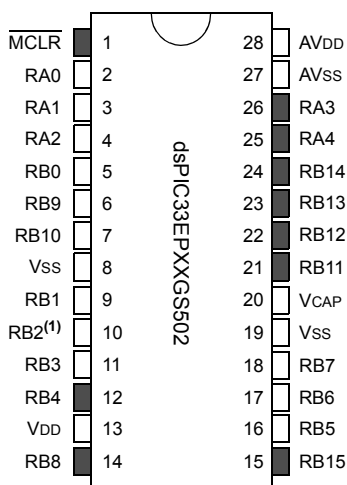
28-Pin SOIC

A note has been added to the RB2 port pin, as shown below in **bold**. This note applies to RB2 on all available packages.

Note 1: At device power-up (POR), a pulse with an amplitude around 2V and a duration greater than 500 μ s, may be observed on this device pin independent of pull-down resistors. It is recommended not to use this pin as an output driver unless the circuit being driven can endure this active duration.
