MSP430F5436A Device Erratasheet

The revision of the device can be identified by the revision letter on the [Package Markings](#) or by the [HW_ID](#) located inside the TLV structure of the device

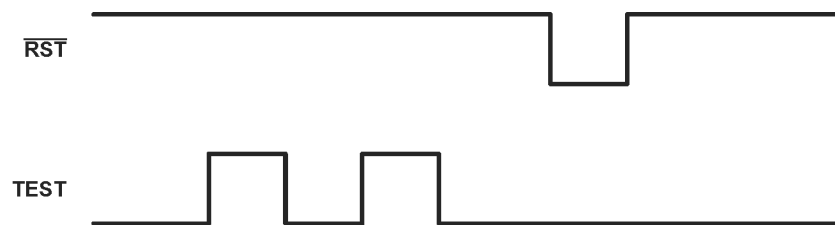
- A Power cycle

- or
- Toggle the TEST pin twice when nRST is high and after 50us pull nRST low.

Note: This toggling of TEST pins is not subject to timing constraints. The appropriate level transitions on TEST pin, followed by a RST pulse after 50us, are sufficient to trigger an exit from BSL mode.
