# OMAP-L138 C6000 DSP+ARM® Processor Silicon Revisions 2.3, 2.1, 2.0, 1.1 and 1.0

## Silicon Errata

Literature Number: SPRZ301M  
June 2009–Revised March 2014

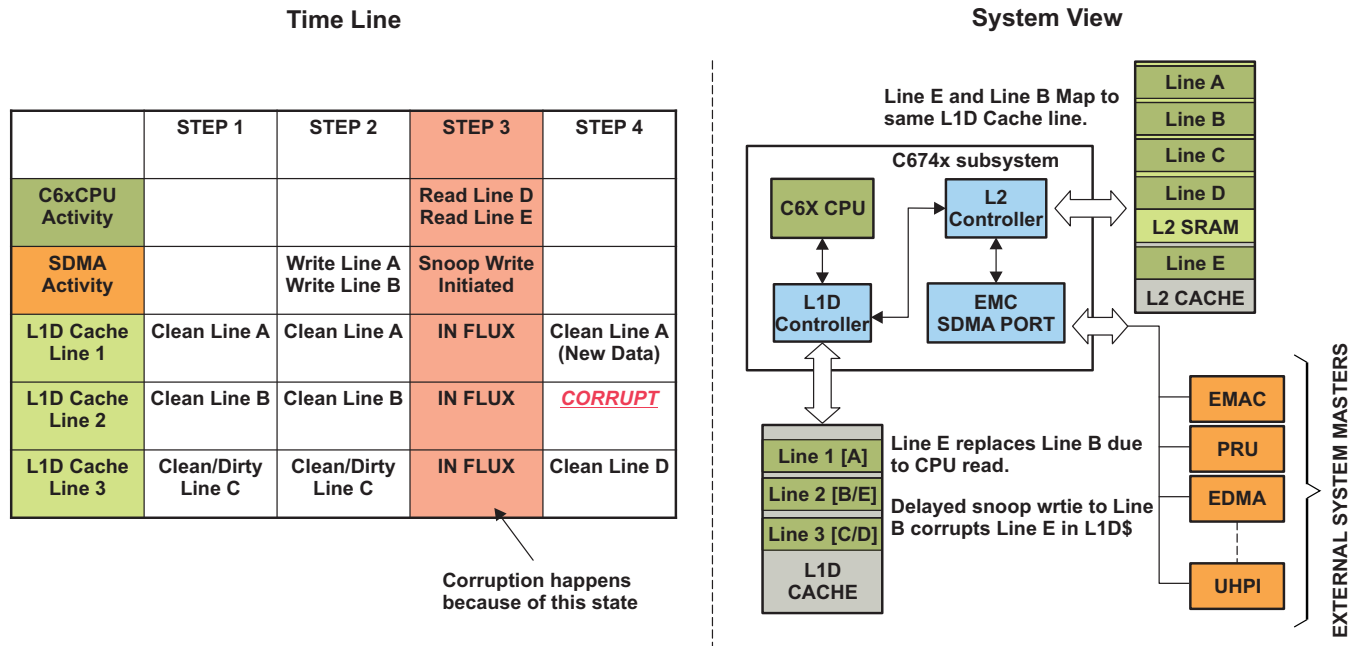
**Figure 4. Example of L1D Cache Corruption**

An L1D cache-line corruption event occurs when all of the conditions in the following steps are met (see [Figure 4](#)):

- Line E in L2 cache is read as a cache hit. Line E is destined to replace Line 2 in L1D Cache, which also has a snoop write pending for the updated Line B content.

- Line D in L2 SRAM is read. Line D will replace Line 3 in L1D cache.
4. When the snoop write operation completes, Line 2 in L1D cache now contains the updated L2 SRAM Line B data instead of the L2 cache Line E data.

The correct behavior would have been to kill the pending snoop write initiated to update L1D cache Line 2 with the updated L2 SRAM Line B data in Step 3. The L1D cache should have evicted Line B and replaced it with Line E data. Instead, the snoop write operation continues and does not complete until after the L1D cache Line 2 has already been replaced with L2 cache Line E data. The snoop write instruction overwrites the L1D cache Line 2 (containing L2 cache Line E data) with the updated L2 SRAM Line B data.

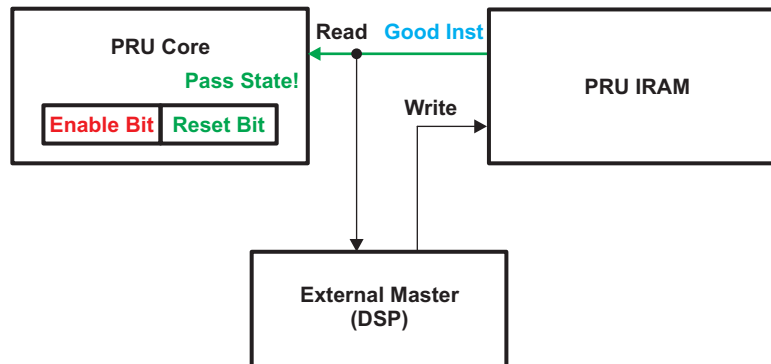
**Figure 15. Secondary Reset**

Although the PRU core execution is stuck, the PRU IRAM read bus is now initialized with a non-reserved instruction that was fetched from the IRAM by the PRU core (see [Figure 15](#)). If a secondary reset is provided to the device (either POR or WARM), the PRU will be able to execute its functional instructions as expected.

Note that in order to recover from this fail state with a secondary reset, the DSP must be allowed to execute its boot ROM up to the point where the PRU has fetched a known instruction from the PRU IRAM. The approximate count of 15k cycles into the boot ROM is sufficient.

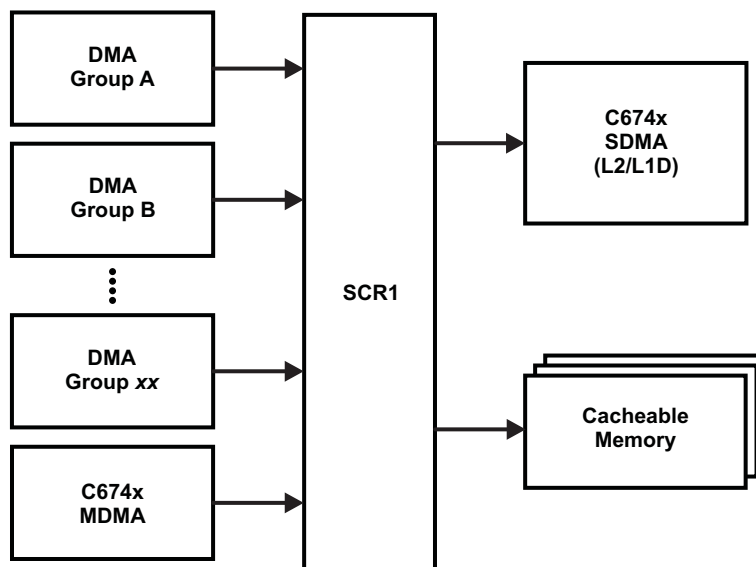
**Figure 22. SCR1 System Interconnect**

Step 2: The DSP's SDMA asserts itself as not ready and is unable to accept the write data from Step 1, and a cache line writeback is initiated from DSP memory to the same cacheable memory from Step 1. The cache line writeback command also passes through SCR1.

With the above scenario, it is possible for SCR1 to order the write commands from Step 1 in front of the write commands from Step 2. Due to the MDMA/SDMA blocking behavior, the SDMA commands from Step 2 will be waiting for the MDMA traffic from Step 1 to finish, resulting in a deadlock situation at SCR1. [Figure 22](#) is provided for illustrative purposes and is incomplete because of simplification.
