dsPIC33FJ06GS101/X02 and dsPIC33FJ16GSX02/X04

dsPIC33FJ06GS101/X02 and dsPIC33FJ16GSX02/X04 Family Silicon Errata and Data Sheet Clarification

The dsPIC33FJ06GS101/X02 and dsPIC33FJ16GSX02/X04 family devices that you have received conform functionally to the current Device Data Sheet (DS70000318G), except for the anomalies described in this document.

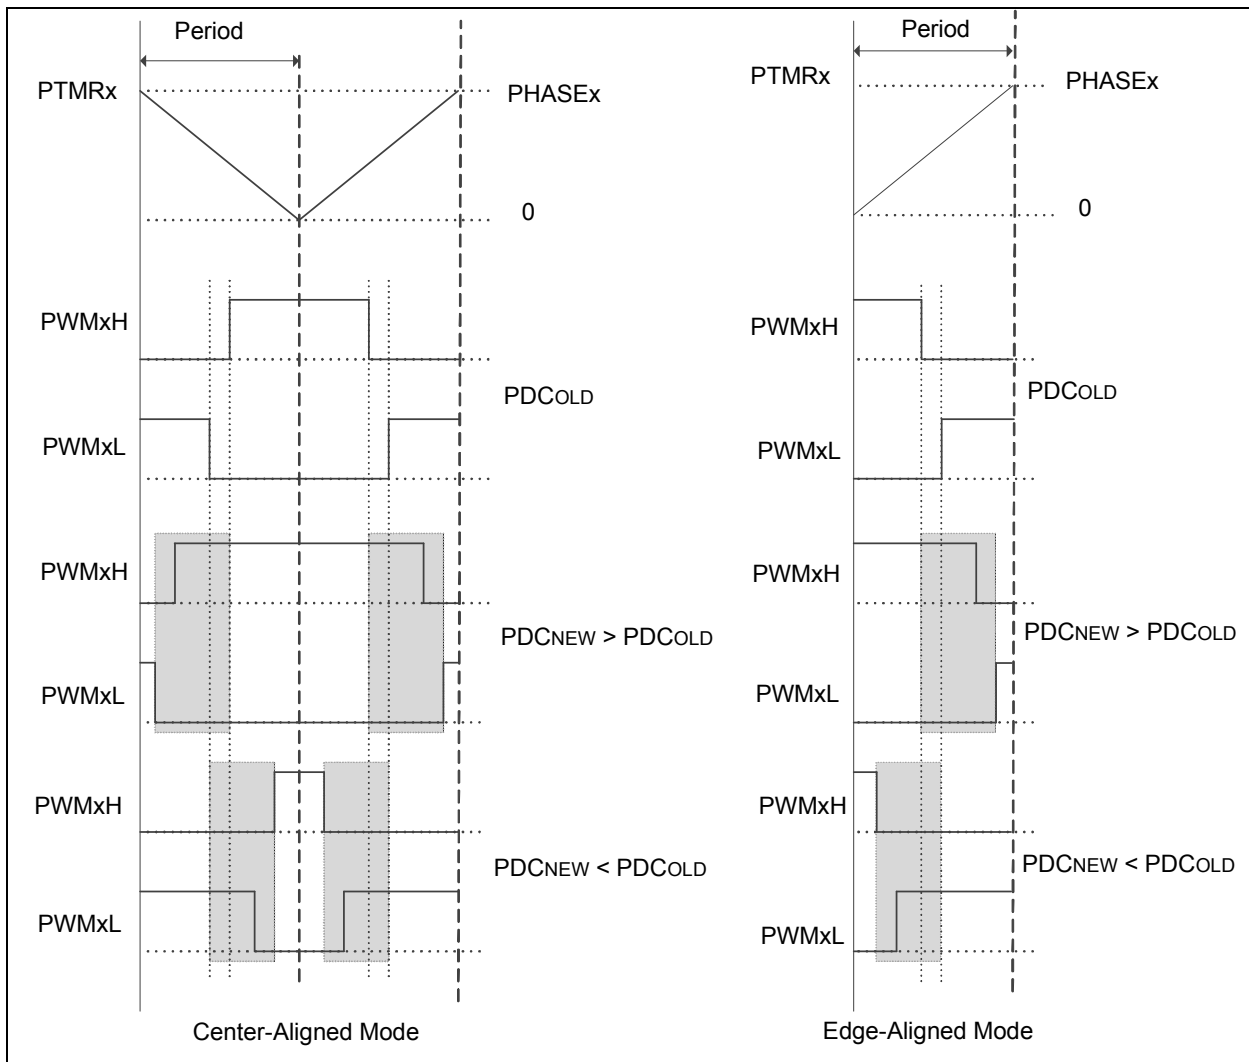
FIGURE 1: TIMING DIAGRAMS FOR CENTER-ALIGNED AND EDGE-ALIGNED MODES

The PWMx generator may not assert dead time on the edges of transitions. This has been observed when all of the following conditions are present:

None. However, in most applications, the duty cycle update timing can be controlled using the TRIGx trigger or Special Event Trigger, such that the above mentioned conditions are avoided altogether.

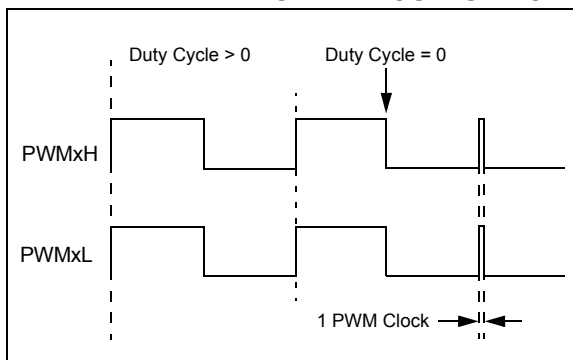
FIGURE 2: ISSUE EXAMPLE FOR REDUNDANT OUTPUT MODE

In Redundant Output mode (IOCONx[11:10] = 01) and Push-Pull Output mode (IOCONx[11:10] = 10), with the Immediate Update disabled (PWMCONx[0] = 0), when the Duty Cycle register is updated from a non-zero value to zero, a glitch pulse of a width equal to 1 PWM clock will appear at the next PWM period boundary, as shown in Figure 2 (for the Redundant Output mode). The Duty Cycle register refers to the PDCx register if PWMCONx[8] = 0 or the MDC register if PWMCONx[8] = 1.

If the application requires a zero duty cycle output, there are two possible work around methods:

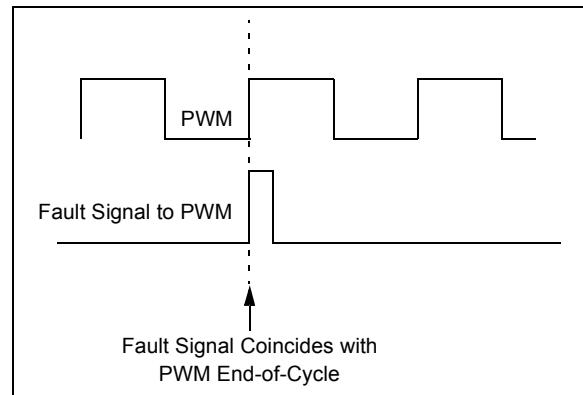
When the PWM module is operated in Complementary, Redundant, Push-Pull or True Independent Output modes and the PWM Fault/Current-Limit Fault are configured to provide a Fault event to the PWM, under certain conditions where the Fault event active edge happens to coincide with the PWM End-of-Cycle (EOC) event, the PWM fails to recognize the Fault event.

Configure the PWM module to include Leading-Edge Blanking bits, LEB[6:0] (LEBCONx [9:3]), with a count always greater than eight, with the appropriate PWMxH/PWMxL Leading-Edge Blanking triggers.
