### STM32F101x8/B, STM32F102x8/B and STM32F103x8/B medium-density device limitations

## Silicon identification

This errata sheet applies to the revisions B, Z, Y, 1, 2, 3 and X of the STMicroelectronics medium-density STM32F101xx access line and STM32F103xx performance line products, and to revision Y, 1, 2 and X of the STM32F102xx USB access line devices. These families feature an Arm® 32-bit Cortex®-M3 core, for which an errata notice is also available (see [Section 1](#) for details).

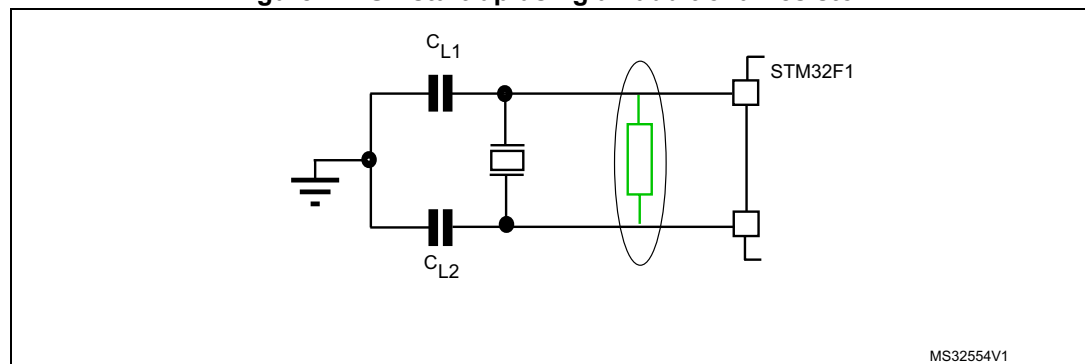
**Figure 1. LSE start-up using an additional resistor**

### Description

The LSE (Low Speed External) oscillator system has been designed to minimize the overall power consumption of the STM32F1 microcontroller. It is extremely important to take specific care in the design of the PCB to ensure this low power oscillator starts in harsh conditions. In some PCB designs without coating, an induced low leakage may prevent the LSE to start-up, regardless of the 32.768 KHz crystal used. This phenomenon is amplified in humid environments that create frost on the OSC32\_IN/OSC32\_OUT tracks. This unwanted behavior may happen only at the first back-up domain power-on of the device.

It is recommended to mount an additional parallel feedback resistor (from 16 M $\Omega$  to 22 M $\Omega$ ) on board to help the oscillation start-up in all cases (see [Figure 1](#)). For more details on compatible crystals and hardware techniques on PCB, refer to AN2867 application note.
