PIC18F97J94 Family Silicon Errata and Data Sheet Clarification

The PIC18F97J94 family devices that you have received conform functionally to the current Device Data Sheet (DS30575A), except for the anomalies described in this document.

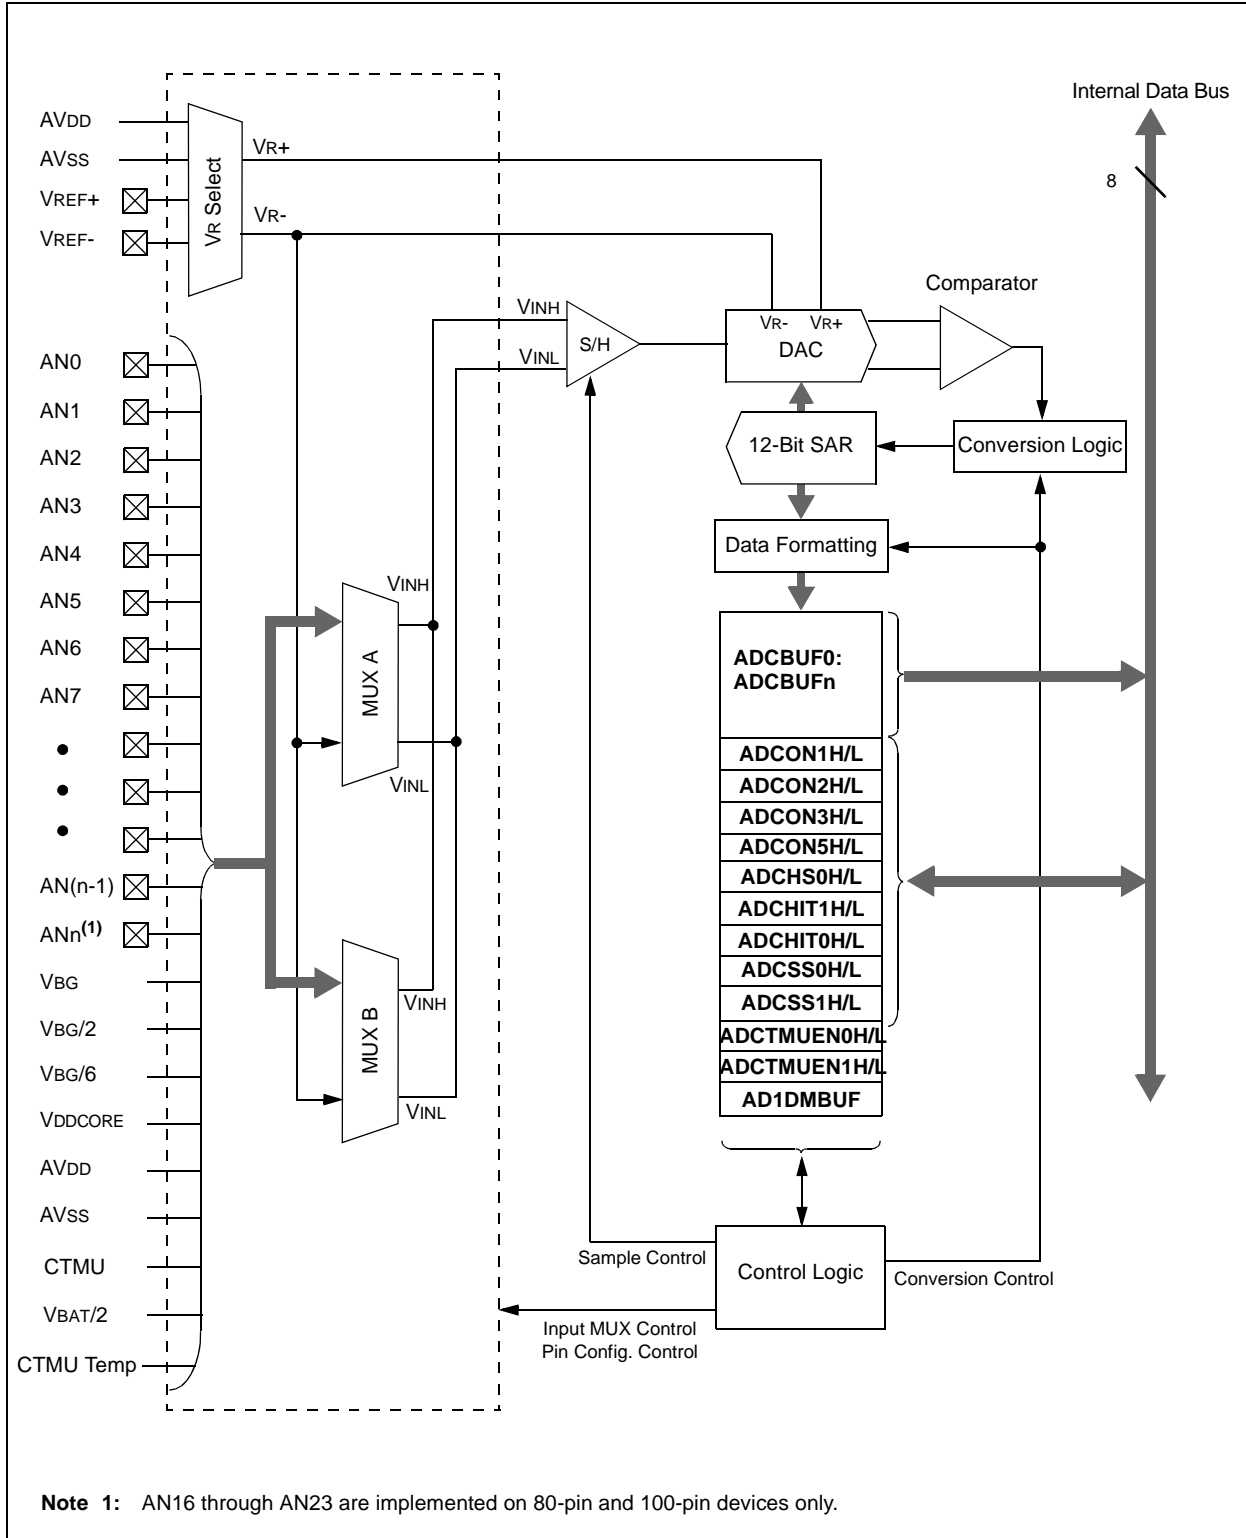
FIGURE 22-1: 12-BIT A/D CONVERTER BLOCK DIAGRAM (PIC18F97J94)

The block diagram in [Figure 22-1](#) contains incorrect names for several registers. The corrected figure is as follows:

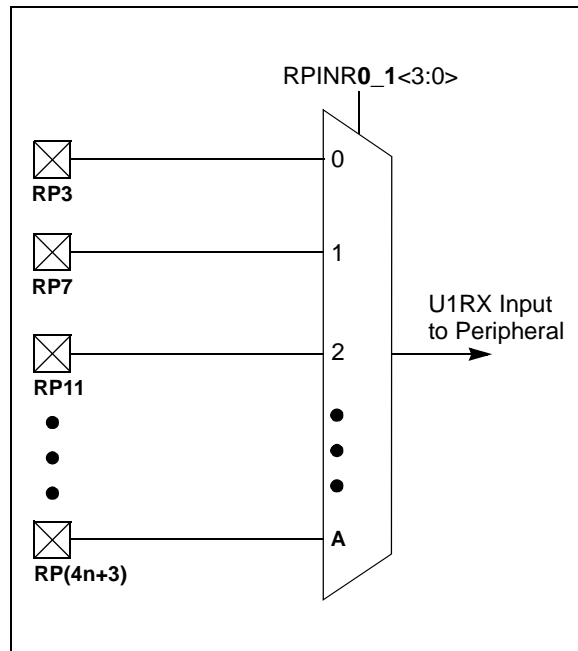
FIGURE 11-7: REMAPPABLE INPUT FOR U1RX

Additionally, [Figure 11-7](#) indicates that the U1RX input can be assigned to any RPn pin, which is incorrect. The U1RX pin can only be remapped to one of the following RP(4n+3) pins, as indicated in [Table 11-13](#): RP3, RP7, RP11, RP15, RP19, RP23, RP27, RP31, RP35, RP39, RP43.

“For example, to assign U1RX to **RP3**, write the value, `h'0`, to `RPINR0_1<3:0>`. [Figure 11-7](#) illustrates remappable pin selection for the U1RX input.”
