TMS320F2805x Piccolo™ MCUs

Silicon Revisions A, 0

This document describes the silicon updates to the functional specifications for the TMS320F2805x microcontrollers (MCUs).

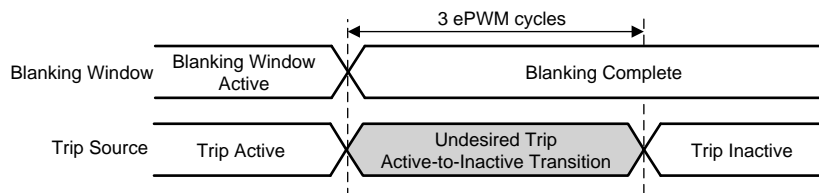
Figure 3. Undesired Trip Event and Blanking Window Expiration

The blanking window is typically used to mask any PWM trip events during transitions which would be false trips to the system. If an ePWM trip event remains active for less than three ePWM clocks after the end of the blanking window cycles, there can be an undesired glitch at the ePWM output.

Figure 3 illustrates the time period which could result in an undesired ePWM output.

Extend or reduce the blanking window to avoid any undesired trip action.
