**MICROCHIP****PIC18F6390/6490/8390/8490****PIC18F6390/6490/8390/8490 Rev. B3 Silicon Errata**

**The following silicon errata apply only to PIC18F6390/6490/8390/8490 devices with these Device/Revision IDs:**

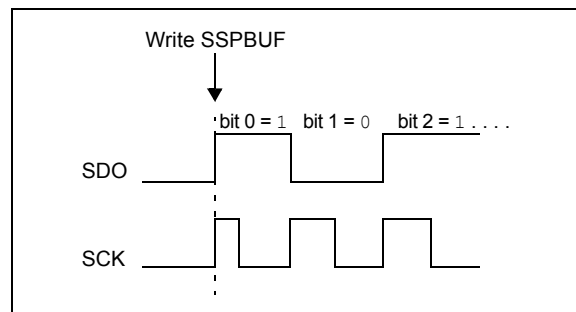
**FIGURE 1: SCK PULSE VARIATION USING TIMER2/2**

When the SPI is using Timer2/2 as the clock source, a shorter than expected SCK pulse may occur on the first bit of the transmitted/received data (Figure 1).

To avoid producing the short pulse, turn off Timer2 and clear the TMR2 register, load the SSPBUF with the data to transmit and then turn Timer2 back on. Refer to Example 4 for sample code.
