## ***TMS320F2802x, TMS320F2802xx MCUs Silicon Revisions B, A, 0***

This document describes the silicon updates to the functional specifications for the TMS320F2802x and TMS320F2802xx microcontrollers (MCUs).

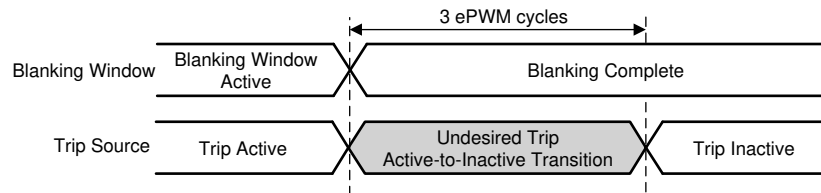
**Figure 5. Undesired Trip Event and Blanking Window Expiration**

The blanking window is typically used to mask any PWM trip events during transitions which would be false trips to the system. If an ePWM trip event remains active for less than three ePWM clocks after the end of the blanking window cycles, there can be an undesired glitch at the ePWM output.

Figure 5 illustrates the time period which could result in an undesired ePWM output.

**Workaround(s)** Extend or reduce the blanking window to avoid any undesired trip action.
