*OMAP3530/25/15/03 Applications Processor*  
**Silicon Revisions 3.1.2, 3.1, 3.0, 2.1, and 2.0**

# Silicon Errata

Literature Number: SPRZ278F  
February 2008—Revised October 2010

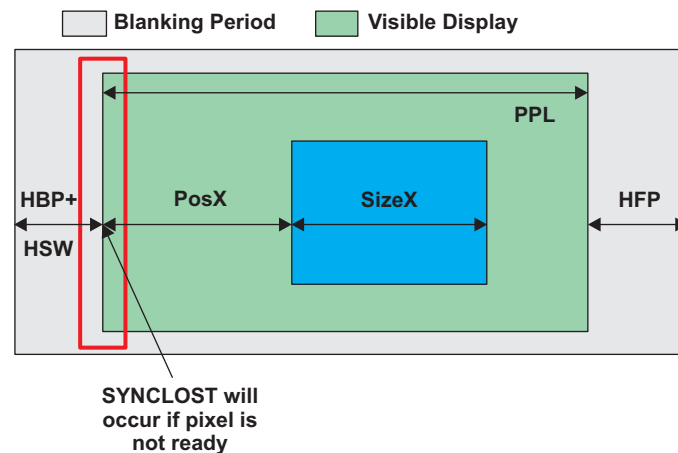
**Figure 2. Synclost Interrupt**

On OMAP35x Applications Processor silicon revisions 3.1.2 and earlier, Synclost interrupts are observed when performing downscaling and shifting resulting windows on the right of the LCD panel. This interrupt occurs because there is not sufficient time to load the necessary lines buffer before performing downscaling operation. DISPC video pipeline is expected to be ready with the pixels at the end of HSW+HBP period. This limitation is applicable on 3 and 5 taps configurations.

To ensure proper downscaling operation, these conditions should be met:

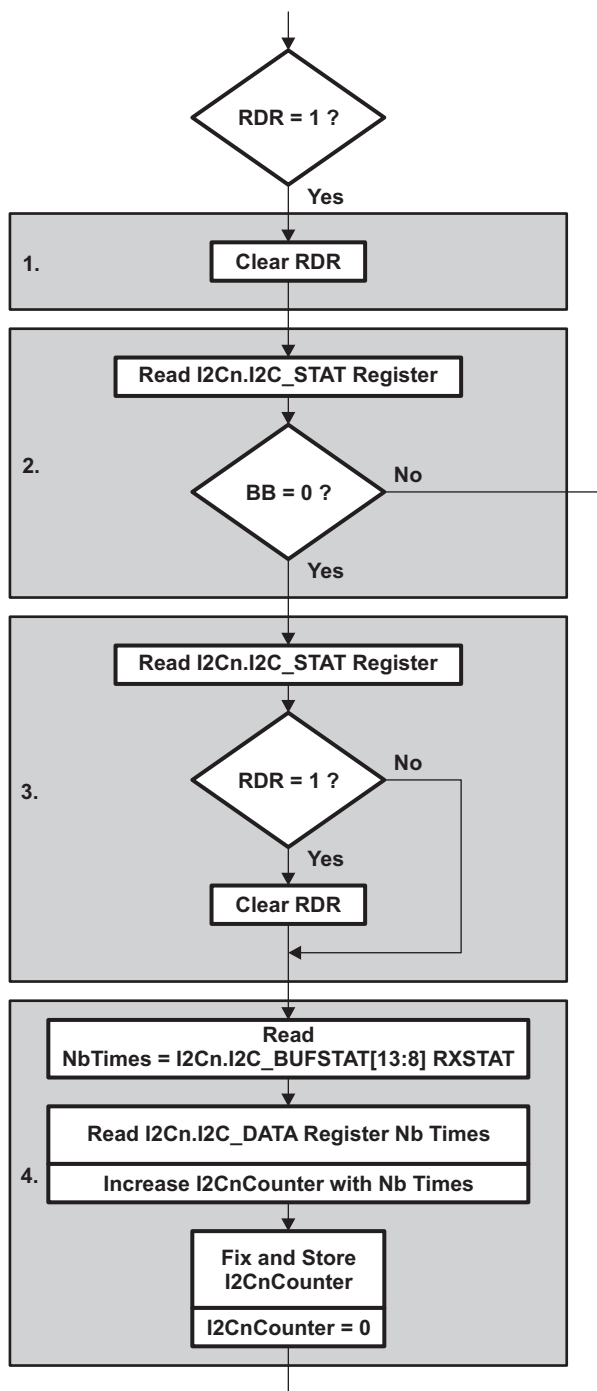
**Figure 3. I2C Flowchart**

**Details**    Under certain rare conditions, the I2C\_STAT[13].RDR bit may be set as well as the corresponding interrupt fire, even when there is no data in the receive FIFO, or the I2C data transfer is still ongoing. These spurious RDR events must be ignored by the software.

**Workaround(s)**    Software must filter out unexpected RDR pulses, using the flowchart illustrated in [Figure 3](#) when receiving an I2C RDR interrupt.

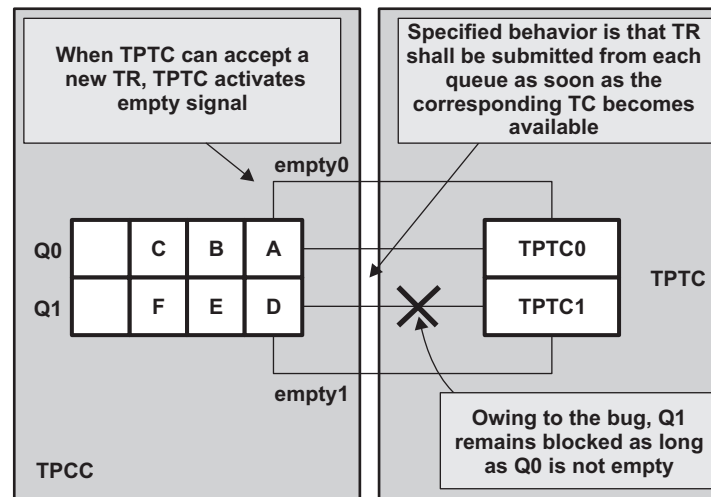
**Figure 4. TR Submission Scheme**

The EDMA channel controller (TPCC) has 2 event queues: Q0 and Q1. Each queue can be mapped to one of the two Transfer Controllers (TPTC): TPTC0 or TPTC1. As explained in the *OMAP35x Technical Reference Manual* (literature number [SPRUF98](#)), the events in each event queue will be extracted as soon as the corresponding TPTC is available for a new Transfer Request (TR) to be programmed into the TPTC. However, due to an issue in the IVA2.2 subsystem, the requests queued in Q1 cannot be submitted to their TPTC as long as Q0 is not empty.

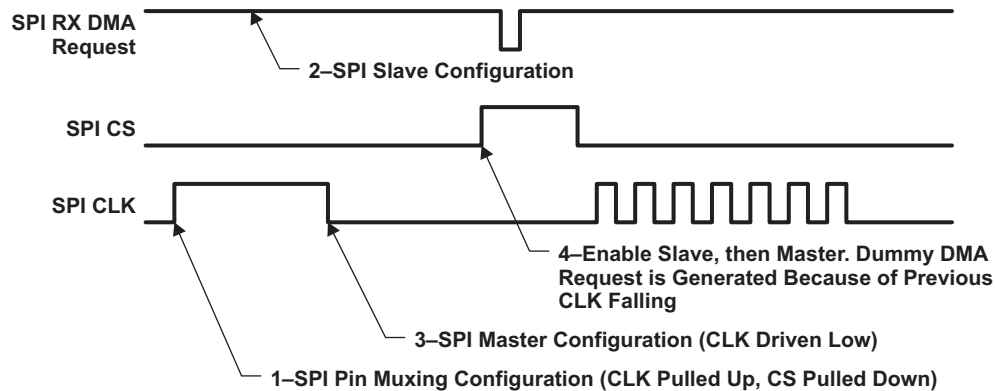
**Figure 5. SPI Dummy DMA RX Generation**

A dummy DMA RX request is generated as soon as the SPI is configured in *slave* mode and a SPI clock edge is detected. The dummy DMA RX request is generated during module configuration, when the module is not performing an SPI transfer. The dummy DMA RX request occurs as soon as the SPI interface signal sensitivity is changed compared to the default value.

The dummy DMA RX request is generated because the mechanism to avoid dummy data capture on a CS glitch is done regardless of channel activation.

**Workaround(s)** Avoid conditions where the SPI is in *slave* mode and the SPI clock toggles (see examples below).

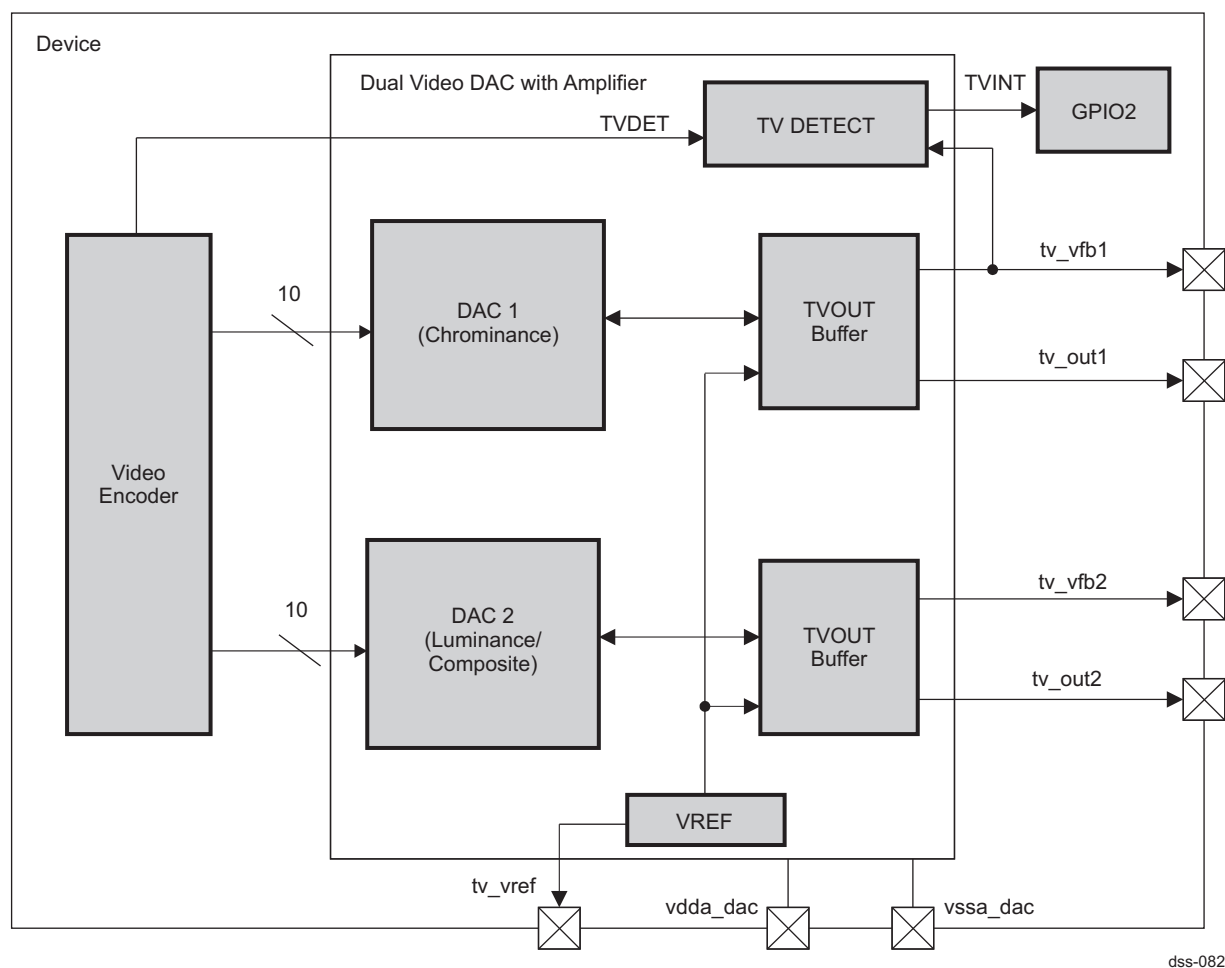
**Details**

Furthermore, for proper TV detection in composite video mode (CVBS), DAC1 should be used for luminance and DAC2 for chrominance. Therefore, as a direct consequence of implementation, the TV detect feature is not available for composite video mode.

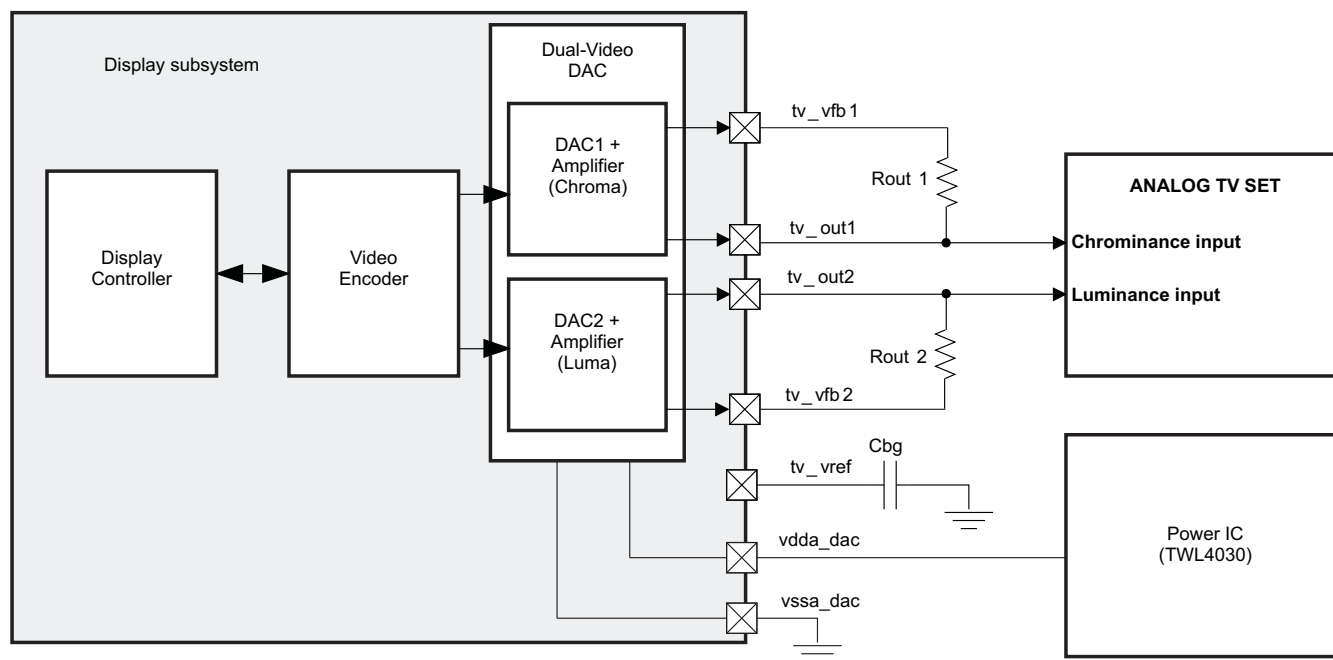
**Figure 17. External Connection to TV Set**

There is no workaround for the TV detect functionality. This feature is unavailable in *composite* video mode.

For proper TV out functionality, the external connection to the TV set must follow the implementation shown in [Figure 17](#).
