# **AM1810 ARM Microprocessor Silicon Revisions 2.3, 2.1 and 2.0**

## **Silicon Errata**

Literature Number: SPRZ339H  
November 2010–Revised September 2014

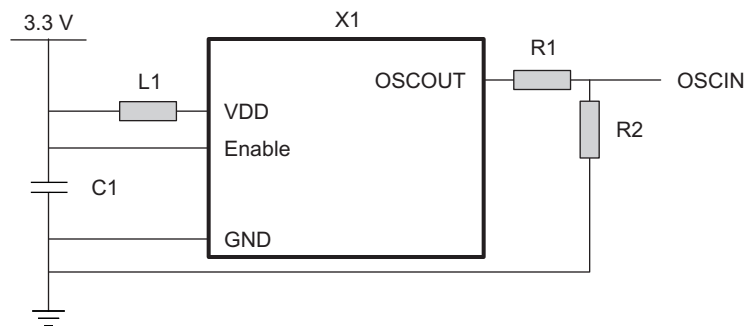
**Figure 2. External 3.3V Clock Source**

On all silicon revisions, certain design elements make this device susceptible to radiated noise during an ESD strike, as described in the standard IEC 61000-4-2. Exposure to the electrical noise caused by the ESD can cause soft device failures due to noise coupling on the system clock (OSCIN). ESD events within the IEC spec range do not cause permanent device damage and full functionality is recoverable with a device reset. The sensitivity to this noise issue is primarily due to the 1.2V oscillator/clock input implemented on this device. The low voltage range, coupled with slow rise and fall times, provides a lower noise margin than other TI devices with higher voltage internal oscillators (for example, 1.8V or 3.3V oscillators).

If ESD robustness is a concern, it is strongly recommended to avoid using the internal oscillator as a clock source. An external 3.3V clock source with a resistor voltage divider as in [Figure 2](#) can be used to externally generate the required 1.2V input clock. By using an external clock input with fast rise/fall times (less than 5 ns), the noise margin improves significantly, increasing ESD noise resistance.

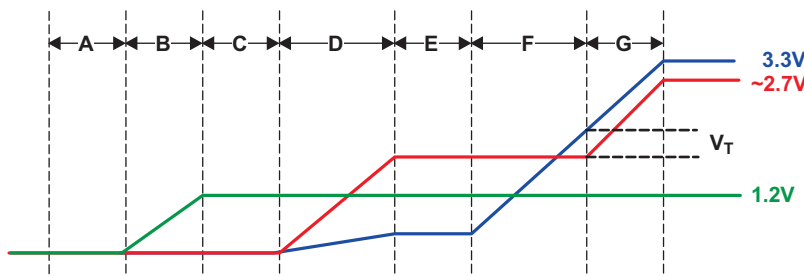
**Figure 4. Faulty power-supply ramp**

The behavior is the same until zone G. When the DVDD3318\_x supply exceeds DVDD18 by a transistor  $V_T$ , the DVDD18 supply begins to be pulled up by the DVDD3318\_x supply and follows the DVDD3318\_x supply by DVDD3318\_x -  $V_T$ . Since the DVDD18 supply is often connected to other 1.8V supplies in the design, these other supplies can be pulled up also.

The condition occurs because the dual-voltage IO buffers have voltage detection circuitry that monitors DVDD3318\_x during reset and determines whether the applied supply voltage is 1.8V or 3.3V. This detection circuitry then configures the IOs to operate at the appropriate voltage. As the DVDD3318\_x supply ramps, there is a small range near DVDD18 +  $V_T$  where the voltage detection circuit finds the state indeterminate and briefly turns on circuitry associated with both voltage options creating a current path between them. This current path can cause the DVDD18 supply to be pulled up. The mechanism for this behavior is explained below:

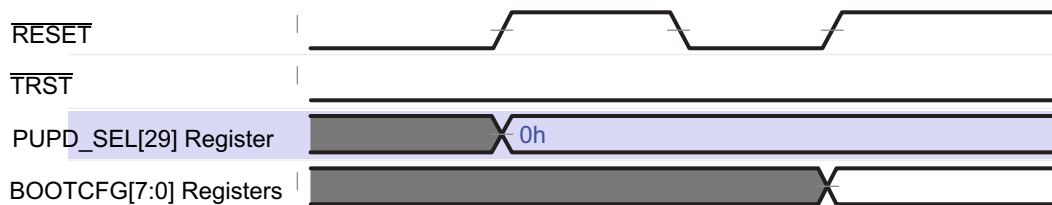
### Initialization of PUPD\_SEL[29] and BOOTCFG[7:0] Registers with Weak or No External Pull Resistors on BOOT[7:0] Pins

Internal pullups being enabled on the BOOT[7:0] pins may result in boot failures. If weak external pulldown resistors are used on the PCB to select the boot mode, they may not be able to overpower the internal pullups. This can result in the wrong boot mode being latched in the BOOTCFG[7:0] register when coming out of Reset.

Once the device is out of Reset, the PUPD\_SEL[29] register is initialized, and the internal pulldown resistors for the BOOT[7:0] pins are all enabled. Issuing a second Power-On Reset ( $\overline{\text{POR}}$ ) results in the intended boot mode being latched, since the pins are internally pulled down as expected.

[Initialization of PUPD\\_SEL\[29\] and BOOTCFG\[7:0\] Registers with Weak or No External Pull Resistors on BOOT\[7:0\] Pins](#) shows the behavior of the PUPD\_SEL[29] register before and after reset. Assuming weak or no external pull resistors are on the BOOT[7:0] pins, the BOOTCFG register will latch the unknown values after the device initially comes out of Reset. Note that,  $\overline{\text{TRST}}$  **must** always be low in order to issue a  $\overline{\text{POR}}$  and latch the boot pin values -- the boot pins are not latched after a Warm Reset.

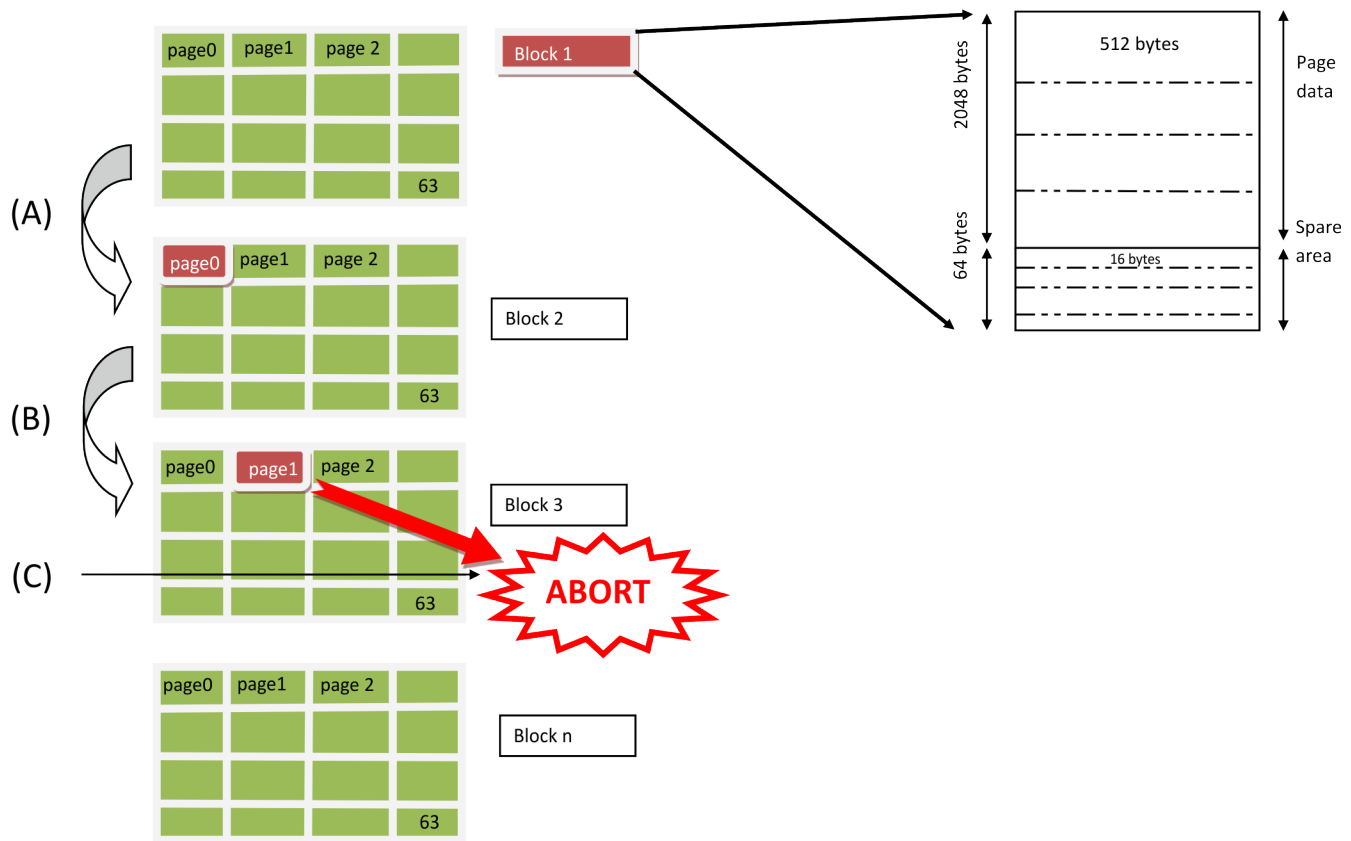
### D800K008 ROM Behavior Before Application of Software Patch<sup>(1)</sup>

However, over the life span of the NAND flash, ECC data stored in the spare area can develop errors due to bit flips. When the calculated syndrome indicates an error in the ECC data, the ECC Correct and Read functions of the RBL abort the read process even though, it is possible to correct up to 4 bit errors combined in user and ECC data. Consequently the device fails to boot.

If page0 of the good block has an ECC data error or an uncorrectable error (more than 4 bit errors combined), the RBL skips to the next block (shown as (B) in [D800K008 ROM Behavior Before Application of Software Patch<sup>\(1\)</sup>](#)). This bad block check mechanism enables the device to check up to the first 32 blocks in the NAND flash for booting (the boot process will fail if all 32 blocks have uncorrectable or ECC data errors in page0). Note that the RBL does not abort on detecting an error in ECC data on page0.

Once the RBL finds a good block with a good page0, it continues to read subsequent pages in that block. If an uncorrectable or ECC error is detected in subsequent pages, the RBL will abort with a boot error (shown as (C) in [D800K008 ROM Behavior Before Application of Software Patch<sup>\(1\)</sup>](#)). The workaround, described below, enables the boot process to continue for both types of errors (ECC data and uncorrectable errors).

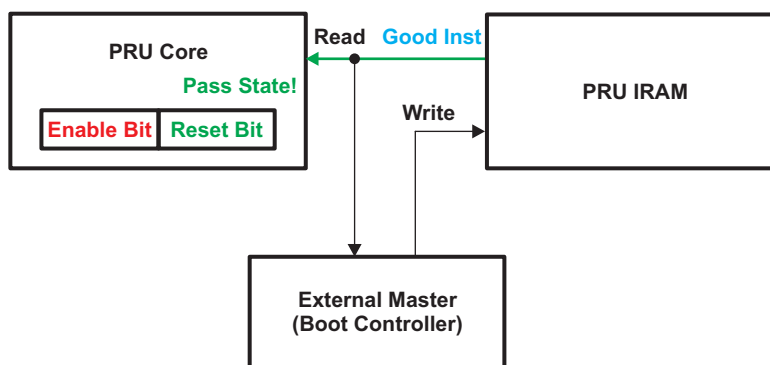
Figure 10. Secondary Reset

Although the PRU core execution is stuck, the PRU IRAM read bus is now initialized with a non-reserved instruction that was fetched from the IRAM by the PRU core (see [Figure 10](#)). If a secondary reset is provided to the device (either POR or WARM), the PRU will be able to execute its functional instructions as expected.

Note that in order to recover from this fail state with a secondary reset, the Boot Controller must be allowed to execute up to the point where the PRU has fetched a known instruction from the PRU IRAM. The approximate count of 15k clock cycles is sufficient.
