## PIC18F6310/6410/8310/8410 Rev. B3 Silicon Errata

The PIC18F6310/6410/8310/8410 Rev. B3 parts you have received conform functionally to the Device Data Sheet (DS39635C), except for the anomalies described below. Any Data Sheet Clarification issues related to the PIC18F6310/6410/8310/8410 will be reported in a separate Data Sheet errata. Please check the Microchip web site for any existing issues.

**The following silicon errata apply only to PIC18F6310/6410/8310/8410 devices with these Device/Revision IDs:**

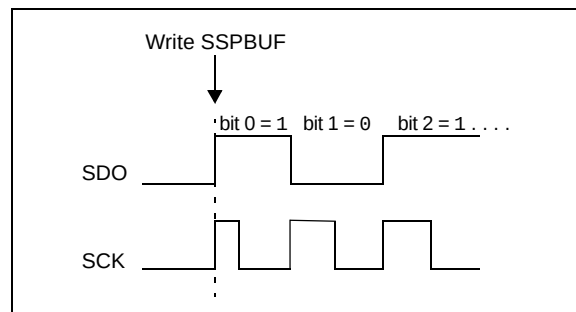
**FIGURE 1: SCK PULSE VARIATION USING TIMER2/2**

When the SPI is using Timer2/2 as the clock source, a shorter than expected SCK pulse may occur on the first bit of the transmitted/received data ([Figure 1](#)).

To avoid producing the short pulse, turn off Timer2 and clear the TMR2 register, load the SSPBUF with the data to transmit and then turn Timer2 back on. Refer to [Example 4](#) for sample code.
