**TMS320C6678**  
**Multicore Fixed and Floating-Point Digital**  
**Signal Processor**  
**Silicon Revision 1.0, 2.0**

# **Silicon Errata**

Literature Number: SPRZ334H  
January 2011–Revised June 2015

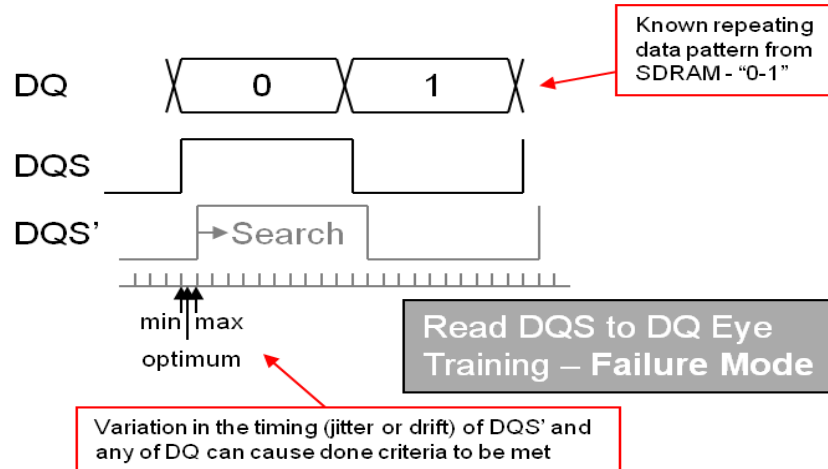
**Figure 4. Read DQS to DQ Eye Training - Failure Mode**

The leveling feature with the problem is the Read Data Eye Training. Depending on the jitter seen on the DQ and DQS signals, this leveling feature will fail to converge on a good data eye, resulting in corrupted DSP to DDR3 SDRAM reads.

However, if too much jitter is present on the DQ or DQS signals, the search can converge to a false edge as shown in Figure 4.

This mode is enabled by setting bit 9 (0-indexed) of the DDR3\_CONFIG\_REG\_23 at address 0x02620460. The lower 8 bits (bits 7:0) must not be overwritten and will contain their default value of 0x34. The default value is recommended for use. After programming DDR3\_CONFIG\_REG\_23, proceed to enable auto-leveling. Please refer to the *DDR3 Initialization Application Report* ([SPRABL2](#)) for details of the sequence of steps.

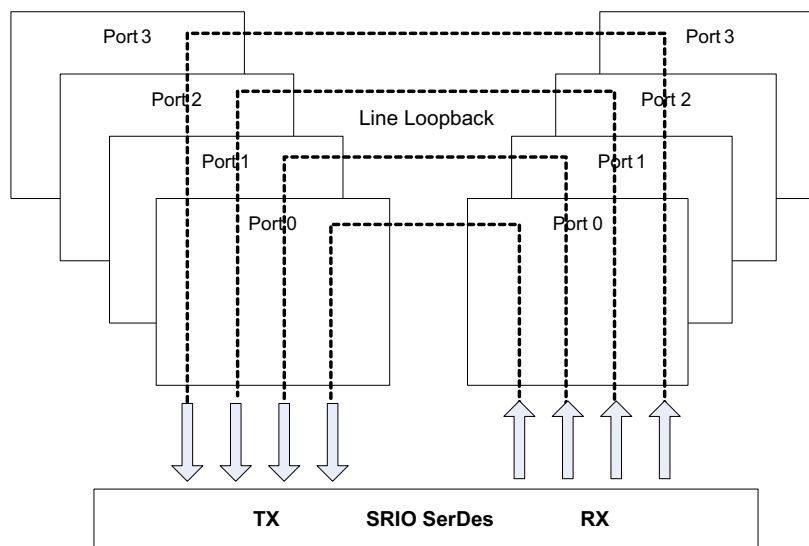
**Figure 5. SRIO SerDes in Loopback Mode**

The port does not provide any clock compensation when line loopback is enabled. The transmit clock must be externally synchronized with the receive clock. There is only a small FIFO that can compensate for PLL jitter or wander. Hence, correct operation of line loopback requires that the link partners use the same reference clock for the SRIO physical layer, in order to avoid overruns or underruns due to clock frequency mismatch between the link partners. As a result, line loopback mode is generally restricted to validation and qualification of board signal integrity in a lab environment.

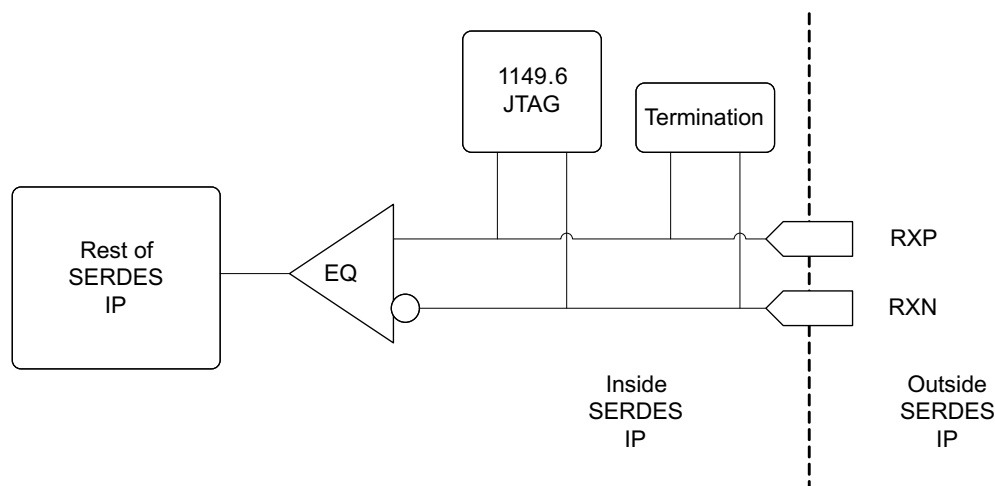
**Figure 7. Simplified SerDes Receiver Block Diagram Depicting Relative Placement of Major Receiver Components**

A problem has been identified in some cases where the AC-JTAG (IEEE 1149.6, edge-sensitive) input cells on Rincewind and Draco receivers do not reliably respond to input edge transitions from an associated transmitter. Because of this failure, the 1149.6 scan-chain users can receive faulty signal levels transitions or no transitions at all.

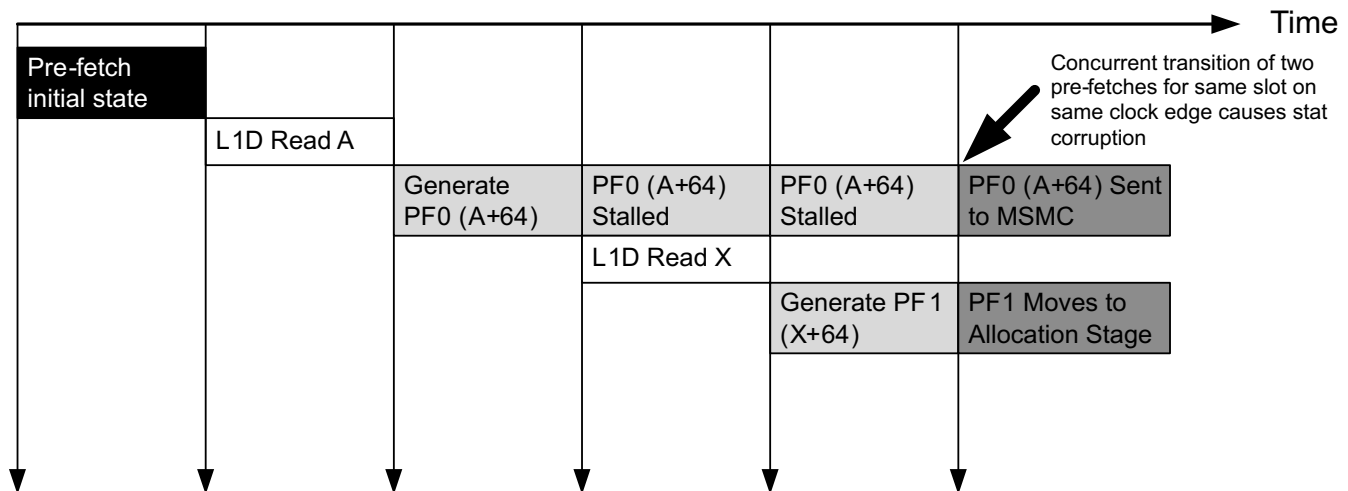
**Figure 11. Sequence diagram**

The fault lies in the 'sorting' hardware which can lead to the first pre-fetch not being marked stale under certain boundary conditions (see pathological sequence below). The subsequent fetch access when the pre-fetch access wasn't marked stale will access the stale data that has been cleared (but not yet marked as stale.) This results in the read exception and/or incorrect data being fetched. Thus, the issue occurs only when the re-fetch feature is triggered and only L1D accesses use the re-fetch feature.

8. Instead of PF0 being marked stale and thrown away when returned, both PF0 and PF1 are marked valid and outstanding.
9. This leads to two valid outstanding pre-fetches for the same data buffer slot which is an invalid state and can result in unexpected behavior for a subsequent pre-fetchable data access to address X+64.
