*RM44x Microcontroller*

**Silicon Revision A**

# **Silicon Errata**

Literature Number: SPNZ231B  
July 2015–Revised May 2016

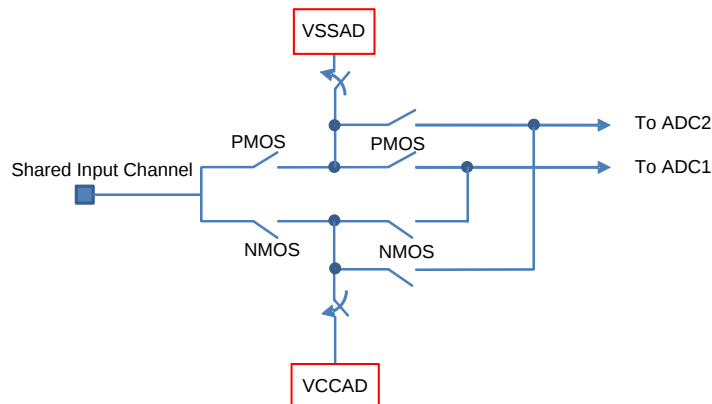
**Figure 2. Shared Input Channel in "Open" State**

**Issue** This microcontroller (MCU) has two Analog-to-Digital Converters (ADCs). Some of the input channels are unique to ADC1 while some are shared between ADC1 and ADC2. [Figure 2](#) shows a block diagram of an input channel shared between ADC1 and ADC2.

The PMOS and NMOS switches are open indicating that this shared input channel is not currently being sampled either by ADC1 or by ADC2. Also, there are switches to VCCAD and VSSAD that are closed. If any current is injected into this analog input, any leakage through the open PMOS switch will be shunted to VSSAD. These switches to VSSAD and VCCAD are opened as soon as this shared input channel is being sampled by either ADC1 or ADC2.
