*RM46x Microcontroller*

**Silicon Revision C**

# **Silicon Errata**

Literature Number: SPNZ219B  
March 2015–Revised May 2016

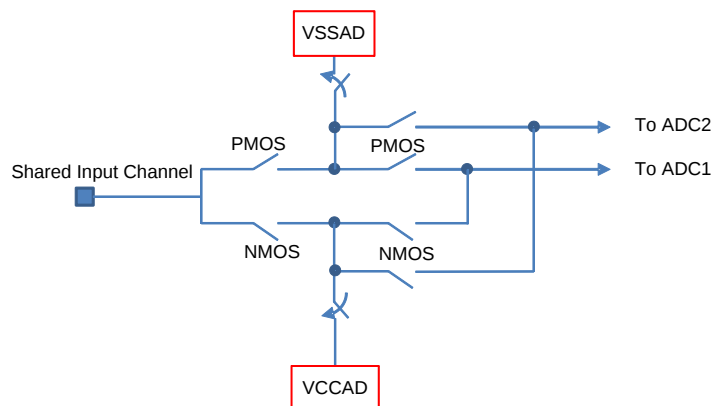
**Figure 2. Shared Input Channel in "Open" State**

**Issue**      This microcontroller (MCU) has two Analog-to-Digital Converters (ADCs). Some of the input channels are unique to ADC1 while some are shared between ADC1 and ADC2. [Figure 2](#) shows a block diagram of an input channel shared between ADC1 and ADC2.

The PMOS and NMOS switches are open indicating that this shared input channel is not currently being sampled either by ADC1 or by ADC2. Also, there are switches to VCCAD and VSSAD that are closed. If any current is injected into this analog input, any leakage through the open PMOS switch will be shunted to VSSAD. These switches to VSSAD and VCCAD are opened as soon as this shared input channel is being sampled by either ADC1 or ADC2.

1. Configure the two ADC modules such that their sampling periods do not overlap, or
2. Limit the shared analog input upper limit to be lower than ( $V_{CCAD} - 0.3V$ ). The PMOS leakage is reduced exponentially if the input is lower than  $V_{CCAD} - 0.3V$ .
