dsPIC33FJ32GS406/606/608/610 and dsPIC33FJ64GS406/606/608/610

dsPIC33FJ32GS406/606/608/610 and dsPIC33FJ64GS406/606/608/610 Family Silicon Errata and Data Sheet Clarification

The dsPIC33FJ32GS406/606/608/610 and dsPIC33FJ64GS406/606/608/610 family devices that you have received conform functionally to the current Device Data Sheet (DS70000591F), except for the anomalies described in this document.

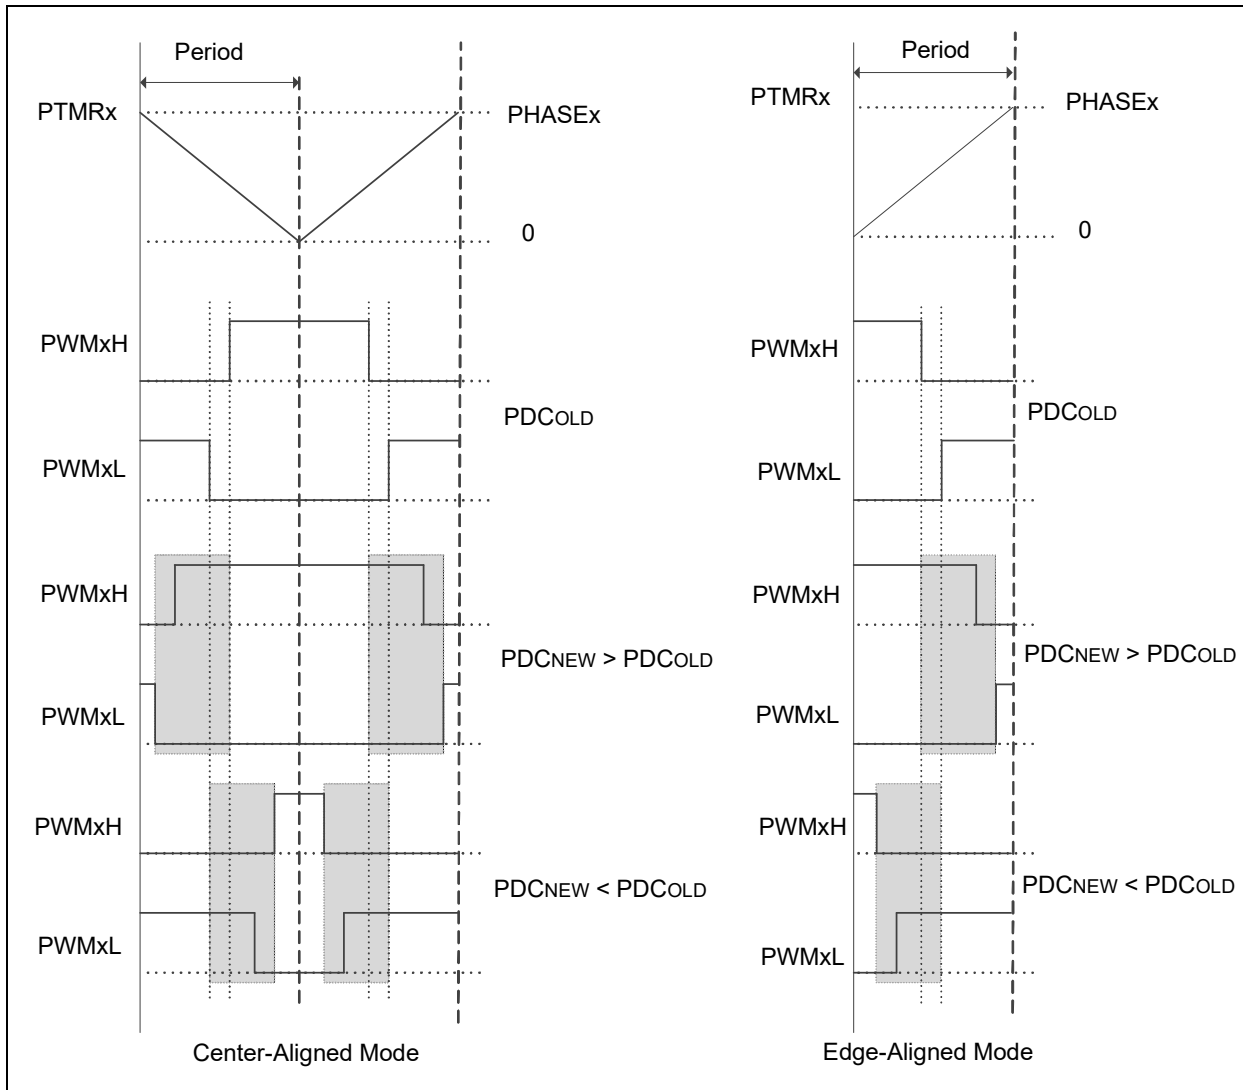
FIGURE 1: TIMING DIAGRAMS FOR CENTER-ALIGNED AND EDGE-ALIGNED MODES

The PWMx generator may not assert dead time on the edges of transitions. This has been observed when all of the following conditions are present:

In [Figure 1](#) (following page), if the duty cycle write occurred in the shaded box, then PWMxH and PWMxL will make an immediate transition without dead time.

None. However, in most applications the duty cycle update timing can be controlled using the TRIGx trigger or Special Event Trigger, such that the above mentioned conditions are avoided altogether.

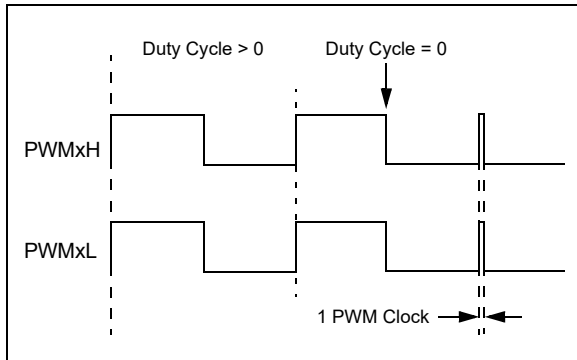
FIGURE 2: ISSUE EXAMPLE FOR REDUNDANT OUTPUT MODE

In Redundant Output mode (IOCONx[11:10] = 01) and Push-Pull Output mode (IOCONx[11:10] = 10), with the Immediate Update Enable bit disabled (PWMCONx[0] = 0), when the Duty Cycle register is updated from a non-zero value to zero, a glitch pulse of a width equal to one PWM clock will appear at the next PWM period boundary, as shown in Figure 2 (for the Redundant Output mode). The Duty Cycle register refers to the PDCx register if PWMCONx[8] = 0 or the MDC register if PWMCONx[8] = 1.

If the application requires a zero duty cycle output, there are two possible work around methods:

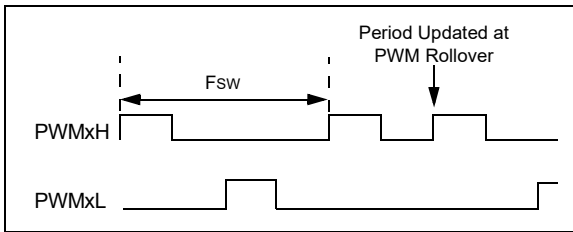
FIGURE 3:

When the PWM module is configured for Push-Pull mode (IOCONx[11:10] = 10) with the Enable Immediate Period Update bit enabled (PTCON [10] = 1), a write to the Period register that coincides with the period rollover event may cause the push-pull output logic to produce back-to-back pulses on the PWMx pins (Figure 3).

Ensure that the update to the PWM Period register occurs away from the PWM rollover event by setting the EIPU bit (PTCON[10] = 1). Use either the PWM Special Event Trigger (SEVTCMP) or the PWM Primary Trigger (TRIGx) to generate a PWM Interrupt Service Routine (ISR) near the start of the PWM cycle. This ISR will ensure that period writes do not occur near the PWM period rollover event.

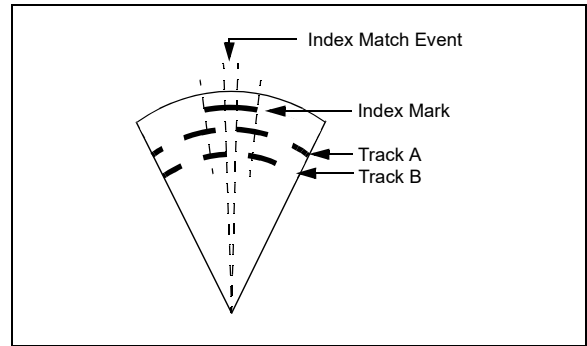
FIGURE 4: ENCODER IN THE SECTOR AROUND THE INDEX MARK

This issue is most likely to be seen in specific motor applications using a rotation encoder with an ungated index pulse, operating at near zero speed and/or in the presence of mechanical vibration. In these applications, the encoder may change direction and incrementally rock back and forth. If this happens with the encoder positioned in the vicinity of its index mark, the module will detect the first index match event as the encoder rotates into the index match event area, but not subsequent events if it drifts into and out of that position but stays within the index mark area (Figure 4). If the encoder count increments or decrements in only one direction, the index match will only occur once.

As a result of this, the value of POSxCNT may leave its expected range of 0 to maximum count (defined as the number of encoder pulses per revolution, minus 1), resulting in erroneous reporting of the rotor's position.

None.

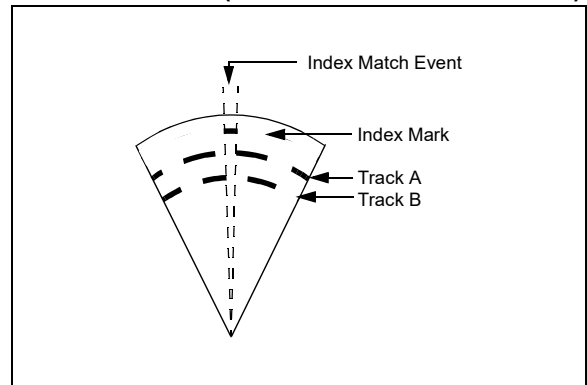
FIGURE 5: ENCODER IN THE SECTOR AROUND THE INDEX MARK (ONE COUNT WIDTH INDEX)

This issue is not seen when the encoder uses an index mark that is one encoder count in width (Figure 5).
