# dsPIC33CH512MP508

## dsPIC33CH512MP508 Family Silicon Errata and Data Sheet Clarification

The dsPIC33CH512MP508 family devices that you have received conform functionally to the current Device Data Sheet (DS70005371D), except for the anomalies described in this document.

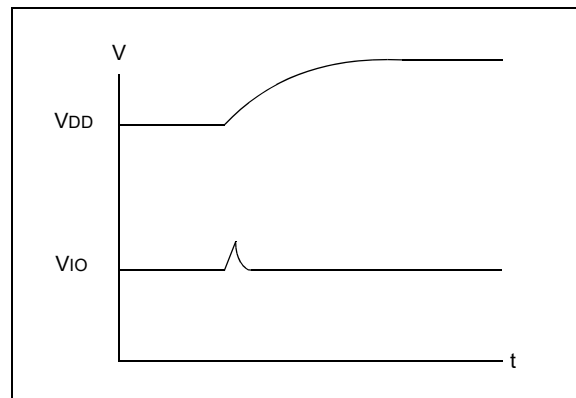
FIGURE 1-1: I/O RAMP

During a fast device power-up, when the VDD ramp is less than 4 mS, the I/O pins may drive up to 100  $\mu$ A current for a duration of up to 10  $\mu$ S (Figure 1-1).

Example applications affected may include complementary power switches, where a transient current shoot-through might occur. High-voltage applications with complementary switches should power the high-voltage 200  $\mu$ Sec later than powering the dsPIC<sup>®</sup> device to avoid the current shoot-through. This behavior is specific to each device and not affected by aging.

1. Slow down the VDD ramp time (greater than 4 mS for VDD to ramp 0V to 3.3V).
2. Ensure the circuitry that is connected to the pins can endure this pulse.
