## Applicability

This document applies to the STM32F078CB/RB/VB devices and their variants shown in [Table 1](#).

# 1 Summary of device limitations

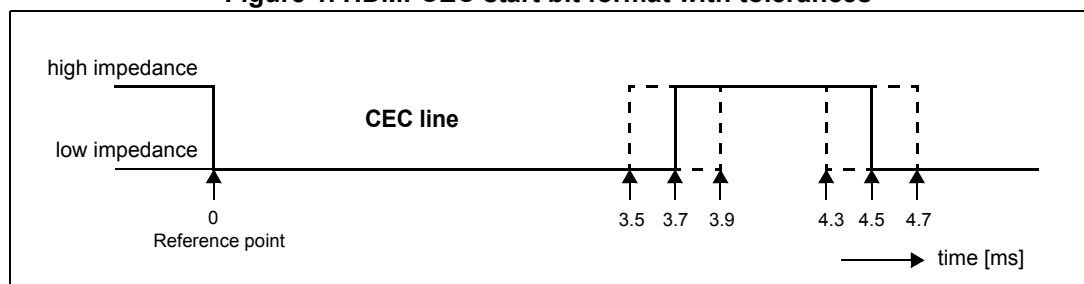
**Figure 1. HDMI-CEC start bit format with tolerances**

This failure is unlikely to happen as the CEC start bit corruption by another device can only occur if that device does not respect the CEC communication protocol.

The start bit timing standard tolerances are shown in [Figure 1](#). The start bit is initiated by the device by driving the CEC line low (reference point). After 3.7 ms, the device releases the CEC line and starts checking its level. The following conditions must be met for the start bit to be valid:

If one of these conditions is not met, the transmission is aborted and never automatically retried. No error flag is set and the TXSOM (Tx Start Of Message) bit is not cleared.

The only way to detect this error is for the application software to start a timeout when setting the TXSOM bit, restart it upon ARBLST or any RX event (as the transmission can be
