# **66AK2G1x Multicore DSP+Arm® KeyStone II System-on-Chip (SoC) Silicon Revision 1.0**

This document describes the known exceptions to the functional specifications (advisories). This document may also contain usage notes. Usage notes describe situations where the device's behavior may not match presumed or documented behavior. This may include behaviors that affect device performance or functional correctness.

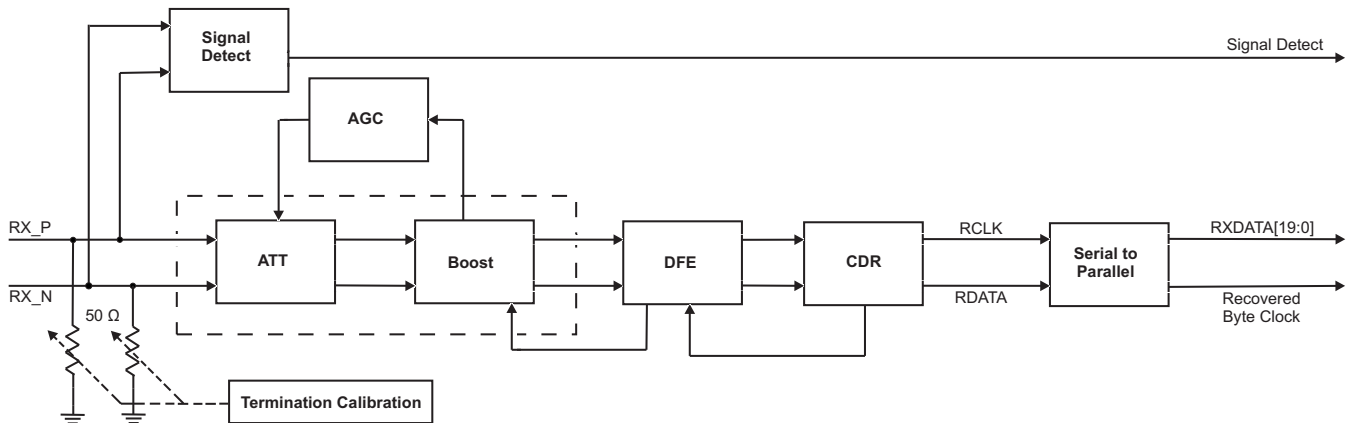
**Figure 2. RX Path Block Diagram**

The SerDes on PCIe will not automatically adapt its RX equalization when provided with certain data encodings common to that peripheral's electrical standard.

The SerDes BOOST block was designed to require a specific set of patterns in order to best adapt its parameters to the channel. If these patterns are not found, the BOOST adaptation algorithm will not update the internal block settings and/or may incorrectly update these settings. The required data pattern is a series of six 0's followed by a 101 pattern. This pattern must occur numerous times on both odd and even bit alignments. This data pattern is not present in the 8b/10b coded symbols that are sent over many of the high speed peripheral links.

If the BOOST has not been properly adapted for the received signal, then there is a chance that the SerDes will be unable to recover the RX data or the error rate may be higher than expected.

The recommended workaround is to not use the RX equalization auto-adaptation mechanism with the impacted interfaces at higher data rates. As an alternative, a user can hardcode the optimal ATT and BOOST values for their channel. These optimal ATT and BOOST values must be determined by the user through one of two options:

- Perform BER test with PRBS sequence and sweep across all values of ATT/BOOST while using a fixed set of TX parameters that have already been optimized. Use optimal ATT and BOOST value permutation that has the most margin. This is the value permutation that is both error-free and "farthest" from permutations with errors.
  - The SerDes DIAG tests can be found under <TI\_PDK\_INSTALL\_DIR>\packages\ti\diag\serdes\_diag in the latest CSL/PDK release and can be configured to perform this test.
- Perform a test where a PRBS data pattern is presented to the RX and the ATT/BOOST are allowed to auto-adapt. This method can also be used to identify the optimal ATT and BOOST value permutation that has the most margin.

The optimal ATT and BOOST values found by one of the two above methods can be hardcoded into the SerDes upon initialization.
