# ES\_LPC1850/30/20/10

Errata sheet LPC1850, LPC1830, LPC1820, LPC1810

Rev. 7.2 — 20 September 2019

Errata sheet

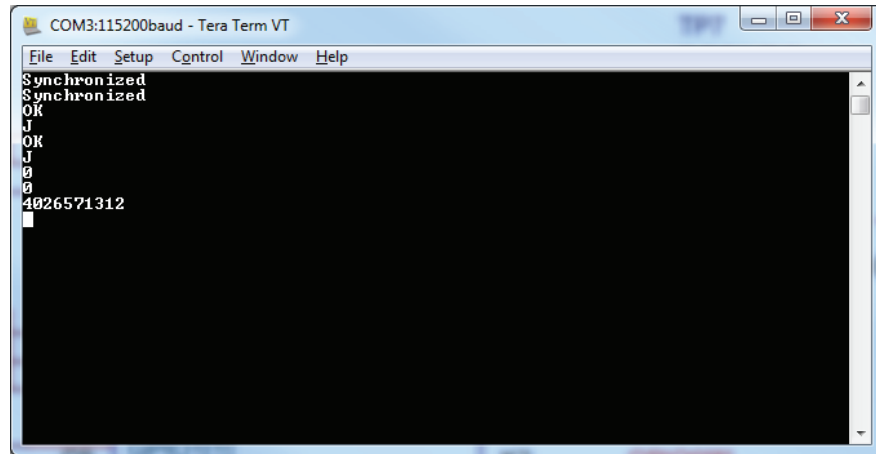
Incorrect example:

The 'J' command in ISP mode should return an error code, followed by an ASCII string representation of the part ID, followed by a 0. However what is actually returned is the error code, followed by a 0, followed by an ASCII string representation of the part ID. The problem is the last two items returned are swapped.

There is no work-around for this problem.

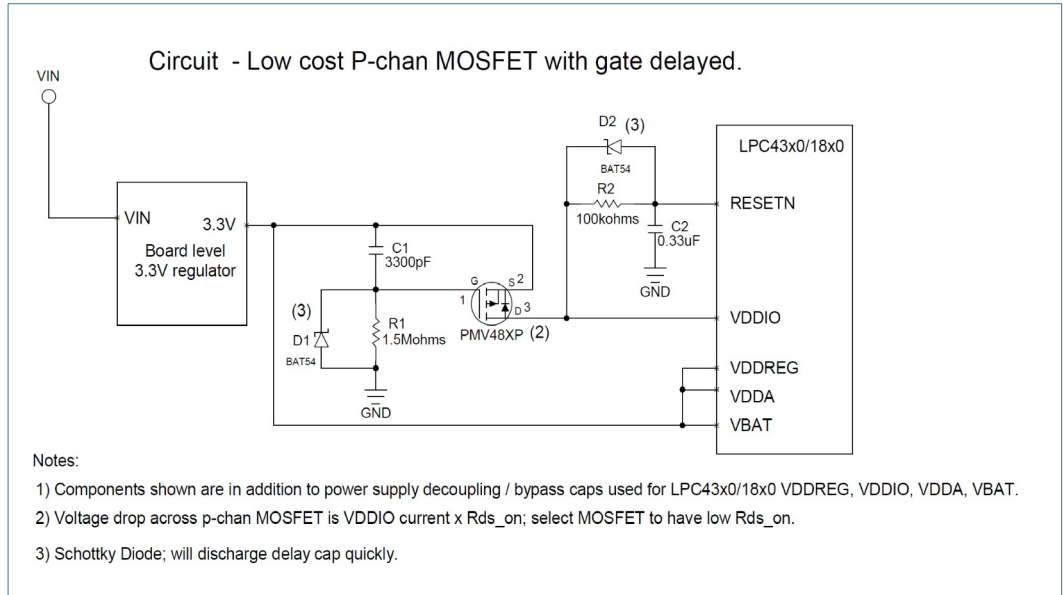
On all packages, repeated power cycling of the device may cause erroneous programming of the OTP banks. During ramp-up, the VDDREG supply voltage does not have enough time to settle and initialize the OTP controller before valid programming voltage is reached on the VPP pin. This may cause accidental programming of the OTP banks. Accidental programming of the OTP banks does not occur during Power-down of the supply voltage.

- Do not tie VDDIO to VDDREG and VDDA pins. The power supplied to the VDDIO pin should be delayed by 2 ms after the power supply on the VDDREG and VDDA pins stabilizes at the operating voltage level. The signal to the RESETN pin must also be delayed by 2 ms after the power supply on the VDDIO pin stabilizes at the operating voltage level.

The following circuit diagram is an example that shows the P-channel MOSFET with the gate delayed and the R-C delay circuit connected to the RESETN pin.

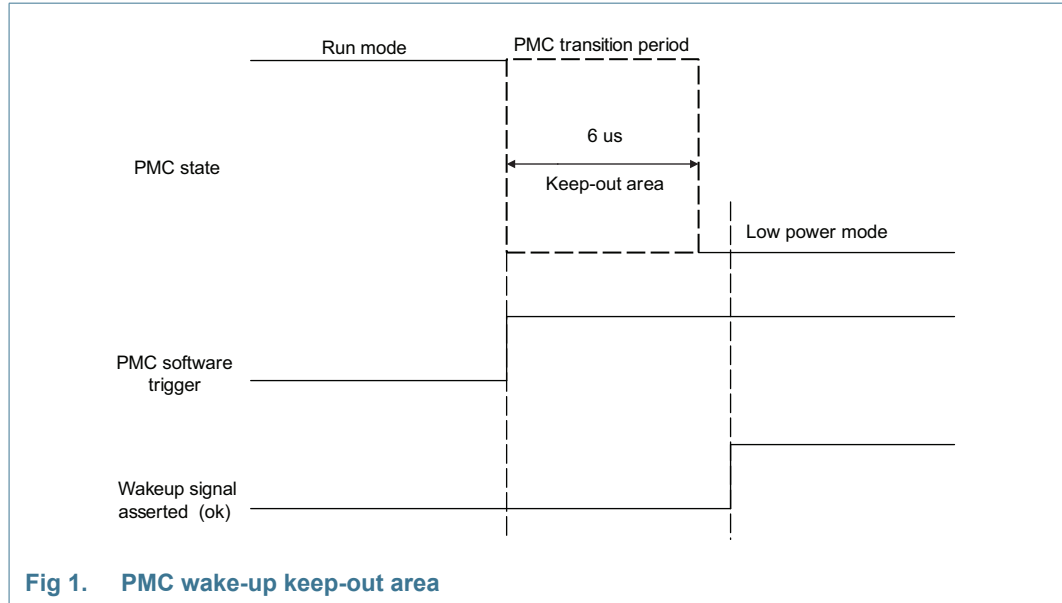
**Fig 1. PMC wake-up keep-out area**

When the chip is in a transition from active to Deep Sleep, Power Down, or Deep Power Down, wake-up events are not captured and they will block further wake-up events from propagating. The time window for this transition is 6  $\mu$ s and is not affected by the chip clock speed. After a wake-up event is received during the PMC transition, the chip can only recover by using an external hardware reset or by cycling power.

Make sure that a wake-up signal is not received during the Deep Sleep, Power Down, or Deep Power Down transition period. An example circuit to work around this could include an external 6  $\mu$ S one shot which could be triggered via software using a GPIO line when entering Deep Sleep, Power Down, or Deep Power Down mode. The one-shot's output could be used to gate the wake-up signal(s) to prevent receiving a wake-up signal during the PMC transition period. Depending on the system design, it may also be needed to latch the wake-up signal(s) so that they will still be present after the one-shot's 6  $\mu$ S time-out.

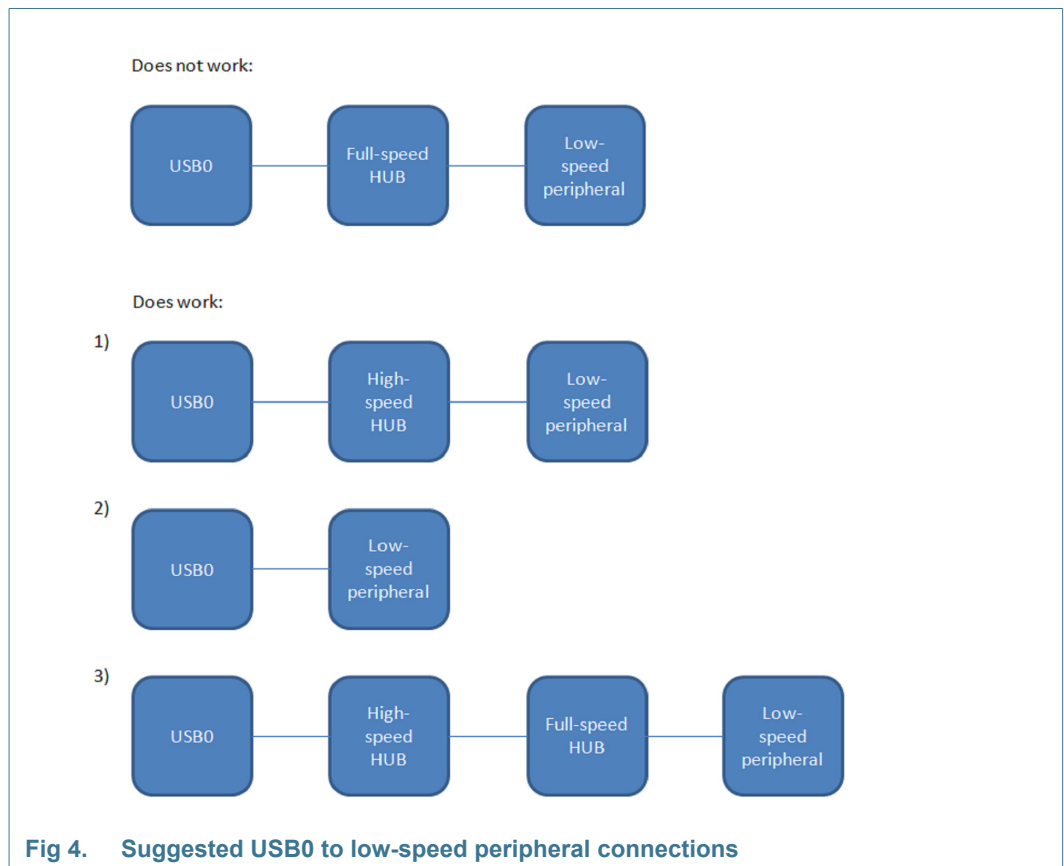
Fig 4. Suggested USB0 to low-speed peripheral connections

The USB controller called USB0 is unable to communicate with a low-speed USB peripheral in host mode when there is a full-speed hub directly connected to the USB0 port and a low-speed peripheral is connected in the tree somewhere below this full-speed hub. Only USB0 has this problem; the other USB controller, USB1 does not.

There is no work-around for this problem. It is suggested that the low-speed USB peripheral is either connected directly to USB0 or a high-speed hub is placed between that peripheral and USB0.

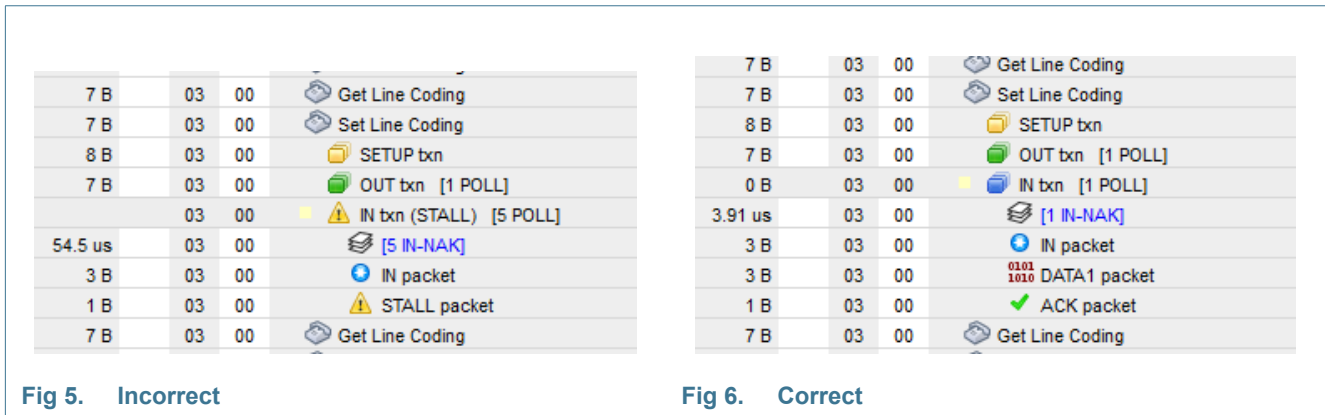
The CDC class USB ROM drivers return a STALL condition after the DATA stage of a Set Line Coding CONTROL transfer from the host. The correct behavior is to return an ACK.

The way to work around this bug is to override the default CDC class specific endpoint 0 handler and handle the processing of OUT packets in your application. Use the following source code in red to accomplish this.
