AM437x Sitara™ Processors

Silicon Revisions 1.1, 1.2

This document describes the known exceptions to the functional specifications (advisories) for the AM437x Sitara Cortex®-A9 Processors. See [AM437x Sitara Processors](#).

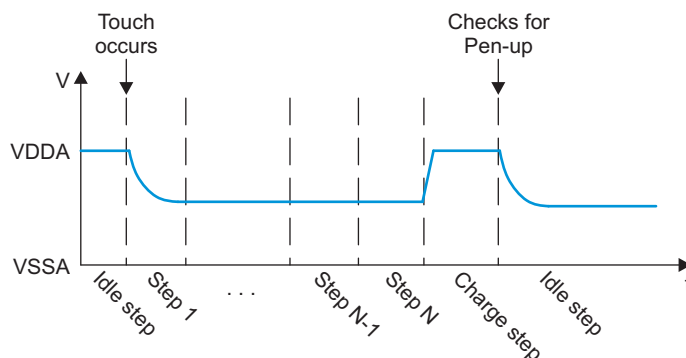
Figure 5. TSC Generates False Pen-up Interrupt

The touchscreen controller (TSC) determines the pen state (up or down) by checking the respective analog input (AIN0 for 4-wire or AIN4 for 5-wire) voltage level immediately after the Charge step. This does not provide enough time for the analog input voltage to return to the normal Pen-down voltage before testing the pen state. This will cause the TSC to generate a false Pen-up interrupt if the Charge step is enabled with the strong pull-up turned on when using hardware synchronized steps. Figure 5 illustrates the effect on the analog voltage when constant pen pressure is applied to the touchscreen and held through the Charge step.
