*TMS570LS12x/11x Microcontroller*

**Silicon Revision B**

# Silicon Errata

Literature Number: SPNZ199F  
February 2013–Revised May 2016

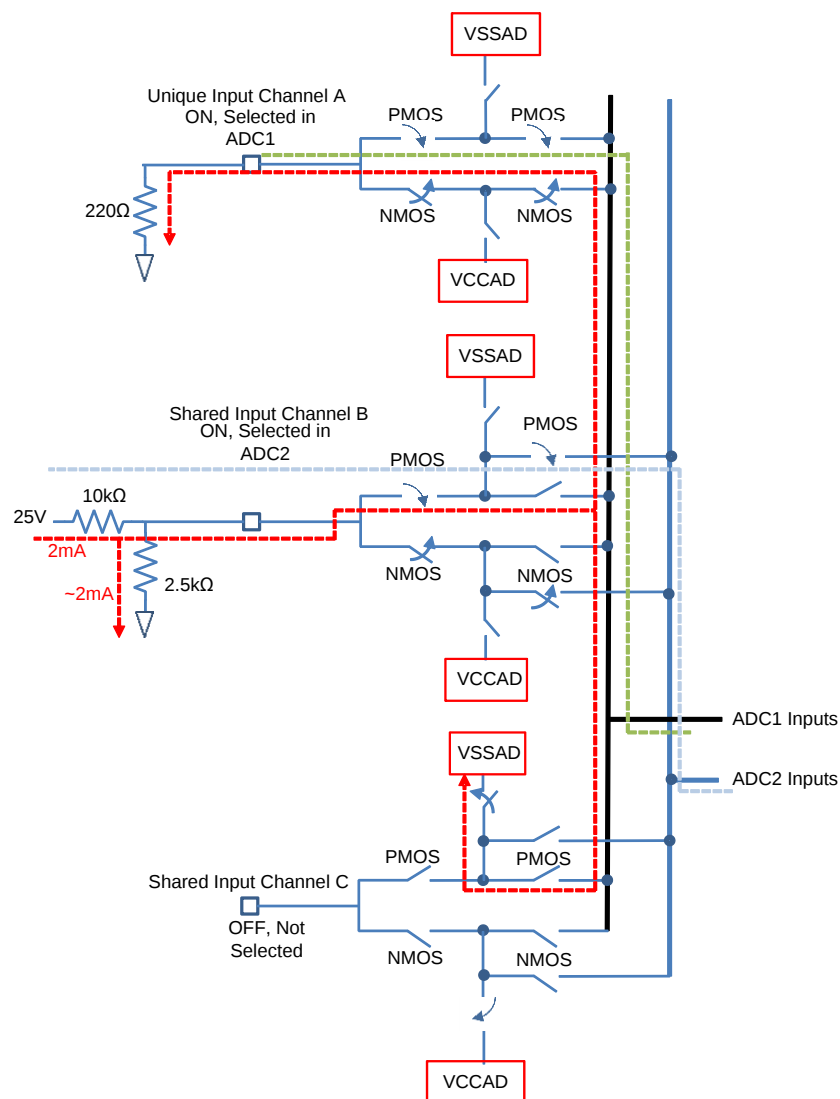
**Figure 3. Example ADC1/ADC2 Channel Connection**

Figure 3 shows an example where a ADC1 is sampling input channel A which is unique to ADC1, and ADC2 is sampling input channel B, which is a shared-input channel. This is shown by the dashed green and light blue current paths.

Another current path is shown in dashed dark red. This is a current injected into channel B as the input level on terminal B is greater than  $V_{CCAD} - 0.3V$ . This is a parasitic current that passes through the "open" PMOS switch, and a part of this current flows to ground through the external 220 ohm resistor connected to input channel A. This causes an offset in the conversion result of channel A being sampled by ADC1.

1. Configure the two ADC modules such that their sampling periods do not overlap, or
2. Limit the shared analog input upper limit to be lower than ( $V_{CCAD} - 0.3V$ ). The PMOS leakage is reduced exponentially if the input is lower than  $V_{CCAD} - 0.3V$ .

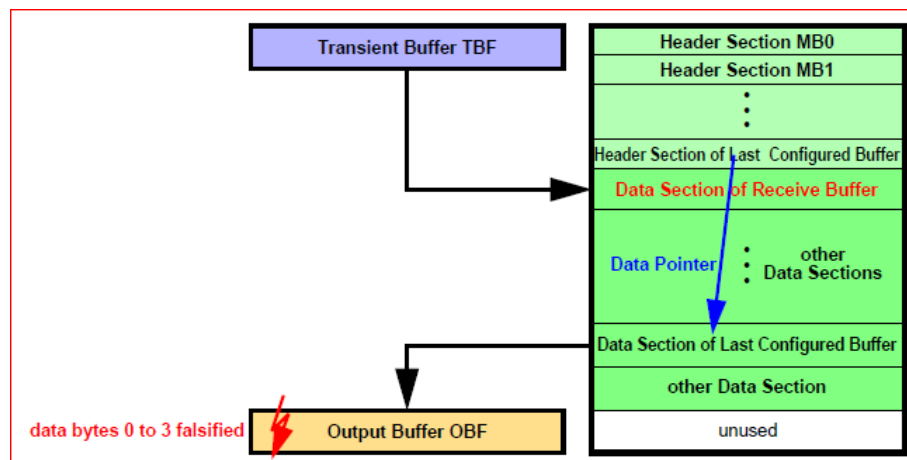
**Figure 4. First Fail Mode**

| <b>Implications</b> | <p>1) When a message is transferred from the Last Configured Buffer in the Message RAM to the OBF and PLC = 127 it may happen, that at the end of the transfer the OBF word on address 00h (payload data bytes 0 to 3) is overwritten with unexpected data (see <a href="#">Figure 4</a>).</p> |

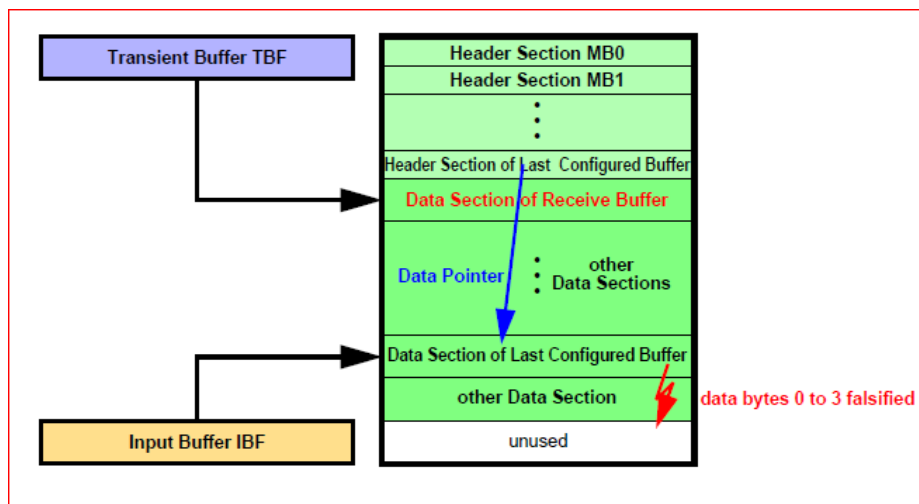
Figure 5. Second Fail Mode

2) When a message is transferred from IBF to the Last Configured Buffer in the Message RAM, it may happen, that at the end of the transfer of the Data Section one additional write access overwrites the following word, which may be the first word of another message's Data Section in the Message RAM (see [Figure 5](#)).
