# **AM5K2E04/02**

## **Multicore ARM KeyStone II SOC**

## **Silicon Errata**

Literature Number: SPRZ416B  
May 2014–Revised August 2015

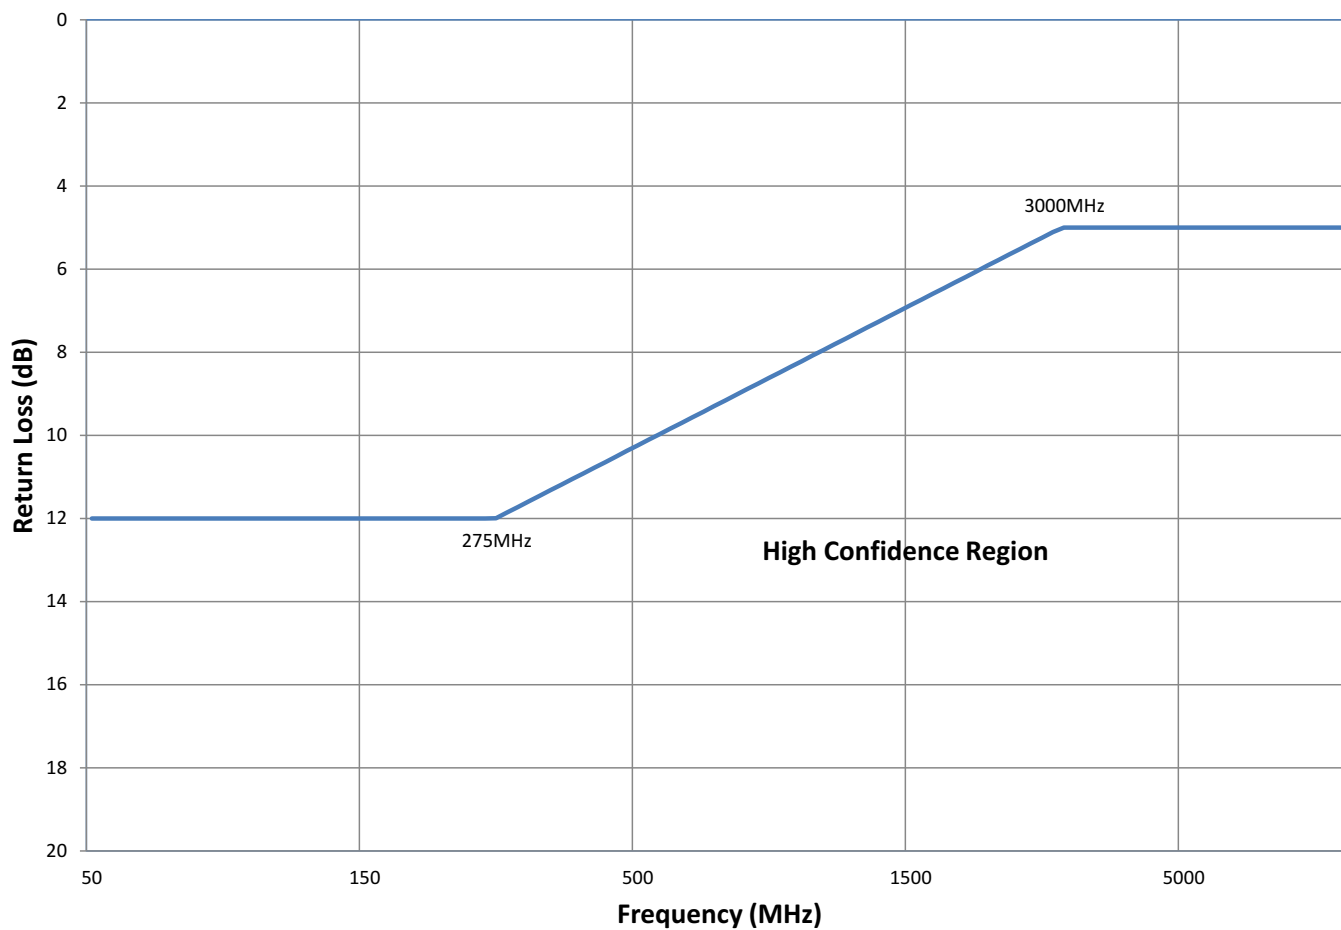
Device characterization has shown that bit error rate performance consistent with the 10GbE-KR standard as published in IEEE 802.3-2008 Annex 69B cannot be met across all device operating extremes. Production devices do operate at the required error rate across all rated operating conditions of voltage and temperature when the channel insertion loss is limited to 20dB at the Nyquist rate of 5.15625GHz. The figure below shows the Insertion Loss template from IEEE 802.3-2008 Annex 69B as well as the reduced Insertion Loss template.

Characterization has shown that channels must also be compliant with the Return Loss template contained in the IEEE 802.3-2008 Annex 69B specification without modification. This is shown below for convenience.

None.

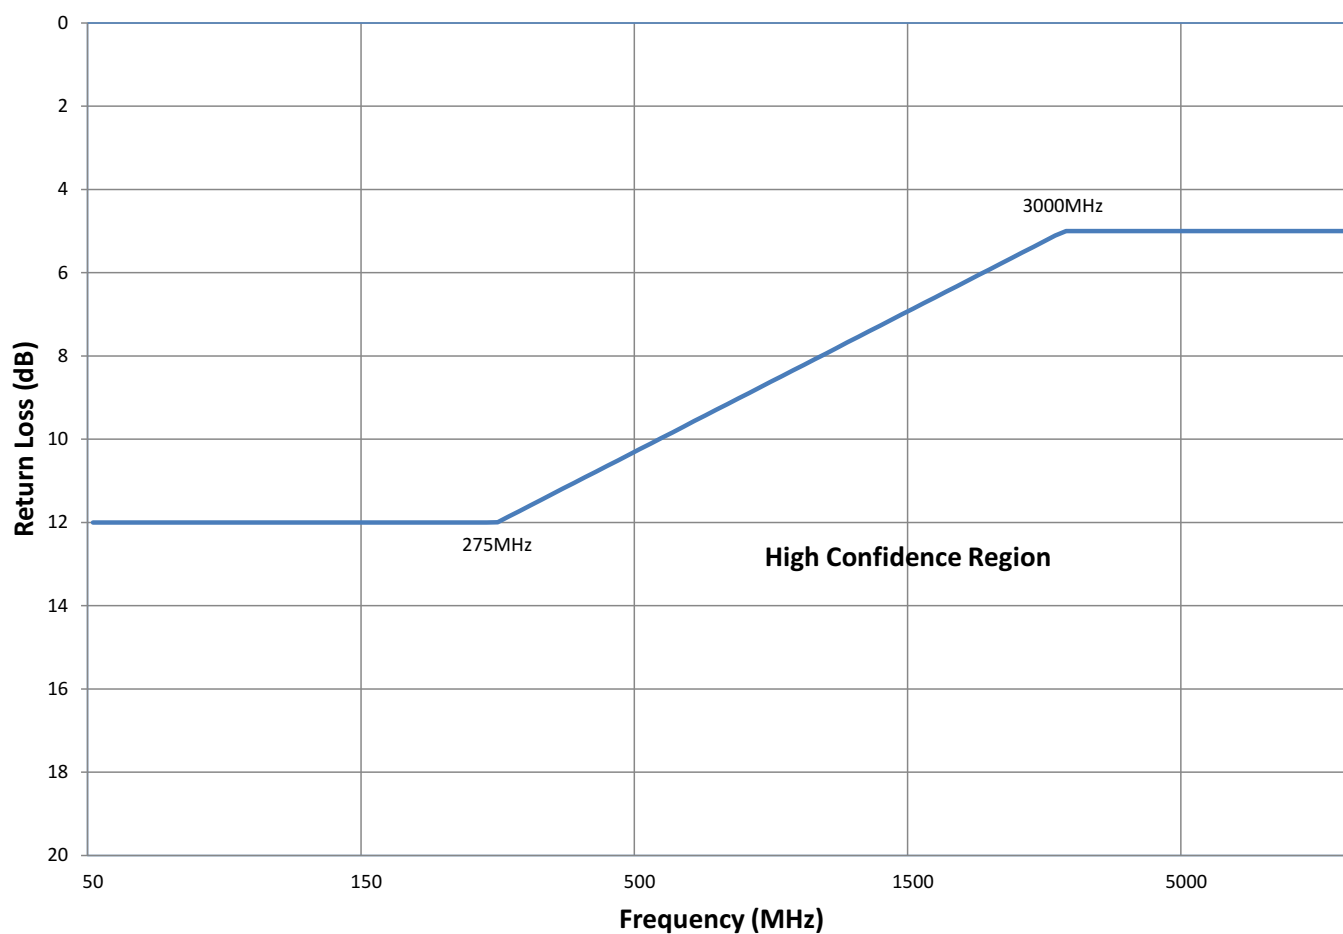
Device characterization has shown that expected bit error rate performance can only be met on layouts that meet constrained channel loss metrics. These can be examined by generating Insertion Loss and Return Loss graphs where loss is plotted versus frequency. Insertion Loss and Return Loss can be estimated during PCB layout using a 3D simulation tool. Insertion Loss and Return Loss should also be measured on early prototypes using a Vector Network Analyzer (VNA). Multiple PCB construction and layout enhancement techniques must be combined to achieve these channel performance requirements as stated in the KeyStone II SERDES User Guide.

An Insertion Loss measurement provides a composite view of the channel's loss versus frequency. Since HyperLink is a short-reach interface, channel loss is limited. Also, due to the high data rate, the Insertion Loss must be monotonic and without discontinuities that would degrade receiver operation. The template shown below provides Insertion Loss limits that will result in a robust channel. This template must be met for the entire channel from transmitter to receiver including the series capacitors.

Device characterization has also shown that channels should be compliant with the Return Loss template shown below. The Return Loss measurement indicates the amount of energy reflected back to the source which is not available to the receiver. Impedance variation in the channel will cause reflected energy that can cause this template to be violated. Careful attention to PCB construction and layout must be followed to meet this requirement. This template must be met for the entire channel from transmitter to receiver including the series capacitors. Note that this is the same template

defined in IEEE 802.3-2008 Annex 69B specification for 10GbE.

None.

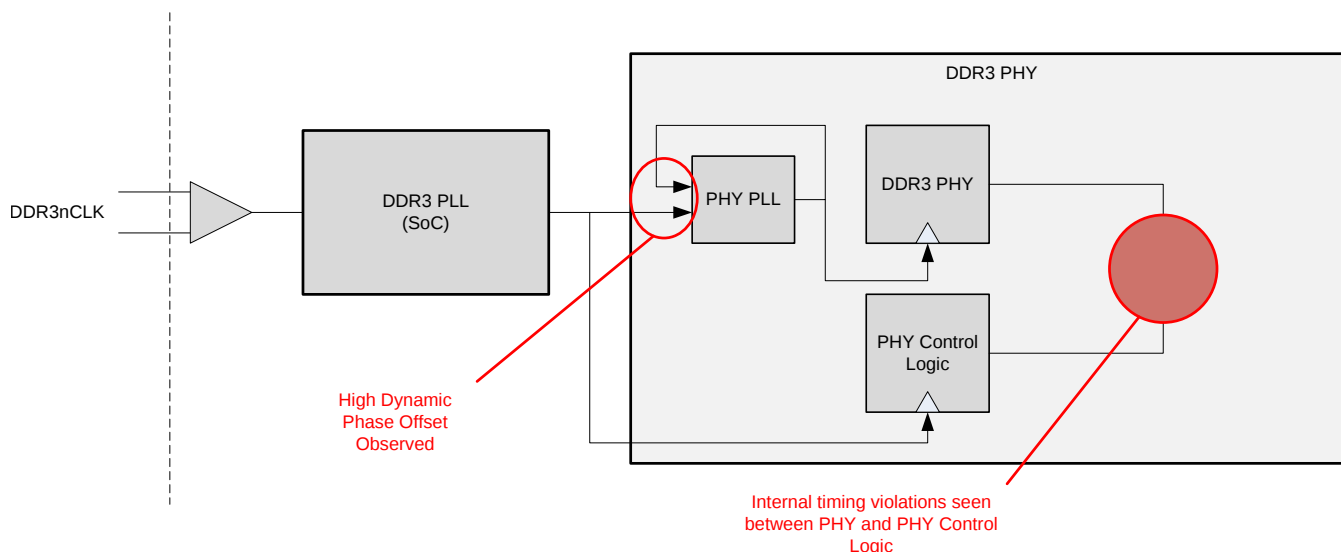
Figure 2. DDR3 PHY

DDR3 read operations may show errors due to increased levels of Dynamic Phase Offset (DPO) inside the DDR3 PHY. These errors are characterized by byte lane data corruption or intermittent bit errors. The byte lane data corruption can only be recovered using a device reset.

The DDR3 clocking architecture is illustrated in the figure below. The DDR3 reference clock input (DDR3nCLK) feeds the DDR3 SoC PLL, which outputs a clock to be used by the PHY Control Logic and provide an input to the PHY PLL.

The Dynamic Phase Offset (DPO) is a measure of the DDR3 PHY PLL's ability to track rapid phase changes in the output of the DDR3 SoC PLL. High DPO can create internal timing violations between the DDR3 PHY and DDR3 PHY Control Logic and result in data errors during reads. As indicated by the shaded red circle in the figure above, the timing violations occur in the data transfer between the PHY and PHY control logic. It was determined that the root cause of the elevated DPO were SoC PLL and PHY PLL configurations that were non-optimized for the timing requirements of the system.

The workaround for this behavior is a change in the PLL configurations used for the DDR3 SoC PLL and the DDR3 PHY PLL. New configurations have been generated for DDR3-1600, DDR3-1333, DDR3-1066, and DDR3-800 operation and are presented in the tables below. Per field alert, "DDR3 Limited to Highest Data Rates Due to Possibility of PLL Instability During Temperature Changes after Startup", operation of DDR3-1066 and/or DDR3-800 is not recommended for affected Keystone2 devices in production systems

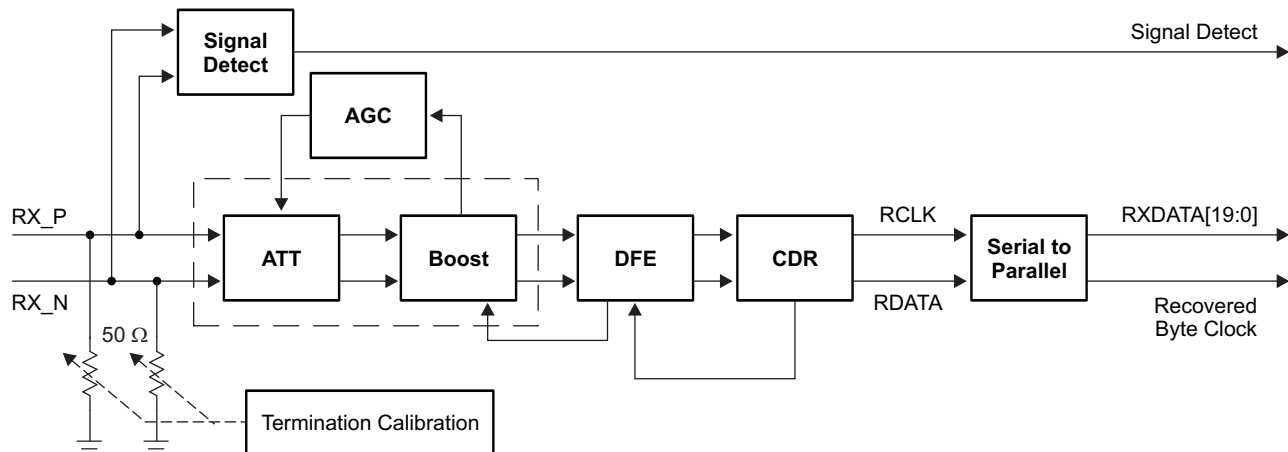
**Figure 3. RX Path Block Diagram**

**Problem Summary:** The SerDes on some peripherals will not automatically adapt its RX equalization when provided with certain data encodings common to that peripheral's electrical standard.

**Details** The TI SerDes contains an adaptation algorithm that allows the RX equalization blocks to adapt their parameters to the SerDes data channel. The adaptation algorithm sets the optimal values for the ATT, BOOST, and DFE blocks in order to equalize the signal, maximize margin, and minimize channel distortion. For higher data rates (i.e. 5Gbps and greater), the high frequency gain provided by the BOOST block is generally considered necessary to compensate for the low-pass characteristics of data channels and widen the data eye.

The SerDes BOOST block was designed to require a specific set of patterns in order to best adapt its parameters to the channel. If these patterns are not found, the BOOST adaptation algorithm will not update the internal block settings and/or may incorrectly update these settings. The required data pattern is a series of six 0's followed by a 101 pattern. This pattern must occur numerous times on both odd and even bit alignments. This data pattern is not present in the 8b/10b coded symbols that are sent over many of the high speed peripheral links.

The recommended workaround is to not use the RX equalization auto-adaptation mechanism with the impacted interfaces at higher data rates. As an alternative, a user can hardcode the optimal ATT and BOOST values for their channel.

The optimal ATT and BOOST values found by one of the two above methods can be hardcoded into the SerDes upon initialization.
