## MSP430G2553 Device Erratasheet

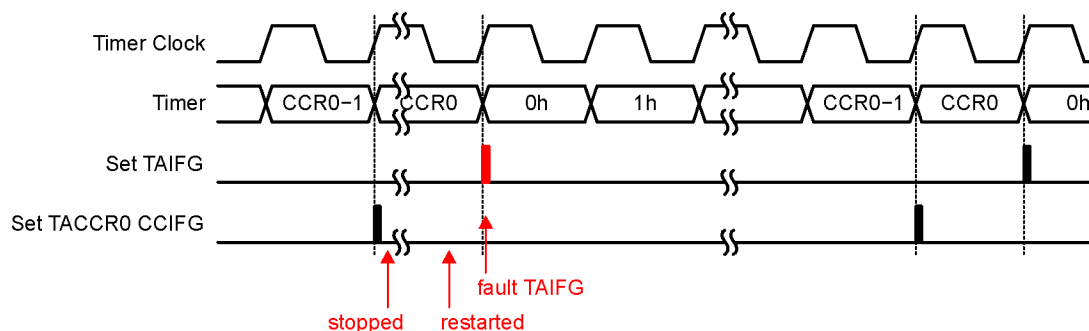
## TA21

**Function** TAIFG Flag is erroneously set after Timer A restarts in Up Mode

**Description** In Up Mode, the TAIFG flag should only be set when the timer counts from TACCR0 to zero. However, if the Timer A is stopped at TAR = TACCR0, then cleared (TAR=0) by setting the TACLR bit, and finally restarted in Up Mode, the next rising edge of the TACLK will erroneously set the TAIFG flag.

**Workaround** None.
