## MSP430F133 Device Erratasheet

### 1 Functional Errata Revision History

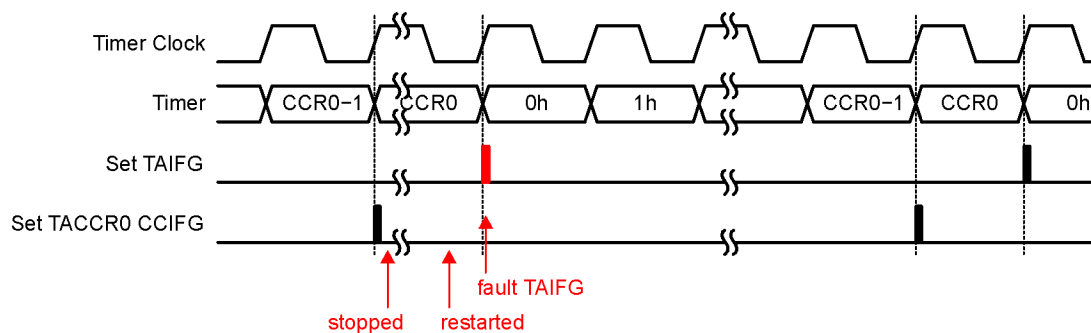
## TA21

TAIFG Flag is erroneously set after Timer A restarts in Up Mode

In Up Mode, the TAIFG flag should only be set when the timer counts from TACCR0 to zero. However, if the Timer A is stopped at  $TAR = TACCR0$ , then cleared ( $TAR=0$ ) by setting the TACLR bit, and finally restarted in Up Mode, the next rising edge of the TACLK will erroneously set the TAIFG flag.

None.

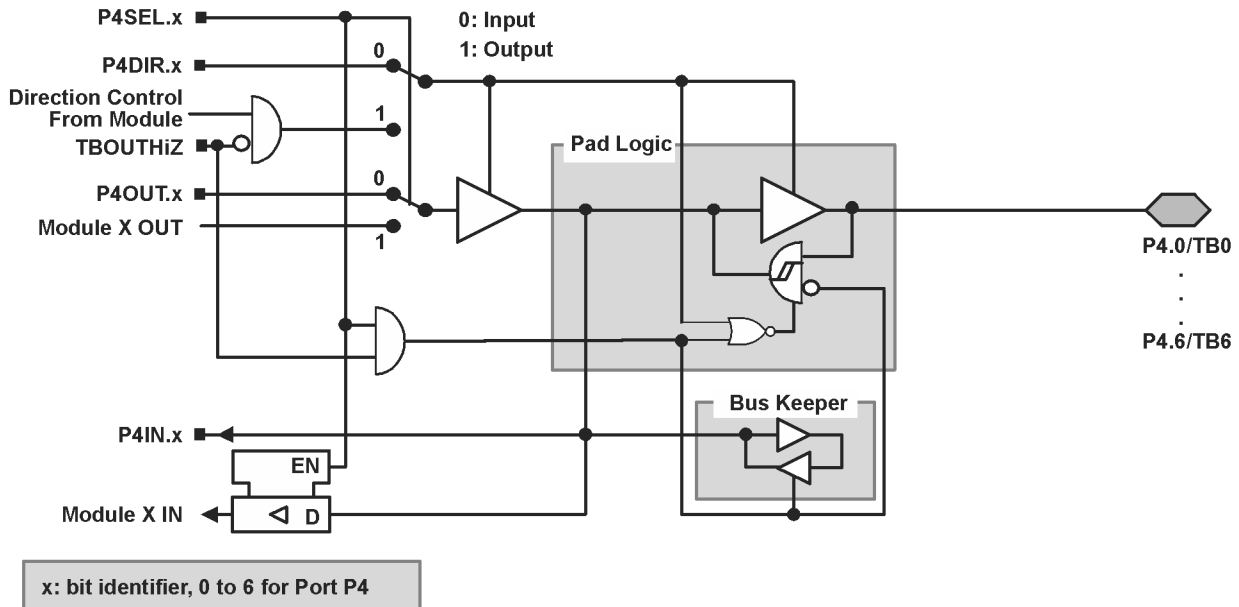
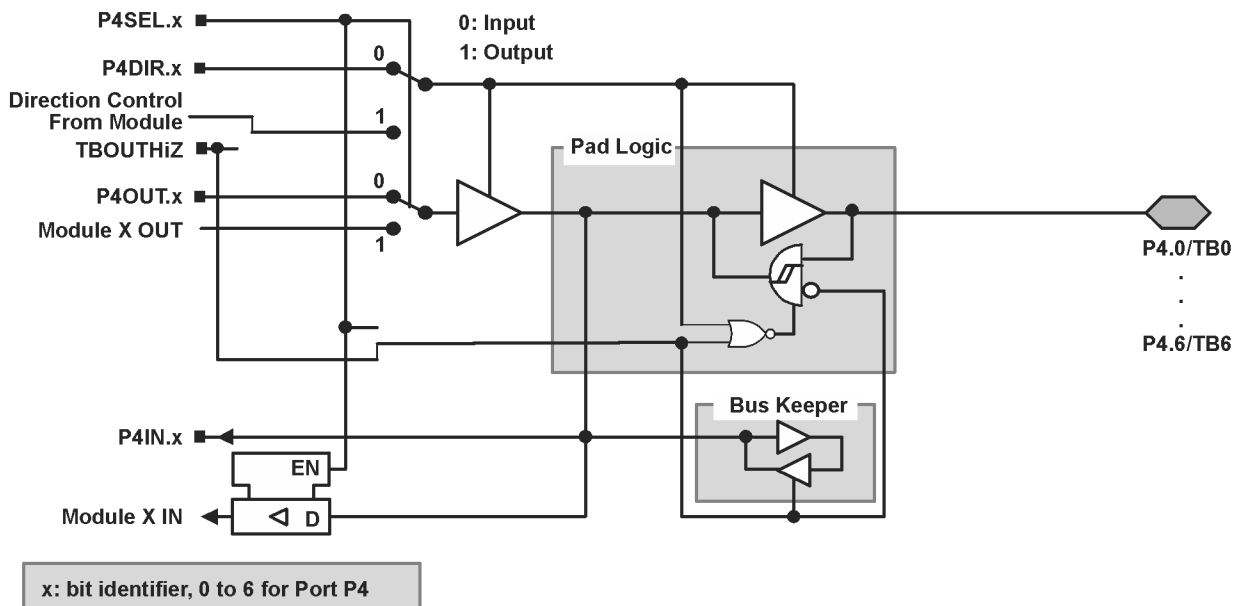
| <b>Function</b> | Port is switched to 3-state independent of selected function |
| <b>Description</b> | <p>Incorrect 3-state function of Ports P4.0/TB0 through P4.6/TB6 (TBoutHiZ control). If TBoutHiZ is set to high, all ports P4.0/TB0 through P4.6/TB6 are set to 3-state, independent of the P4SEL.x control signals. This means a port P4.x is switched to 3-state with TBoutHiZ, even if it is not selected for Timer_B function. In addition, the ports P4.0/TB0 through P4.6/TB6 are switched to 3-state with TBoutHiZ, even if the port direction (direction control from module) is set to input. This is in accordance with the specification description but, nevertheless, is an unexpected behavior.</p> |

**Port Realization With TB3 Bug**

No workaround.

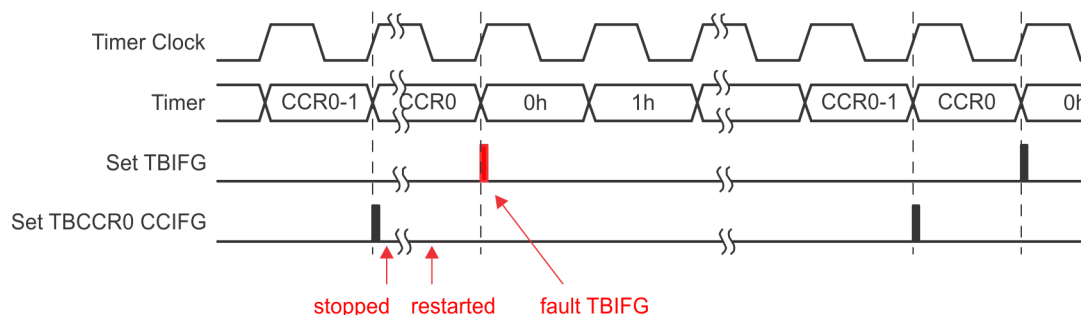
## TB24

| <b>Function</b> | TBIFG Flag is erroneously set after Timer B restarts in Up Mode |
| <b>Description</b> | In Up Mode, the TBIFG flag should only be set when the timer resets from TBCCR0 to zero. However, if the Timer B is stopped at TBR = TBCCR0, then cleared (TBR=0) by setting the TBCLR bit, and finally restarted in Up Mode, the next rising edge of the TBCLK will erroneously set the TBIFG flag. |

None.
