## MSP430F5333 Device Erratasheet

The revision of the device can be identified by the revision letter on the [Package Markings](#) or by the [HW\\_ID](#) located inside the TLV structure of the device

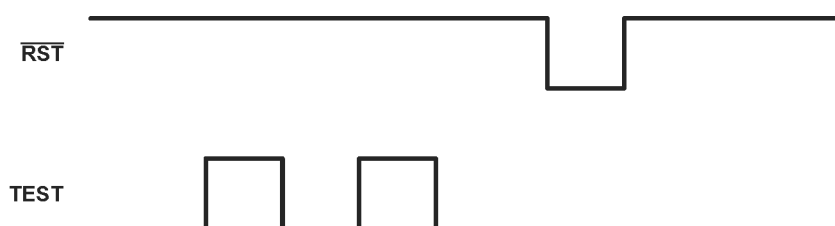
BSL does not exit to application code

The methods used to exit the BSL per MSP430 Programming Via the Bootstrap Loader (SLAU319) are invalid.

To exit the BSL one of the following methods must be used.

- Toggle the TEST pin twice when nRST is high and after 50us pull nRST low.

Note: This toggling of TEST pins is not subject to timing constraints. The appropriate level transitions on TEST pin, followed by a RST pulse after 50us, are sufficient to trigger an exit from BSL mode.
