**66AK2Lxx**  
**Multicore DSP+ARM KeyStone II SOC**  
**Silicon Revision 1.0**

# **Silicon Errata**

Literature Number: SPRZ430

April 2015

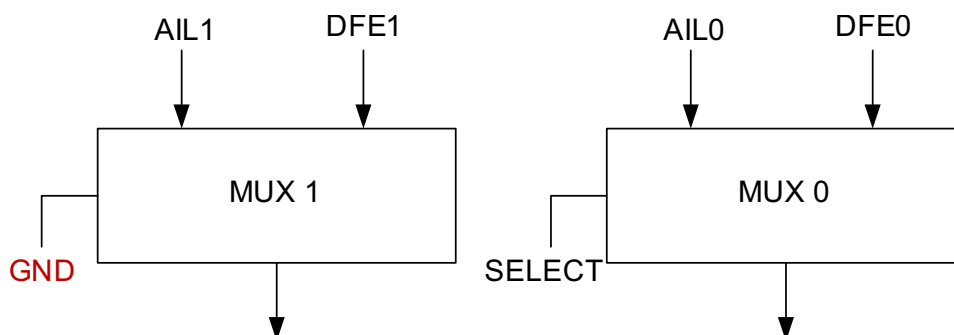
**Figure 2. AIL Lanes**

IQN2 has two AIL lanes (AIL0 and AIL1). AIL1 lane does not transmit or receive any data. AIL0 lane can transmit or receive data without showing any problem.

As shown in [Figure 2](#) below, the AIL0 and AIL1 lanes are connected to a SERDES MUX with respect DFE lanes. This SERDES MUX is used to select data path between IQN2 and DFE. The mux select for the AIL1 and DFE1 mux is not connected correctly and is connected to Ground. So DFE1 lane is always selected irrespective of the configuration selected by mux pins.

There is no SW workaround for this problem.
