KSZ9893R Silicon Errata and Data Sheet Clarification

This document describes known silicon errata for the Microchip KSZ9893R. The silicon errata discussed in this document are for silicon revisions as listed in [Table 1](#). The silicon revision can be determined by the device's top marking. A summary of KSZ9893R silicon errata is provided in [Table 2](#).

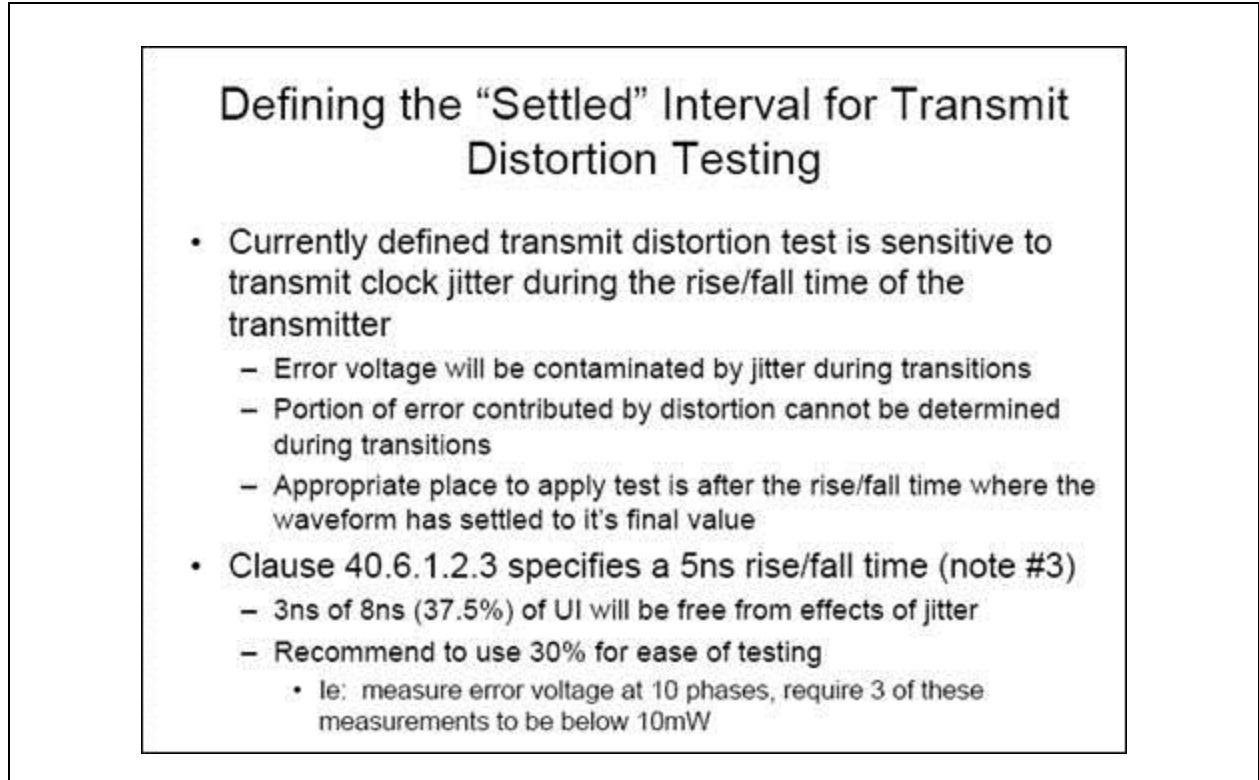
FIGURE 2: IEEE DOCUMENT PAGE 7

- On page 7:
 - The transmit distortion test is sensitive to transmit clock jitter during the rise/fall time.
 - It is recommended to change the requirement to use at least 30%, instead of at least 60%, of the UI within the eye opening for the <10mV peak transmitter distortion.
