**TMS320C6672**  
**Multicore Fixed and Floating-Point Digital**  
**Signal Processor**  
**Silicon Revision 1.0, 2.0**

**Silicon Errata**

Literature Number: SPRZ335H  
January 2011–Revised June 2015

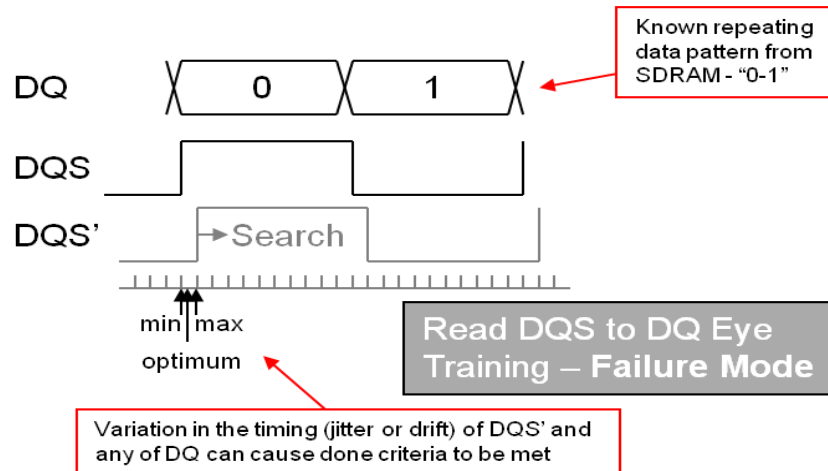
Figure 4. Read DQS to DQ Eye Training - Failure Mode

The leveling feature with the problem is the Read Data Eye Training. Depending on the jitter seen on the DQ and DQS signals, this leveling feature will fail to converge on a good data eye, resulting in corrupted DSP to DDR3 SDRAM reads.

However, if too much jitter is present on the DQ or DQS signals, the search can converge to a false edge as shown in Figure 4.

**Workaround 1:**

This mode is enabled by setting bit 9 (0-indexed) of the DDR3\_CONFIG\_REG\_23 at address 0x02620460. The lower 8 bits (bits 7:0) must not be overwritten and will contain their default value of 0x34. The default value is recommended for use. After programming DDR3\_CONFIG\_REG\_23, proceed to enable auto-leveling. Please refer to the *DDR3 Initialization Application Report* ([SPRABL2](#)) for details of the sequence of steps.

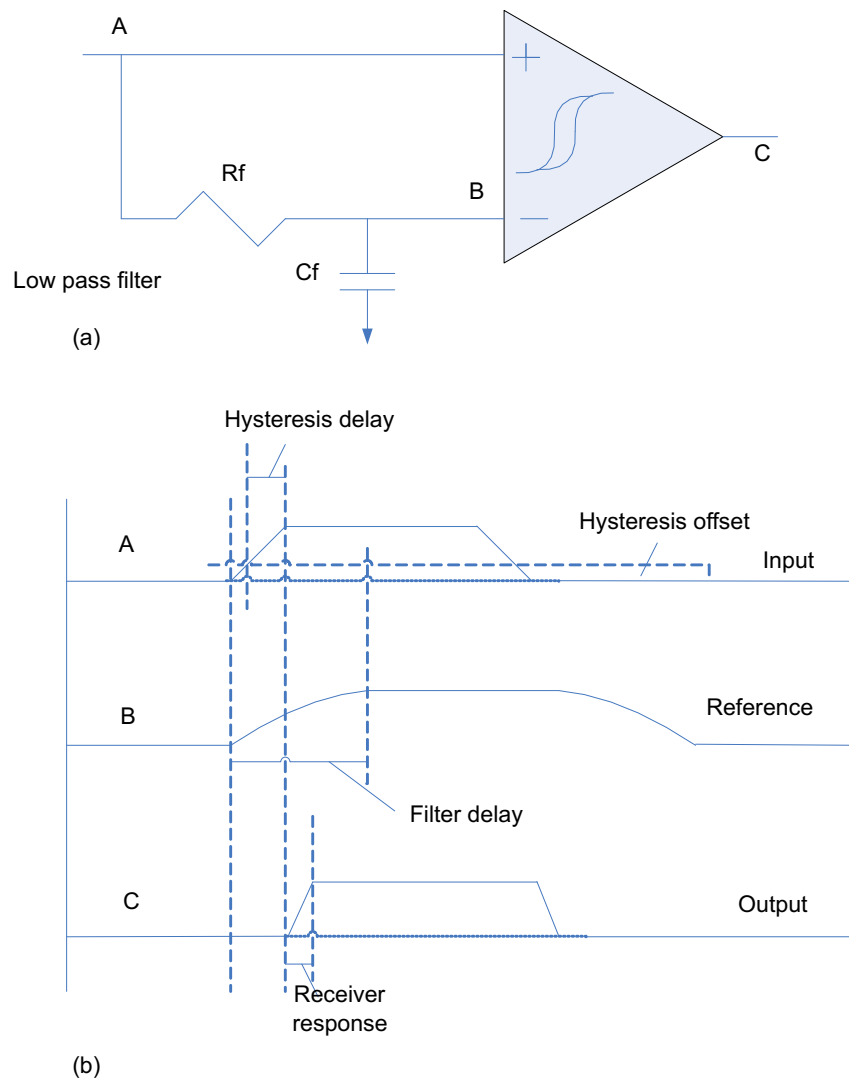
**Figure 8. Self-referenced Comparator and Response**

The AC-JTAG input cell is based on a self-referenced, hysteretic comparator. See [Figure 8](#). If the SerDes receiver pins are idle (no transitions are applied), the voltage of the pins will settle to the programmed, receiver common-mode voltage (0.80V nominally). From this idle state a single edge transition applied to the AC-JTAG input cell can push both terminals of the AC-JTAG comparator inputs past the VDDT (1.0V) supply voltage level.

When the comparator inputs are saturated the comparator gain is minimized and under certain PVT conditions (strong silicon, 125C junction temperature, minimum VDDT), the comparator can fail to switch to the proper state, or not respond at all.

One potential workaround has been identified. The failure mode of the AC-JTAG comparator is most pronounced by single edge transitions at low frequency as this creates the highest likelihood of the comparator inputs being saturated and switching incorrectly. More frequent transitions can result in proper switching of the comparator output.

The basic procedure is to initiate multiple edge transitions and then read the state of the RX input cell in question. However, due to the nature of the failure, the exact number would have to be determined experimentally for a given device.

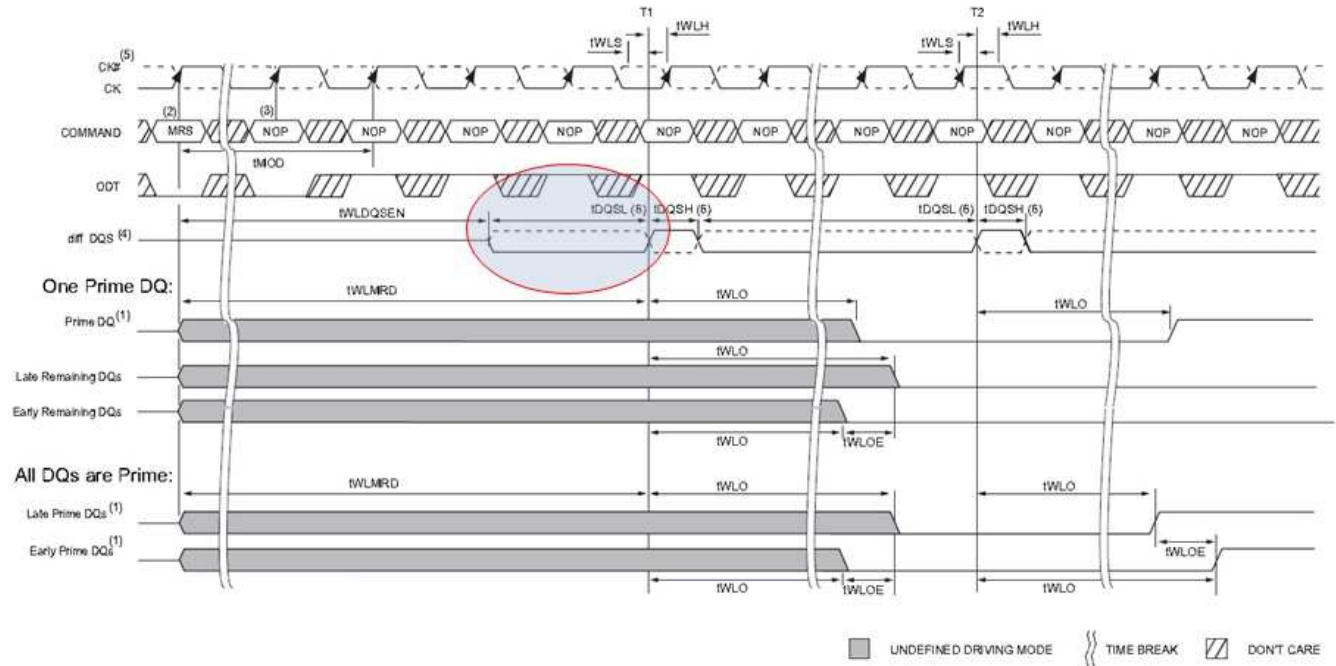
**Figure 9. Timing Details of Writing Leveling Sequence**

As shown in [Figure 9](#), the DDR3 JEDEC standard requires that the DQS strobe be sent with a preamble (DQS=0) for at least tDQSL during write leveling, prior to the first rising edge of the DQS strobe (DQS=1). It was observed in simulations that the first DQS strobe is sent immediately following the high impedance state of the DQS line and without a preamble. This Z->1 transition on the DQS line may allow incremental write leveling to fail. Note that this issue impacts only the incremental write leveling feature of the DDR3 Memory controller. No issue is expected with automatic write leveling.

At this time, incremental write leveling is not supported on this device and we recommend that the incremental write leveling intervals in RDWR\_LVL\_CTRL and RDWR\_LVL\_RMP\_CTRL be programmed to 0 to disable this feature.

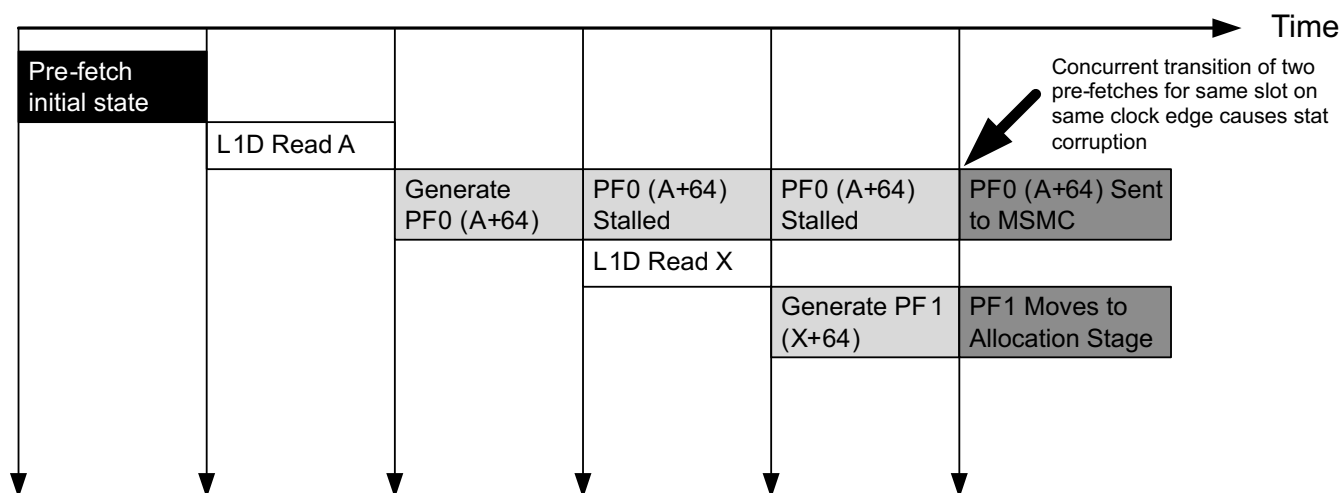
**Figure 11. Sequence diagram**

7. PF0 transitions to the XMC output (to MSMC) on the exact same clock edge that PF1 is transitioning to the buffer allocation pipeline stage

8. Instead of PF0 being marked stale and thrown away when returned, both PF0 and PF1 are marked valid and outstanding.
9. This leads to two valid outstanding pre-fetches for the same data buffer slot which is an invalid state and can result in unexpected behavior for a subsequent pre-fetchable data access to address X+64.
