# DM385/DM388 DaVinci™ Digital Media Processor Silicon Revisions 1.1, 1.0

## Silicon Errata

Literature Number: SPRZ387B  
April 2013–Revised December 2013

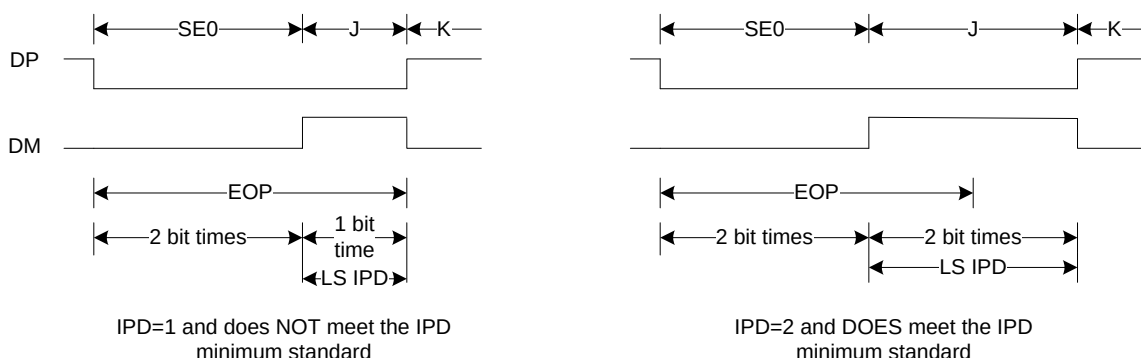
The problem is due to the length of the IPD between the Receiver-to-Transmitter (Rx-to-Tx) transactions. The Host IPD between Rx-to-Tx transactions for LS transactions should range from 2 to 6.5 LS bit times. It has been verified that the controller's LS IPD for Rx-to-Tx is only 1. This is shown in the following figure.

IPDs are measured from the SE0-to-J transition at the end of EOP to the J-to-K transition that starts the next packet.

The impact is that this specific mouse will not work with the processor's USB port.

**Workaround:**
