# **AM389x Sitara™ ARM® Microprocessors (MPUs) Silicon Revisions 2.1, 2.0, 1.1, 1.0**

## **Silicon Errata**

Literature Number: SPRZ327H  
November 2010–Revised March 2015

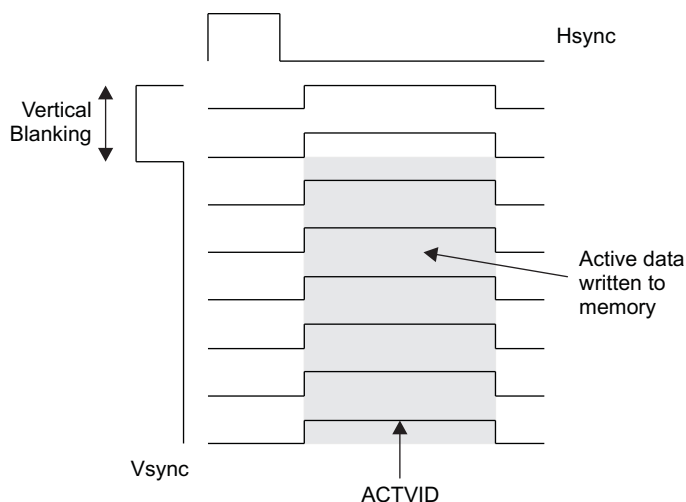
**Figure 3. ACTVID Signal Active for All Lines of Incoming Data**

**Details:** The VIP port supports a discrete sync capture mode where the ACTVID signal is used to determine the active region of the video and then the VPDMA writes this active video frame to memory. However, with some external video decoders, this mode does not work by default.

**Workaround:** The VIP parser requires that the ACTVID signal is active for all lines of the incoming data, including the vertical blanking region. The vertical blanking region, itself, is not written to memory by the VPDMA. [Figure 3](#) illustrates this.

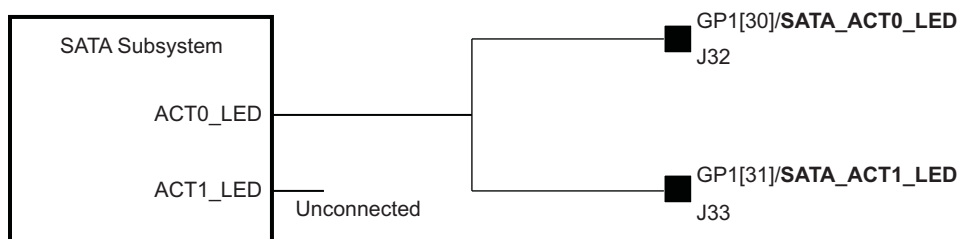
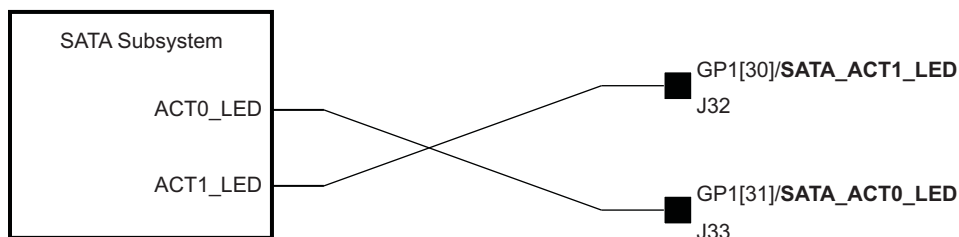
**Figure 4. SATA Activity LED Connectivity**

This issue is corrected on revision 2.0, but with the output pins reversed. SATA\_ACT1\_LED is mapped to pin J32 and SATA\_ACT0\_LED to pin J33 (see [Figure 4](#)).
