# **TMS320DM647/DM648**

## **Digital Media Processors**

# **Silicon Errata**

Literature Number: SPRZ263G  
May 2007–Revised November 2011

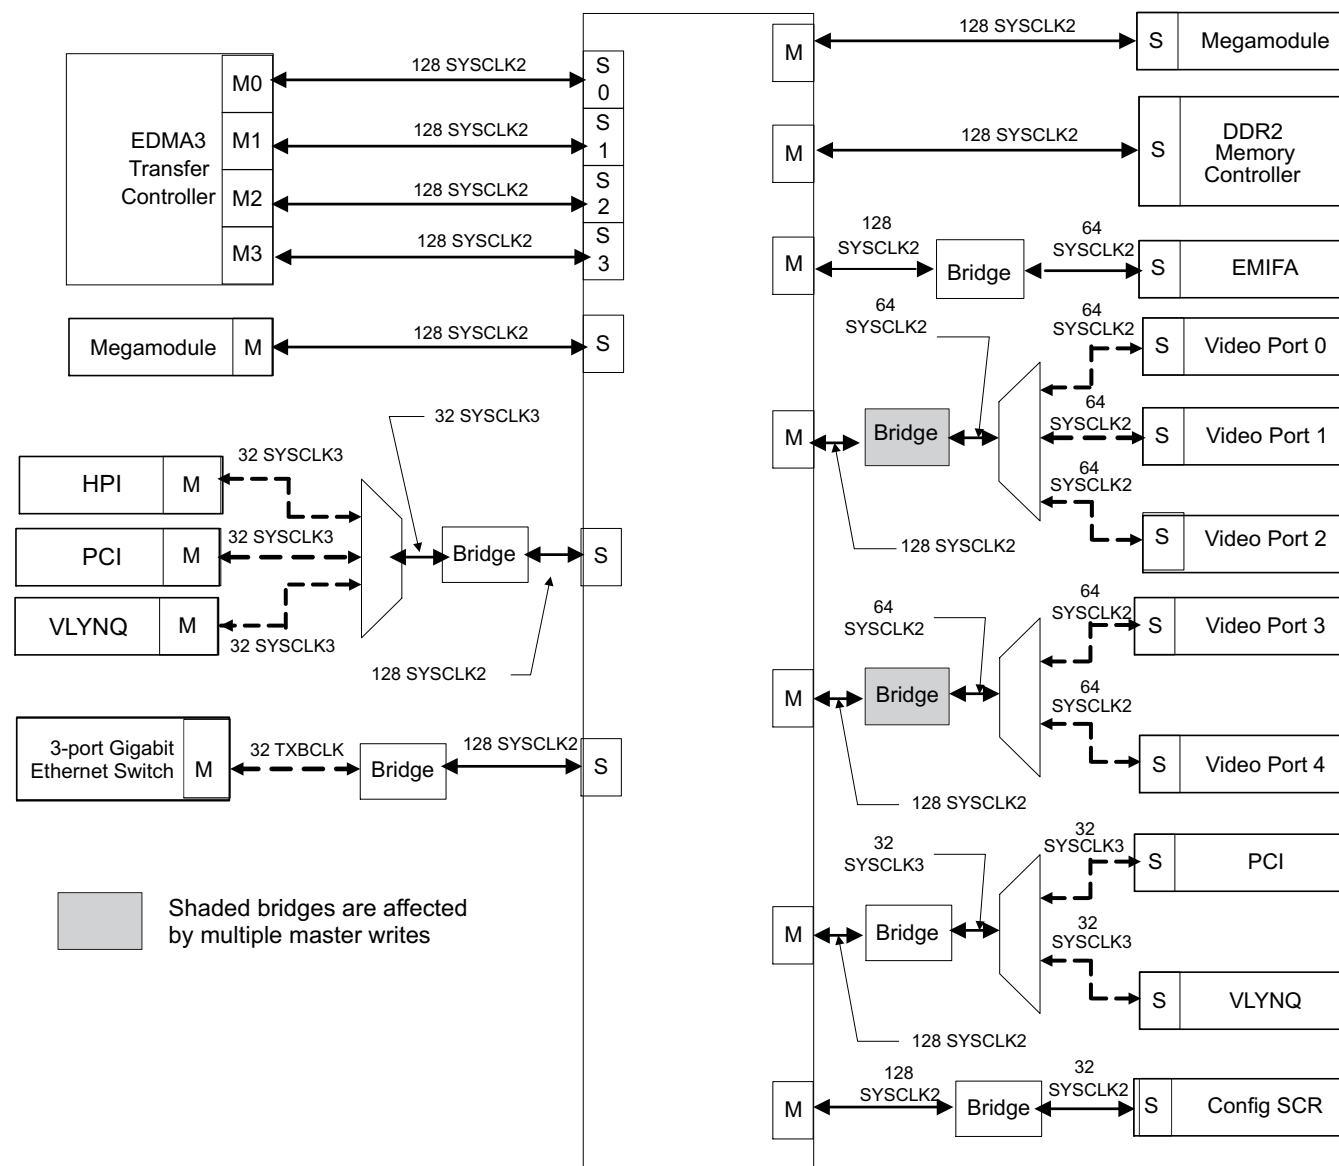
**Figure 2. Data SCR (with shading to show affected bridges)**

Certain peripheral groups are susceptible to data corruption when multiple masters write to members of the group due to a bridge in the path. On this device there are two groups that are susceptible to the problem. Group one consists of Video Port 0, Video Port 1, Video Port 2; group two consists of Video Port 3, Video Port 4.

Data corruption can happen only when multiple masters (e.g., different Transfer Controllers in the EDMA) write to members of an affected group. See the bridges affected in Figure 2. All read operations and writes from a single source are not affected. Therefore, all writes to members of a group must come from the same master. Different groups can safely have different write masters.

One software workaround is to prevent writing from multiple masters to the same group. For example, software must program a single EDMA port to issue writes to an affected

group as opposed to using 2 EDMA ports.

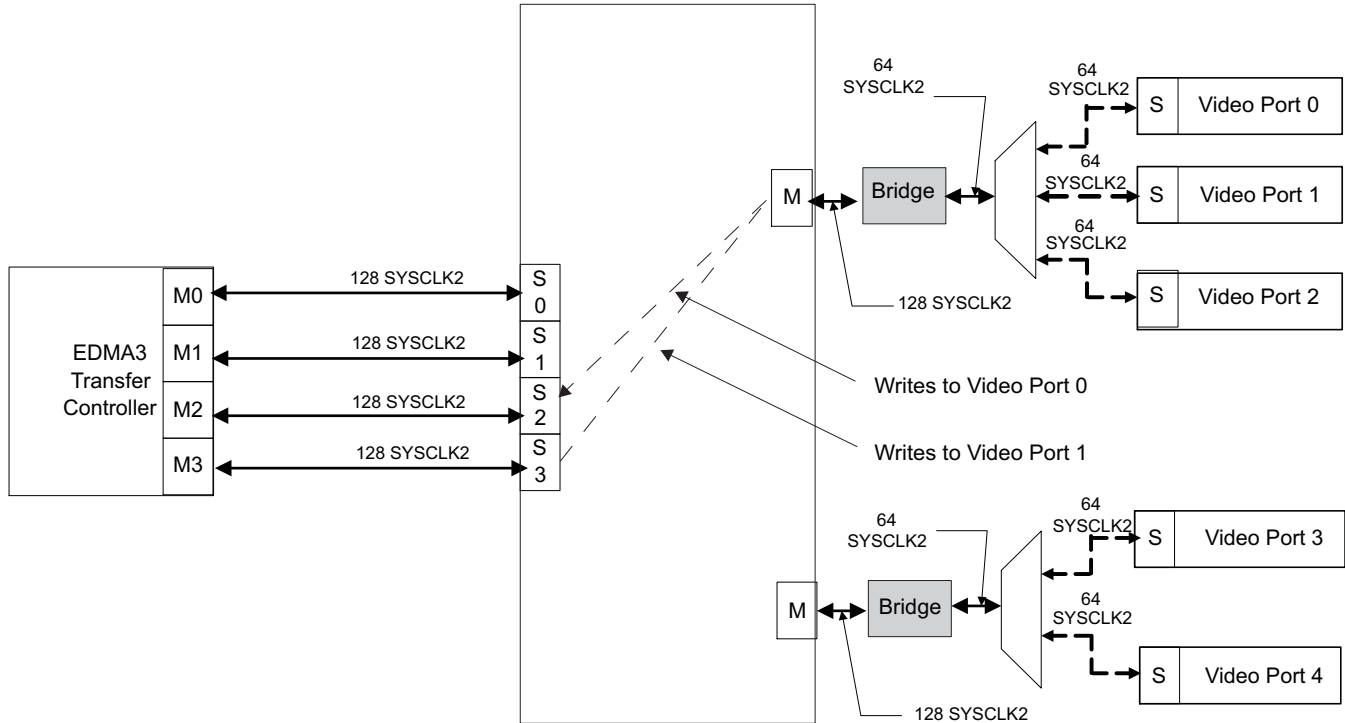
**Figure 3. Scenario to Avoid**

For example, if Video Port 0 and Video Port 1 are used in display mode and use EDMA3 Transfer Controller 2 for writes to Video Port 0 and EDMA3 Transfer Controller 3 for writes to Video Port 1, then displayed data in Video Port 0 or Video Port 1 or both may be corrupted.

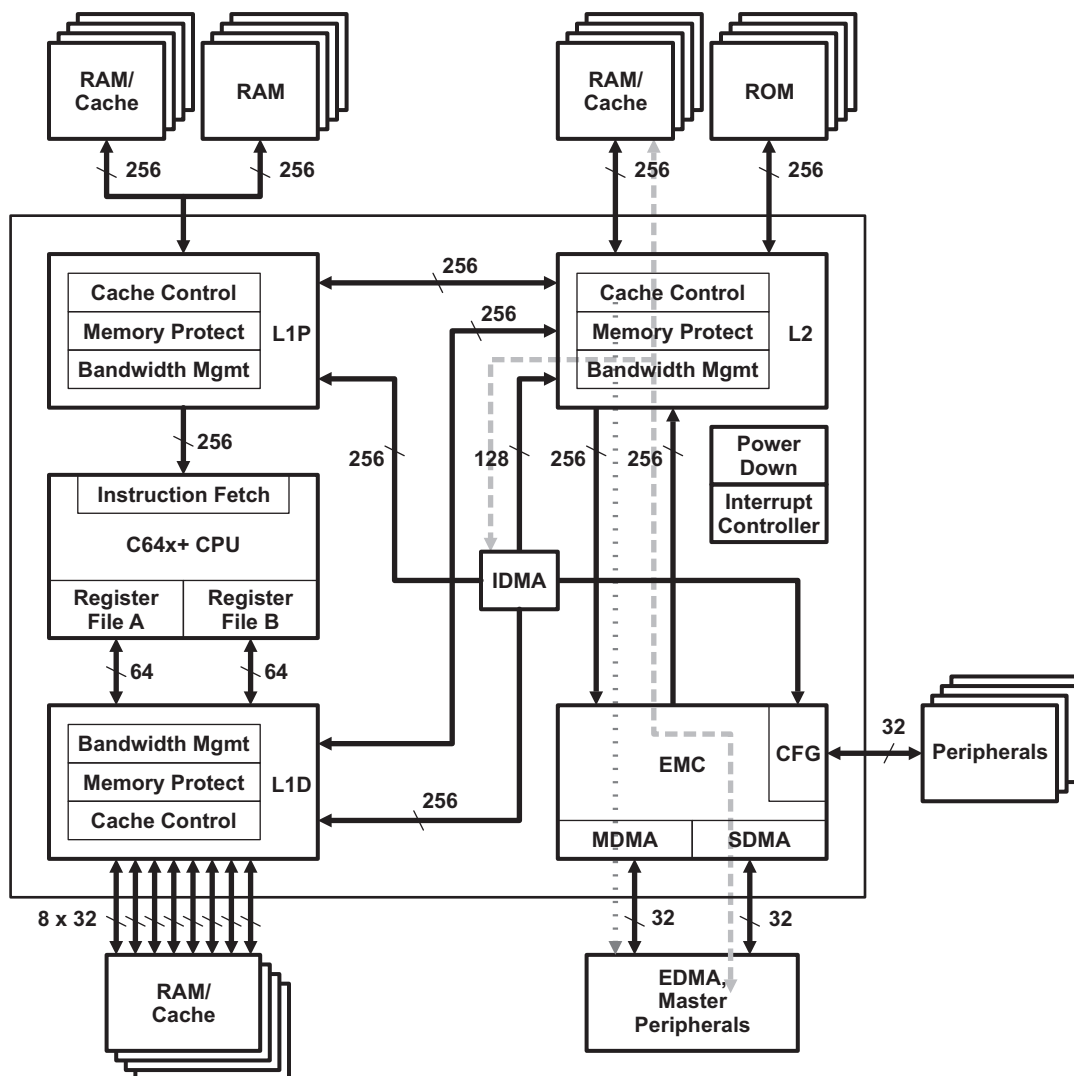
**Figure 5. IDMA, SDMA, MDMA Paths**

Ideally, the MDMA (dotted line in [Figure 5](#)) and SDMA/IDMA paths (dashed lines in [Figure 5](#)) operate independently with minimal interference. Normally, MDMA accesses may stall for extended periods of time due to expected system level delays (e.g., bandwidth limitations, DDR2 memory refreshes). However, when using L2 as RAM, SDMA and IDMA accesses to L2/L1 may experience unexpected stalling in addition to the normal stalls seen by the MDMA interface. For latency-sensitive traffic, the SDMA stall can result in missing real-time deadlines. In a more severe case, the SDMA stall can produce a deadlock condition in the device. An IDMA stall cannot produce a deadlock condition.

SDMA/IDMA stalls may occur during the following scenarios. Each of these scenarios describes expected normal DSP functionality, but the SDMA/IDMA access potentially exhibits additional unexpected stalling.

As previously mentioned, a possible deadlock scenario is introduced in the presence of the SDMA stalls just described. This scenario occurs for certain masters connected to the data SCR, either directly or indirectly, through a bridge. For the DM647/DM648 devices, the masters that fall into this category are the EDMA transfer controllers (EDMA TCs), PCI, UHPI, VLYNQ, and 3PSW. If the following sequence of events occurs, then a deadlock situation might arise:

In the above scenario, it is possible for data phases from the write command issued to DDR2 (or EMIFA) to be stuck behind the data phases for the write to the DSP's SDMA in the SCR.

Therefore, if the DSP issues victim traffic to the same slave (DDR2 or EMIFA), then data associated with the victim traffic (#2) intended for DDR2 (or EMIFA) will be stuck behind write commands issued for #1. However, due to the MDMA/SDMA blocking issue, the SDMA traffic for #1 will be waiting for the MDMA traffic for #2 to finish, manifesting itself into a deadlock situation.

Entirely eliminate SDMA/IDMA stalling and potential for a deadlock condition using one, or both, of the following methods:

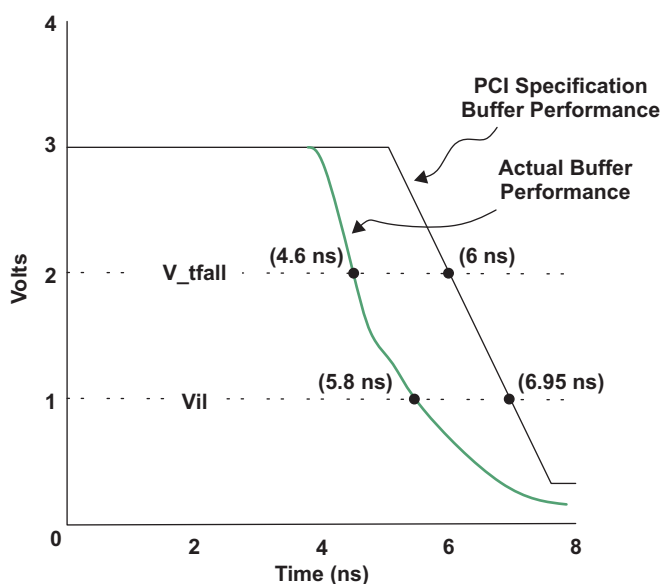
**Figure 6. 66-MHz Buffer Slew and Timing Performance vs Specification Performance**

[Table 6](#) shows the system timing budget for 66-MHz PCI with values from the specification and values in a system where the device is driving with reduced slew rate.

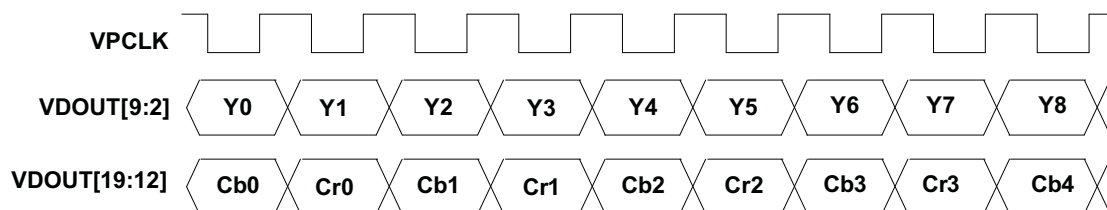
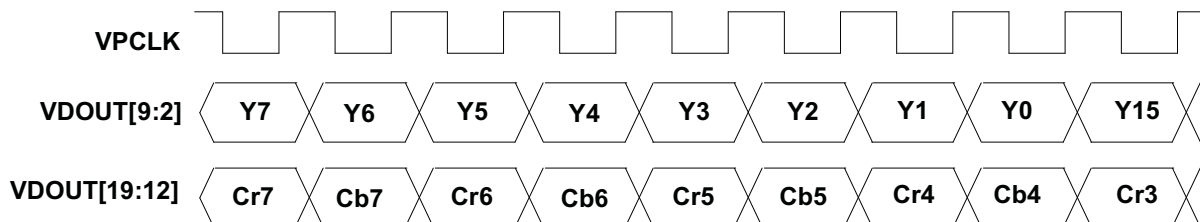
[Figure 7](#) shows an example of what is expected out of Video Port in 8-bit Y/C display and [Figure 8](#) and shows the actual output.

**Figure 7. Expected Data at the VDOUT Pins for Y/C 8-bit Display**

**Figure 8. Actual Data at the VDOUT Pins for Y/C 8-bit Display**
