## Active AT85C51SND3Bx Errata List

**MP3**  
**Microcontrollers**

**AT85C51SND3Bx**

**Errata Sheet**

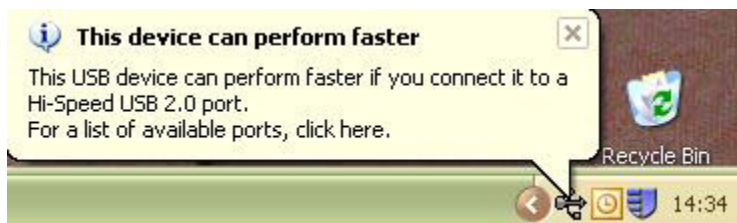
## 6. ISP – ISP USB enumeration on Windows™ XP

When connecting the device to windows XP, an informational pop-up is opened near the status bar:

This is a windows dummy message since ISP is done in full speed mode.

None. Do not take care of this pop-up.
