## Applicability

This document applies to the STM32F048C6/G6/T6 devices and their variants shown in [Table 1](#).

**Table 1. Device variants**

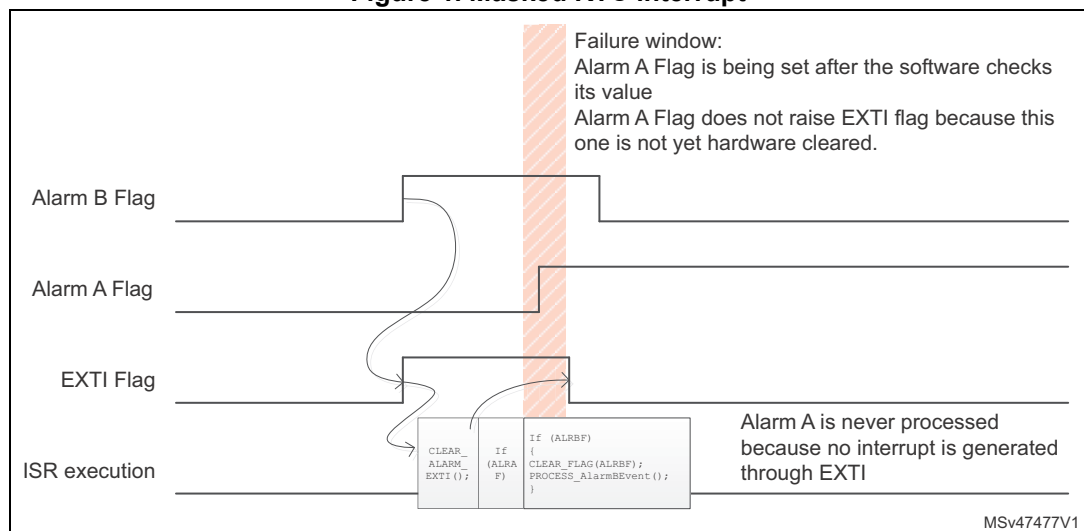
**Figure 1. Masked RTC interrupt**

One RTC interrupt can mask another RTC interrupt if both share the same EXTI configurable line, such as the RTC Alarm A and Alarm B, of which the event flags are OR-ed to the same EXTI line (refer to the **EXTI line connections** table in the **Extended interrupt and event controller (EXTI)** section of the reference manual).

The following code example and figure illustrate the failure mechanism: The Alarm A event is lost (fails to generate interrupt) as it occurs in the failure window, that is, after checking the Alarm A event flag but before the effective clear of the EXTI interrupt flag by hardware. The effective clear of the EXTI interrupt flag is delayed with respect to the software instruction to clear it.

In the interrupt service routine, apply three consecutive event flag checks - source one, source two, and source one again, as in the following code example:

```
void RTC_Alarm_IRQHandler(void)
{
    CLEAR_ALARM_EXTI(); /* Clear the EXTI's line Flag for RTC Alarm */
    If(ALRAF) /* Check if AlarmA triggered ISR */
    {
        CLEAR_FLAG(ALRAF); /* Clear the AlarmA interrupt pending bit */
        PROCESS_AlarmAEvent(); /* Process AlarmA Event */
    }
    If(ALRBF) /* Check if AlarmB triggered ISR */
    {
        CLEAR_FLAG(ALRBF); /* Clear the AlarmB interrupt pending bit */
        PROCESS_AlarmBEvent(); /* Process AlarmB Event */
    }
    If(ALRAF) /* Check if AlarmA triggered ISR */
    {
        CLEAR_FLAG(ALRAF); /* Clear the AlarmA interrupt pending bit */
        PROCESS_AlarmAEvent(); /* Process AlarmA Event */
    }
}
```

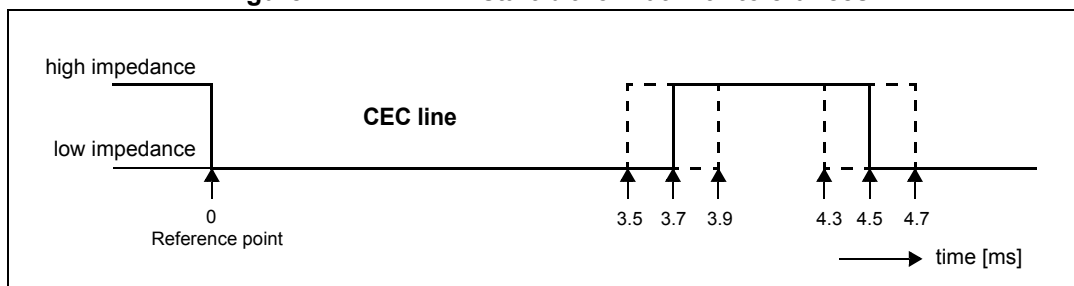
Figure 2. HDMI-CEC start bit format with tolerances

The start bit timing standard tolerances are shown in [Figure 2](#). The start bit is initiated by the device by driving the CEC line low (reference point). After 3.7 ms, the device releases the CEC line and starts checking its level. The following conditions must be met for the start bit to be valid:

If one of these conditions is not met, the transmission is aborted and never automatically retried. No error flag is set and the TXSOM (Tx Start Of Message) bit is not cleared.

The only way to detect this error is for the application software to start a timeout when setting the TXSOM bit, restart it upon ARBLST or any RX event (as the transmission can be delayed by interleaved reception), and stop it upon TXBR (proof that the start bit was transmitted successfully) or TXEND event, or upon any TX error (which clears TXSOM). If the timeout expires (because none of those events occurred), the application software must restart the HDMI-CEC peripheral and retransmit the message.
