## SCH3227/SCH3226/SCH3224/SCH3222 Silicon Errata and Data Sheet Clarifications

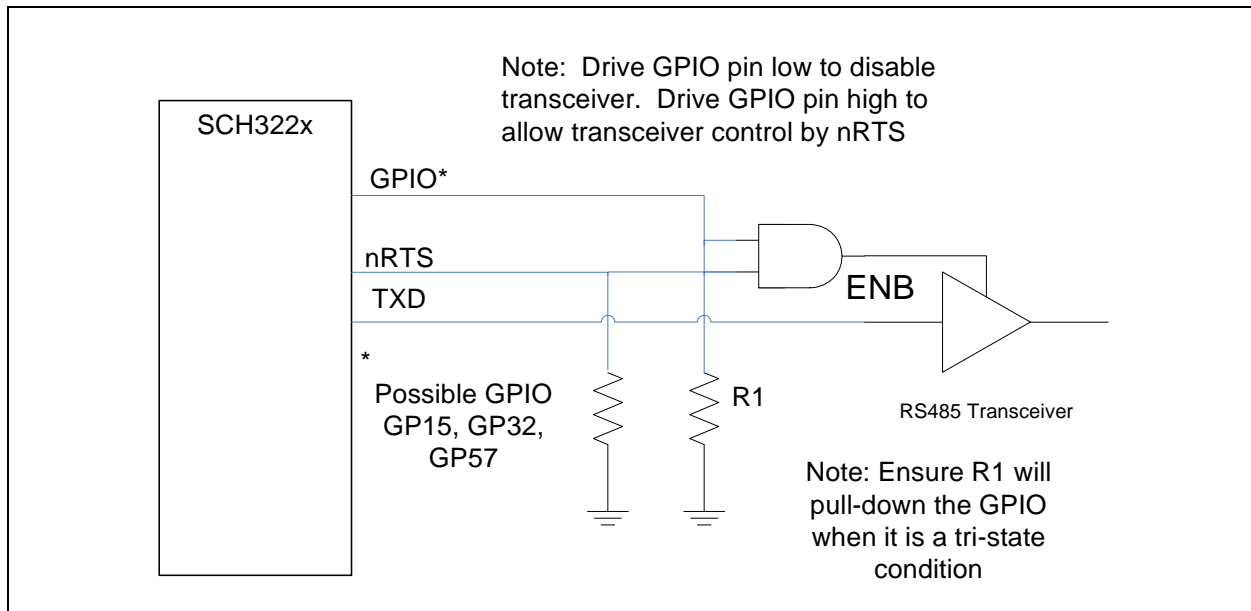
UART 3 and UART 4 do not tri-state their outputs on a PCI\_RESET as do UART 1 and UART 2.

UART 3 and UART 4 outputs are not controlled by the Configuration Register 0x30 ACTIVATE bit.

UART 3 and UART 4 outputs will drive High when PCI\_RESET goes active or when the ACTIVATE bit is cleared, and if the platform uses RTS to control an RS485 transceiver this may interrupt communication.

Use GPIO pin to disable RS485 transceiver when ACTIVATE bit is cleared.
