## MSP430F149 Device Erratasheet

### 1 Functional Errata Revision History

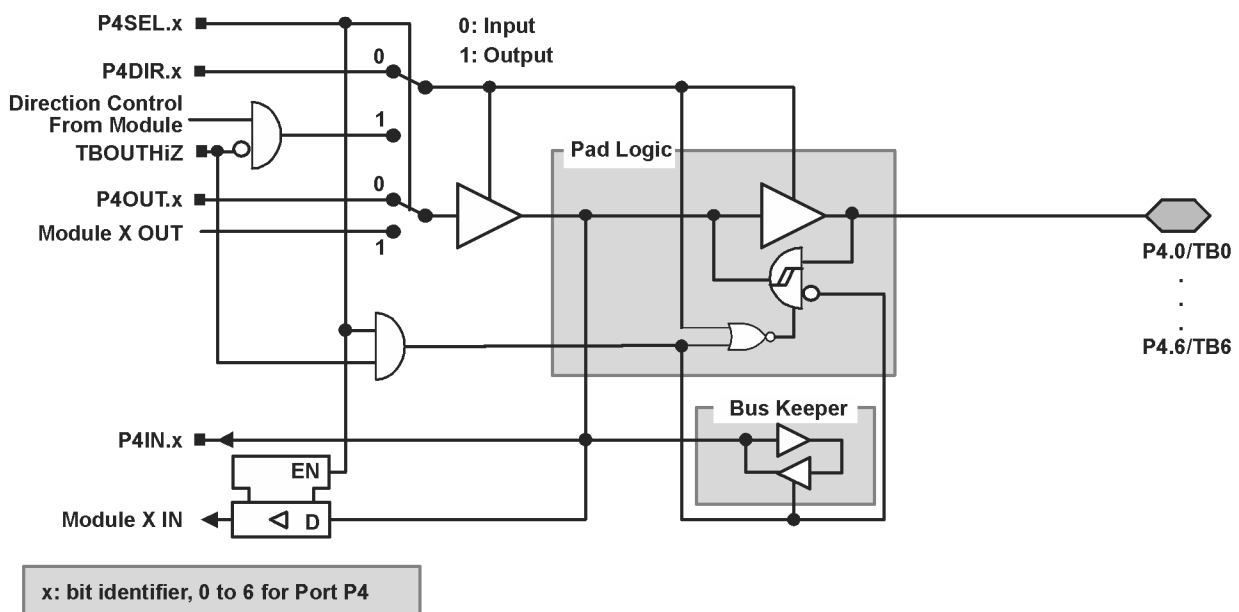
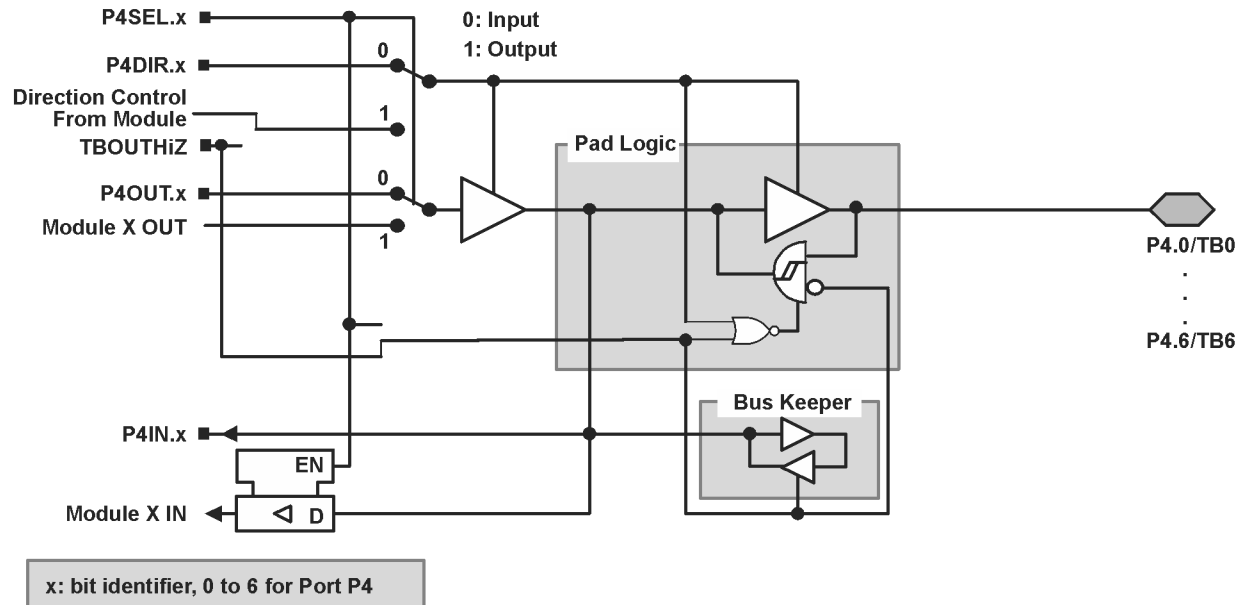
Port Realization With TB3 Bug

| <b>Function</b> | Port is switched to 3-state independent of selected function |
| <b>Description</b> | <p>Incorrect 3-state function of Ports P4.0/TB0 through P4.6/TB6 (TBoutHiZ control). If TBoutHiZ is set to high, all ports P4.0/TB0 through P4.6/TB6 are set to 3-state, independent of the P4SEL.x control signals. This means a port P4.x is switched to 3-state with TBoutHiZ, even if it is not selected for Timer_B function. In addition, the ports P4.0/TB0 through P4.6/TB6 are switched to 3-state with TBoutHiZ, even if the port direction (direction control from module) is set to input. This is in accordance with the specification description but, nevertheless, is an unexpected behavior.</p> |

| <b>Workaround</b> | <p>No workaround.</p> <p>Port function as specified</p> |
