## CC430F6126 Device Erratasheet

The revision of the device can be identified by the revision letter on the [Package Markings](#) or by the [HW\\_ID](#) located inside the TLV structure of the device

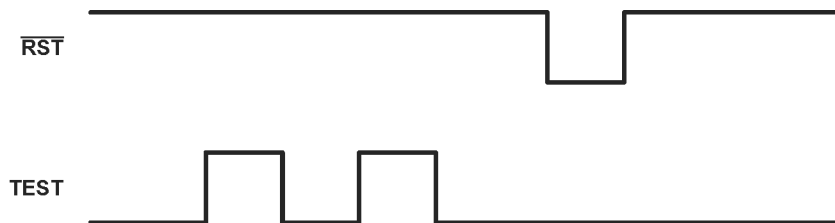
| <b>Description</b> | The methods used to exit the BSL per MSP430 Programming Via the Bootstrap Loader (SLAU319) are invalid. |

| <b>Workaround</b> | To exit the BSL one of the following methods must be used.<br>- A Power cycle<br>or<br>- Toggle the TEST pin twice when nRST is high and after 50us pull nRST low. |

Note: This toggling of TEST pins is not subject to timing constraints. The appropriate level transitions on TEST pin, followed by a RST pulse after 50us, are sufficient to trigger an exit from BSL mode.
