AM571x (SR 2.0, 1.0) and AM570x (SR 2.1, 2.0) Sitara™ Processors

1 Introduction

This document describes the known exceptions to the functional specifications for the device.

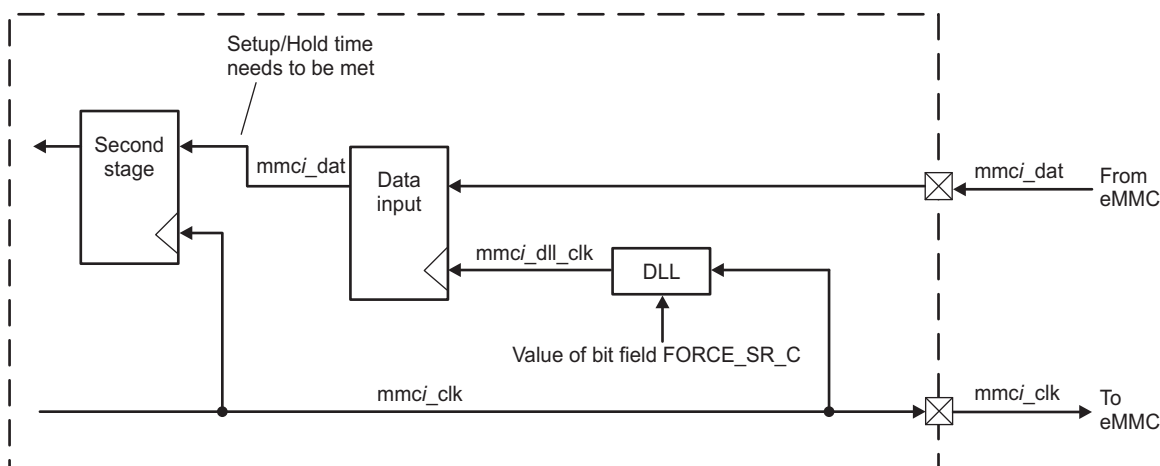
Figure 1. Simplified SoC 192-MHz Mode DLL Block Diagram

Internal to the MMC module, a second stage latch is used to recapture data captured by DLL delayed clock, `mmci_dll_clk`. The second stage latch captures with the original transmitting clock, `mmci_clk`.

mmci_dll_clk and mmci_clk both run at the same clock frequency. This results in a narrow range of tuning ratio elements, where the delayed mmci_dll_clk comes in phase with mmci_clk. If the clocks are in phase, the data captured by the first clock violates the setup and hold time requirements needed for the second stage latch, resulting in incorrectly read data. This is known as tuning re-timing errors.

For systems in which MMC DLL tuning algorithm* chooses a ratio less than 40, which is sufficiently far from the lowest re-timing error ratio element, no workaround is necessary.

A DLL tuning algorithm has been implemented that can avoid the tuning re-timing errors. More details on this can be found in App Note [SPRACA9](#). The following notes summarize the updated algorithm:

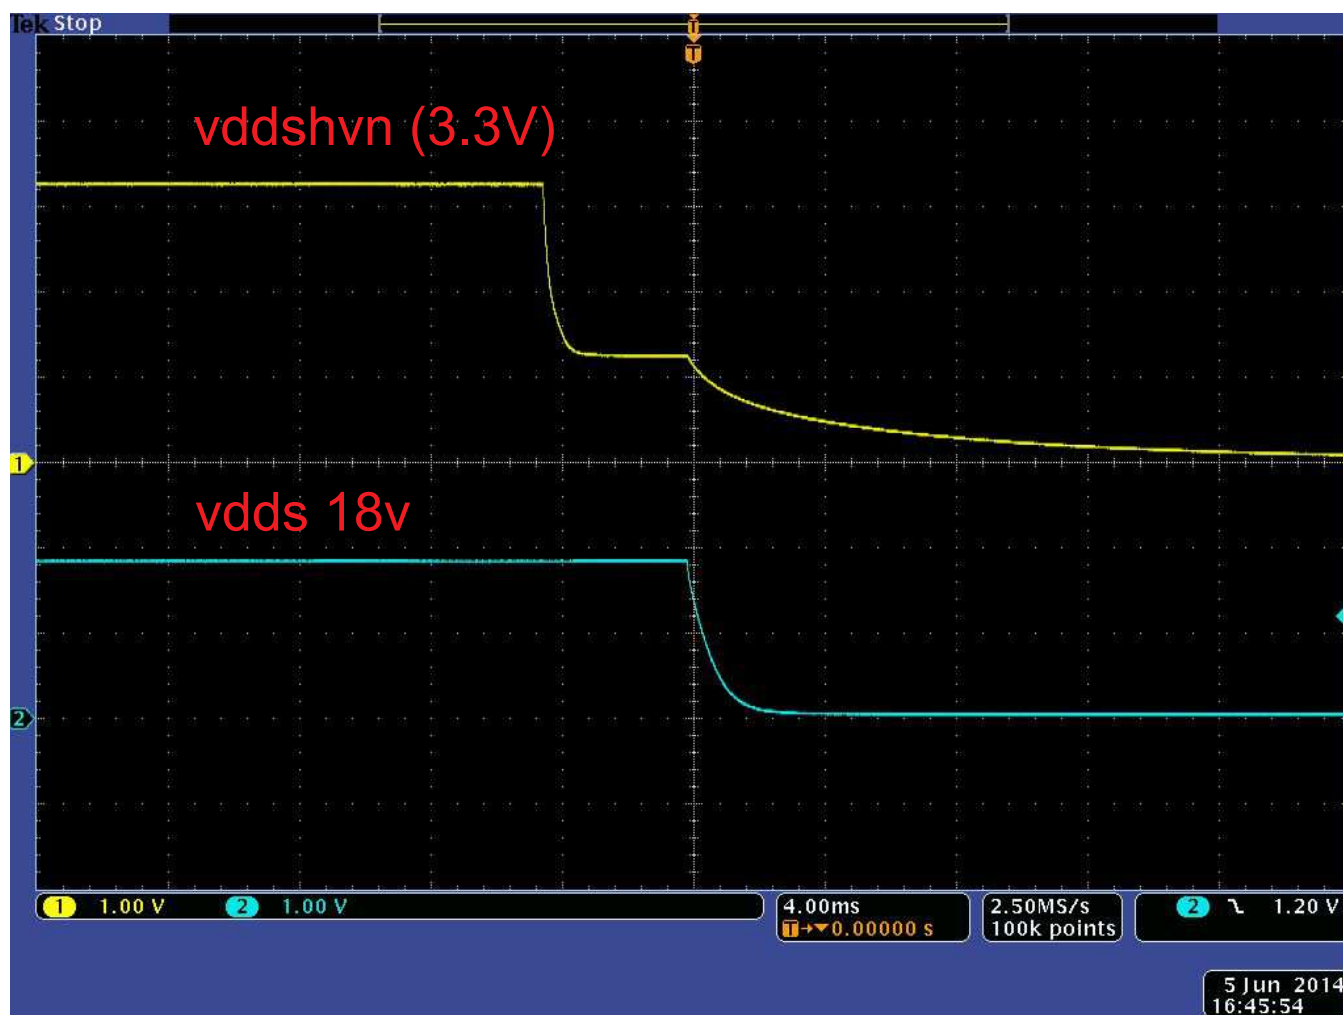
Figure 2. PAB_RevA

A subset of the SOC's LVC MOS IOs (refer to DM for details) have a pull-up resistor that is active by default, including during reset and power-down. The SOC's IOs that have internal or external pull-ups will stay at Plateau Level (<1.5V) during the power-down. If other ICs on the board that are interfaced to the SOC's LVC MOS signals use a separate supply then it's possible that the other IC's signals can be pulled to the Plateau Level while its power supply is off.

The root cause of the plateau is related to the LVC MOS IO buffer Dual Voltage detection circuitry. The LVC MOS Dual Voltage IO includes voltage comparator circuitry to determine if the IO is in 3.3V mode or 1.8V mode. During powerdown of vddshvn domains, a current path in the internal bias transistors results in the vddshvn rail being held to an intermediate voltage level (<1.5 V). This path can consume at most 500 uA per IO - worst case estimate is ~150 mA (based on 280 IOs) from the vdds18v supply

during power down. This path is not a reliability concern for the device.

In general, TI recommends using the same supply source for connected components. E.g., a single LDO should drive vddshvn and the related 3.3V external components.

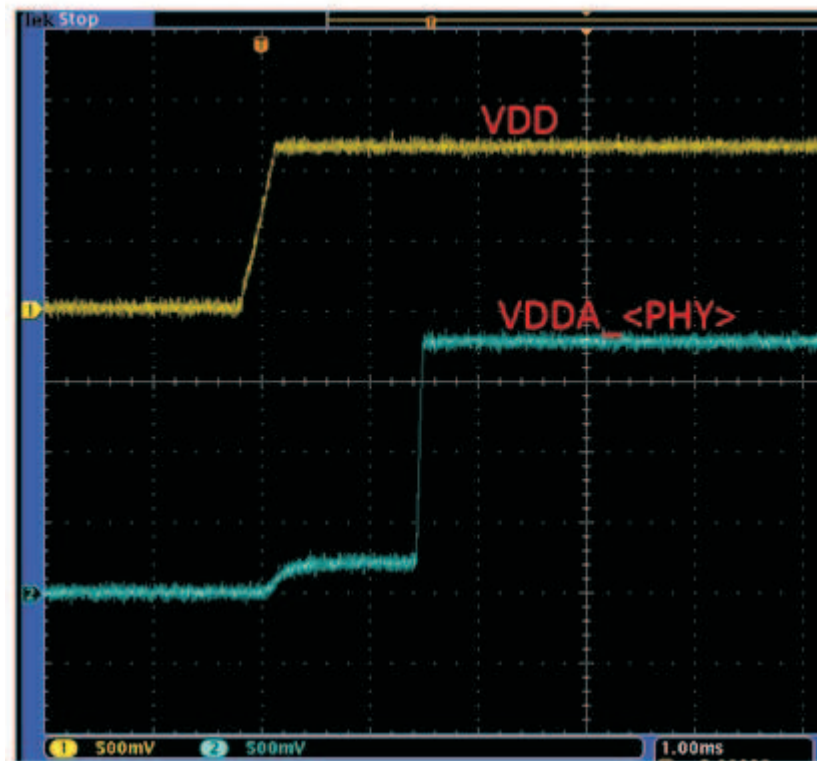
Figure 3. Leakage Voltage

The device-specific Data Manual requires Core AVS rail (VDD) to power up before the 1.8 V high speed analog PHY domain(s). When this sequence is followed, the high speed analog PHY domain will have a small step-up to a voltage plateau (< 0.5 V) that aligns to the beginning of the VDD ramp-up, and is maintained until the ramp-up of high speed analog PHY rail, as shown in [Figure 3](#). Note the leakage value will differ from system to system, but will be less than 500 mV. The leakage voltage in the provided capture is approximately 250 mV.

A similar condition exist during supply power down sequence. The high speed analog PHY domain(s) are required to be powered down prior to Core AVS rail (VDD), and may cause a small plateau to exist until Core AVS rail (VDD) is ramped down.

The root cause of the voltage plateau during power-up/down sequencing is related to the parasitic diodes in logic blocks which have multiple power sources. This leakage path is not a reliability concern for this device.

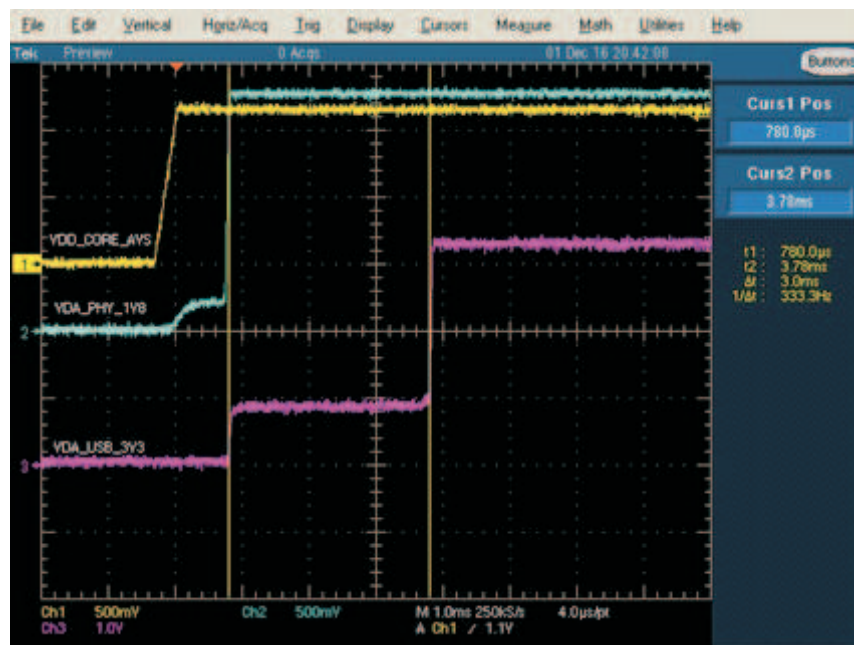
Figure 4. Original Power-Up Sequence

DESCRIPTION An unintended leakage current path between VDDA_PCIE (1.8 V) and VDDA33V_USB1 (3.3 V) due to ESD protection diode connection across the signal to I/O supply pads exists. This path can allow current to flow from VDDA_PCIE to VDDA33V_USB1. The current flows whenever the voltage level on VDDA_PCIE exceeds VDDA33V_USB by more than a diode drop during certain power-up and power-down sequences.

This leakage current causes the un-energized VDDA33V_USB1 to rise to a ~1 V plateau (see Figure 4) due to the power resource's "off impedance" seen between the VDDA33V_USB1 power rail to ground. When the minimum "off impedance" is $\geq 100 \Omega$, the SoC leakage current is small and sustainable with no SoC reliability impacts.

Note: Figure 4 shows in VDA_PHY_1V8 rail a plateau approximately 250 mV documented in i931, VDD to VDDA_"PHY" Current Path.

GUIDELINES TI recommended Power Delivery Networks (PDNs) could have multiple different PMIC LDO power resources connected to the VDDA33V_USB1 rail. The LP87332D/LP873220 PMICs have a minimum OFF resistance equal to 150Ω so a PDN using these PMICs would not exceed safe leakage current level and could continue to use the original SoC power sequences. However, the TPS65916 PMICs have a minimum OFF resistance equal to 30Ω and would exceed the safe leakage current limit. As a result, any PDN using TPS65916 PMICs must implement the power sequencing as shown in DM version C or later. The specific sequence changes are:
