## ***F28M35x Concerto™ MCUs Silicon Errata Silicon Revisions E, B, A, 0***

This document describes the silicon updates to the functional specifications for the F28M35x microcontrollers (MCUs).

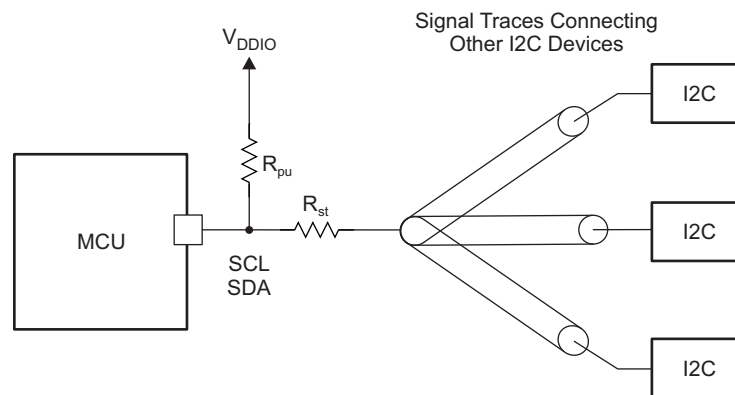
**Figure 8. Placement of Series Termination Resistor and Pullup Resistor**

| <b>Advisory</b> | <b><i>Master Subsystem I2C: SDA and SCL Open-Drain Output Buffer Issue</i></b> |
|---|---|
| <b>Details</b> | <p>The SDA and SCL outputs are implemented with push-pull 3-state output buffers rather than open-drain output buffers as required by I2C. While it is possible for the push-pull 3-state output buffers to behave as open-drain outputs, an internal timing skew issue causes the outputs to drive a logic-high for a duration of 0–5 ns before the outputs are disabled. The unexpected high-level pulse will only occur when the SCL or SDA outputs transition from a driven low state to a high-impedance state and there is sufficient internal timing skew on the respective I2C output.</p> <p>This short high-level pulse injects energy in the I2C signals traces, which causes the I2C signals to sustain a period of ringing as a result of multiple transmission line reflections. This ringing should not cause an issue on the SDA signal because it only occurs at times when SDA is expected to be changing logic levels and the ringing will have time to damp before data is latched by the receiving device. The ringing may have enough amplitude to cross the SCL input buffer switching threshold several times during the first few nanoseconds of this ringing period, which may cause clock glitches. This ringing should not cause a problem if the amplitude is damped within the first 50 ns because I2C devices are required to filter their SCL inputs to remove clock glitches. Therefore, it is important to design the PCB signal traces to limit the duration of the ringing to less than 50 ns. One possible solution is to insert series termination resistors near the SCL and SDA terminals to attenuate transmission line reflections.</p> <p>This issue may also cause the SDA output to be in contention with the slave SDA output for the duration of the unexpected high-level pulse when the slave begins its ACK cycle. This occurs because the slave may already be driving SDA low before the unexpected high-level pulse occurs. The glitch that occurs on SDA as a result of this short period of contention does not cause any I2C protocol issue but the peak current applies unwanted stress to both I2C devices and potentially increases power supply noise. Therefore, a series termination resistor located near the respective SDA terminal is required to limit the current during the short period of contention.</p> <p>A similar contention problem can occur on SCL when connected to I2C slave devices that support clock stretching. This occurs because the slave is driving SCL low before the unexpected high-level pulse occurs. The glitch that occurs on SCL as a result of this short period of contention does not cause any I2C protocol issue because I2C devices are required to apply a glitch filter to their SCL inputs. However, the peak current applies unwanted stress to both I2C devices and potentially increases power supply noise. Therefore, a series termination resistor located near the respective SCL terminal is required to limit the current during the short period of contention.</p> <p>If another master is connected, the unexpected high-level pulses on the SCL and SDA outputs can cause contention during clock synchronization and arbitration. The series termination resistors described above will also limit the contention current in this use case without creating any I2C protocol issue.</p> <p><b>Workaround(s)</b> Insert series termination resistors on the SCL and SDA signals and locate them near the SCL and SDA terminals. The SCL and SDA pullup resistors should also be located near the SCL and SDA terminals. The placement of the series termination resistor and pullup resistor should be connected as shown in <a href="#">Figure 8</a>.</p> |

Table 8 provides series termination and pullup resistor value recommendations. The I2C signal level and respective  $V_{DDIO}$  power supply voltage is shown in the first column. Two resistor value combination options are provided for each voltage. One option supports a maximum high-level input current of 200  $\mu A$  to all attached I2C devices, while the other option supports a maximum high-level input current of 100  $\mu A$  to all attached I2C devices.
