## PIC18F85J11 Family Silicon Errata and Data Sheet Clarification

The PIC18F85J11 family devices that you have received conform functionally to the current Device Data Sheet (DS39774D), except for the anomalies described in this document.

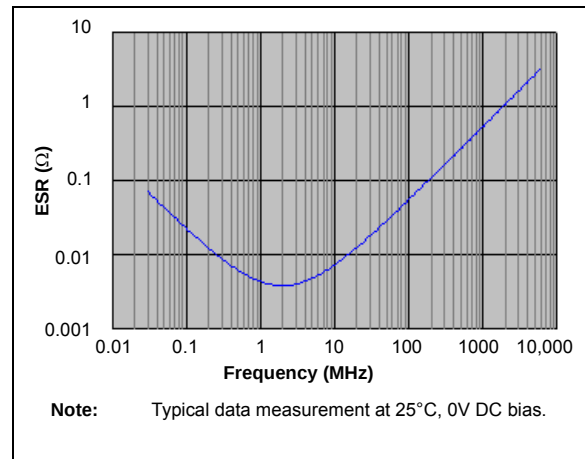
**FIGURE 2-3 FREQUENCY vs. ESR PERFORMANCE FOR SUGGESTED VCAP**

When the regulator is enabled, a low-ESR ( $< 5\Omega$ ) capacitor is required on the VCAP/VDDCORE pin to stabilize the voltage regulator output voltage. The VCAP/VDDCORE pin must not be connected to VDD and must use a capacitor of 10  $\mu\text{F}$  connected to ground. The type can be ceramic or tantalum. Suitable examples of capacitors are shown in [Table 2-1](#). Capacitors with equivalent specifications can be used.

Designers may use [Figure 2-3](#) to evaluate ESR equivalence of candidate devices.

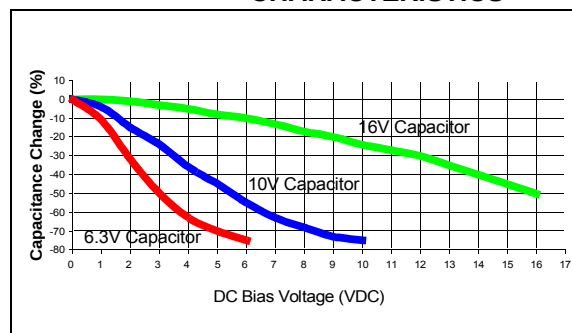
**FIGURE 2-4 DC BIAS VOLTAGE vs. CAPACITANCE CHARACTERISTICS**

In addition to temperature tolerance, the effective capacitance of large value ceramic capacitors can vary substantially, based on the amount of DC voltage applied to the capacitor. This effect can be very significant, but is often overlooked or is not always documented.

A typical DC bias voltage vs. capacitance graph for X7R type and Y5V type capacitors is shown in Figure 2-4.

When selecting a ceramic capacitor to be used with the VDDCORE voltage regulator, it is suggested to select a high-voltage rating, so that the operating voltage is a small percentage of the maximum rated capacitor voltage. For example, choose a ceramic capacitor rated at 16V for the 2.5V VDDCORE voltage. Suggested capacitors are shown in Table 2-1.
