PIC32MX534/564/664/764 Family Silicon Errata and Data Sheet Clarification

The PIC32MX534/564/664/764 family devices that you have received conform functionally to the current Device Data Sheet (DS60001156K), except for the anomalies described in this document.

Note: This document summarizes all silicon errata issues from all revisions of silicon, previous as well as current. Only the issues indicated in the last column of [Table 2](#) apply to the current silicon revision (**A2**).

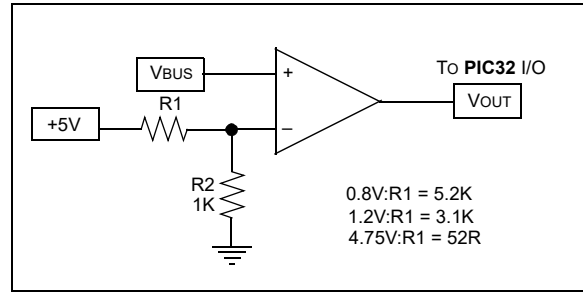
FIGURE 1: EXTERNAL COMPARATOR SCHEMATIC EXAMPLE

When the USB model is configured for OTG operation, it may not recognize all required OTG voltage levels on VBUS pin.

Use external comparator circuit to detect OTG specific voltage levels on VBUS pin.
