## MSP430F5635 Device Erratasheet

The revision of the device can be identified by the revision letter on the [Package Markings](#) or by the [HW\\_ID](#) located inside the TLV structure of the device

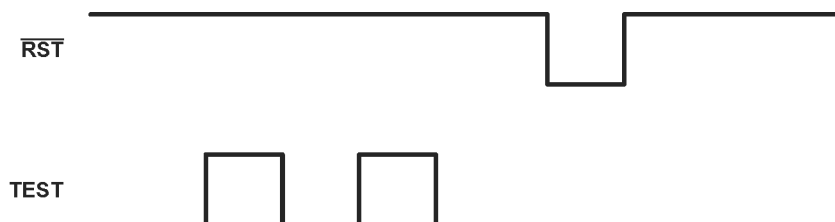
| <b>Description</b> | The methods used to exit the BSL per MSP430 Programming Via the Bootstrap Loader ( <a href="#">SLAU319</a> ) are invalid. |

| <b>Workaround</b> | <p>To exit the BSL one of the following methods must be used.</p> <ul style="list-style-type: none"> <li>- A Power cycle</li> </ul> <p>or</p> <ul style="list-style-type: none"> <li>- Toggle the TEST pin twice when nRST is high and after 50us pull nRST low.</li> </ul> |

Note: This toggling of TEST pins is not subject to timing constraints. The appropriate level transitions on TEST pin, followed by a RST pulse after 50us, are sufficient to trigger an exit from BSL mode.
