# MPC5200B (M62C) Errata

by: Microcontroller Division

This document identifies implementation differences between the MPC5200B, M62C (Rev. 1), and the processor’s description contained in the *MPC5200B User’s Guide* and the *MPC5200B Microcontroller Data Sheet*. Refer to <http://www.freescale.com> for the latest updates.

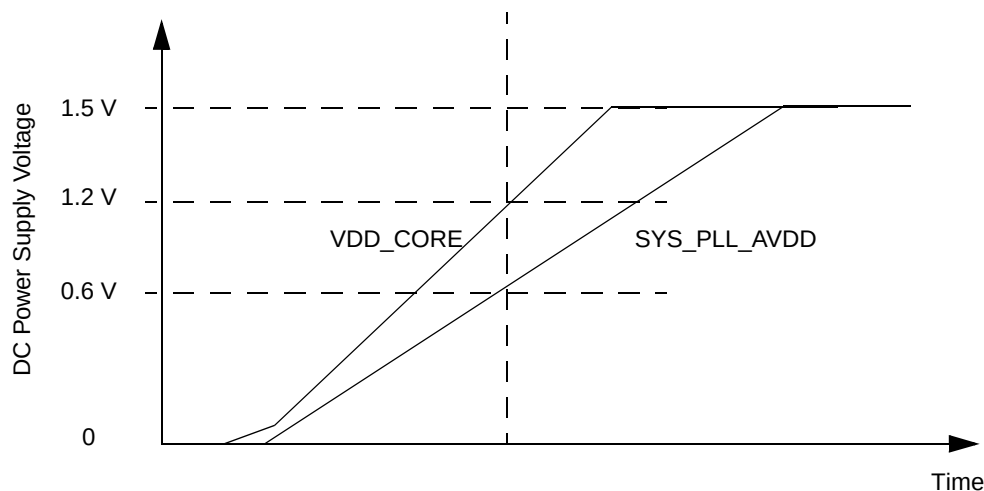
The system PLL can fail to start properly if the power supply pins on the MPC5200B are not properly sequenced. In particular, if the SYS\_PLL\_AVDD pin rises too early with respect to VDD\_CORE, the system PLL can drive the VCO to oscillate at a frequency beyond the capability of the PLL to respond. The overall result is that the internal bus clocks run too fast and the device fails to fetch instructions.

A filter/delay circuit must be implemented so that SYS\_PLL\_AVDD is delayed with respect to VDD\_CORE. Specifically, VDD\_CORE must reach a value of 1.2 volts before SYS\_PLL\_AVDD reaches 0.6 volts.
