PIC32MX1XX/2XX/5XX 64/100-pin Family Silicon Errata and Data Sheet Clarification

The PIC32MX1XX/2XX/5XX 64/100-pin family devices that you have received conform functionally to the current Device Data Sheet (DS60001290F), except for the anomalies described in this document.

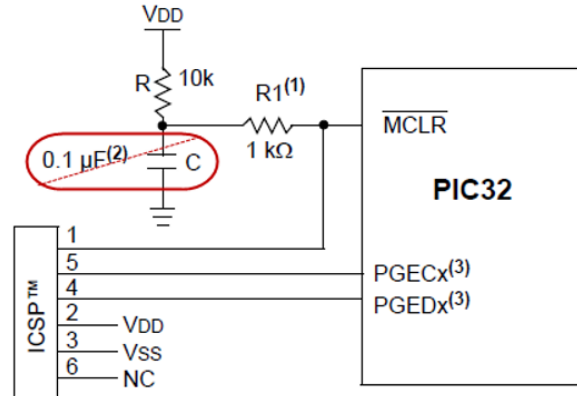
17. Module: I/O Port - Initial Pin State

On power-up depending on the VDD ramp rate, the I/O pins can be in an active random output driving state if MCLR is active until a BOR event.

Work around 1:

If, not using an external reset supervisor IC or equivalent, remove the MCLR capacitor as shown below, and retain the MCLR Pull-up resistor.

Work around 2:

If using an external reset supervisor IC or equivalent, increase the value of the VCAP capacitor to $\geq 47 \mu\text{F}$ ceramic or solid tantalum capacitor with an ESR $\leq 1 \text{ ohm}$.
