PIC32MZ Graphics (DA) Family Silicon Errata and Data Sheet Clarification

The PIC32MZ Graphics (DA) family devices that you have received conform functionally to the current Device Data Sheet (DS60001361H), except for the anomalies described in this document.

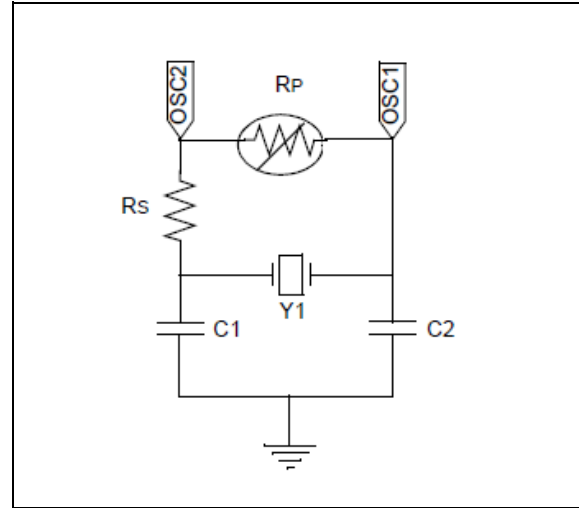
FIGURE 1: Posc CRYSTAL CIRCUIT

The POSC has been tested in a normal power-up sequence and supports specific crystal operation.

The Primary Oscillator (POsc) has been characterized to operate at 8 MHz and 12 MHz when the circuit shown in [Figure 1](#) is implemented, and the operating conditions listed in [Table 3](#) are met.

Alternatively, use an external clock or Internal FRC Oscillator. Note that communication interfaces (DDR2, USB, etc.,) with tighter clock accuracy requirements will not function with the FRC as clock source.
