*TMS570LS12x/11x Microcontroller*

**Silicon Revision C**

# **Silicon Errata**

Literature Number: SPNZ218C  
January 2015–Revised May 2016

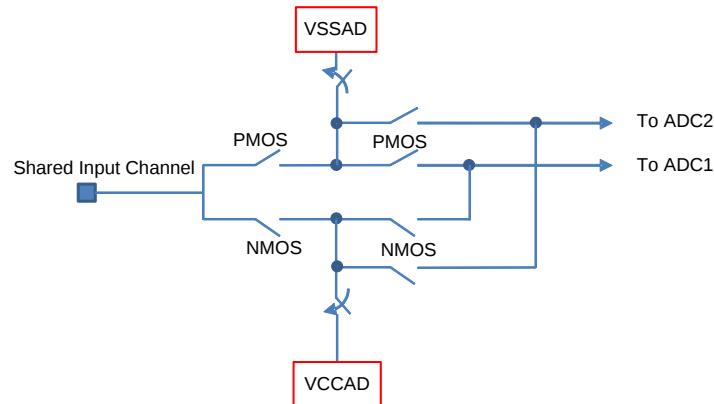
**Figure 2. Shared Input Channel in "Open" State**

**Issue** This microcontroller (MCU) has two Analog-to-Digital Converters (ADCs). Some of the input channels are unique to ADC1 while some are shared between ADC1 and ADC2. [Figure 2](#) shows a block diagram of an input channel shared between ADC1 and ADC2.

The PMOS and NMOS switches are open indicating that this shared input channel is not currently being sampled either by ADC1 or by ADC2. Also, there are switches to VCCAD and VSSAD that are closed. If any current is injected into this analog input, any leakage through the open PMOS switch will be shunted to VSSAD. These switches to VSSAD and VCCAD are opened as soon as this shared input channel is being sampled by either ADC1 or ADC2.
