PIC32MZ Embedded Connectivity with Floating Point Unit (EF) Family Silicon Errata and Data Sheet Clarification

The PIC32MZ Embedded Connectivity with Floating Point Unit (EF) family of devices that you have received conform functionally to the current Device Data Sheet (DS60001320G), except for the anomalies described in this document.

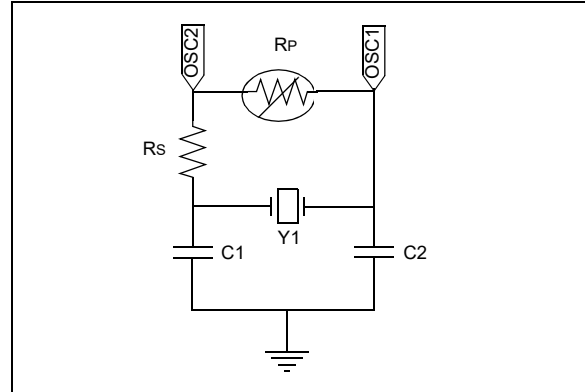
FIGURE 1: Posc CRYSTAL CIRCUIT

Revision A1 Silicon: A crystal oscillator cannot be used as an input to the Primary Oscillator (Posc) pins OSC1 and OSC2.

Revision A3 and B2 Silicon: The Posc has been tested in a normal power-up sequence and supports specific crystal operation.

The Primary Oscillator (Posc) has been characterized to operate at 8 MHz, 12 MHz, and 24 MHz when the circuit in [Figure 1](#) is implemented, and the operating conditions listed in [Table 3](#) are met.
