**TMS320VC5441**  
**Digital Signal Processor**  
**Silicon Errata**

SPRZ190C  
June 2002 – Revised April 2006

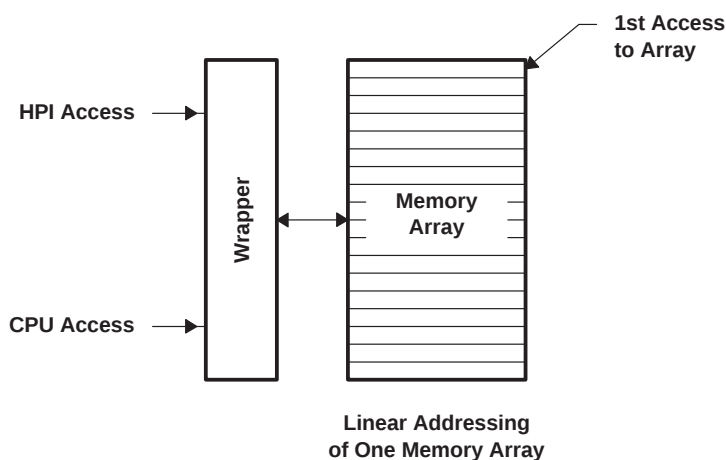
**Figure 3. Linear Addressing**

**Details:** During testing of the 5441 devices, an issue was found on the 5441 digital signal processor (DSP) that affected the initial access to memory blocks. This includes accesses performed by the DSP CPU or by a host using the HPI peripheral. The **first** access to any local memory block, regardless of the address within the block, may be erroneous (i.e., erroneous data is either read from or written to only the first address location accessed). Depending on the application, the first memory access could be the first logical address in the memory array, the last, or anywhere in between.

The problem is related to the memory array clock circuitry after a Power-On Reset (POR). Correct operation is to turn on the clock circuitry so that the memory arrays are initialized and then turn off the memory clocks for power savings. However, the clock circuitry does not always initialize fully before the clock output is turned off. As a result, the memory arrays are not initialized after the device is powered. An initial access to the memory array turns on the clock circuitry completely and the invalid memory array state is cleared.

In order to be certain that no failure occur during normal operation, all local memory arrays should be “dummy” accessed at least once after POR. For shared memory, at least two consecutive and contiguous “dummy” accesses must be performed. The memory array block configuration (from an HPI perspective) is shown below:

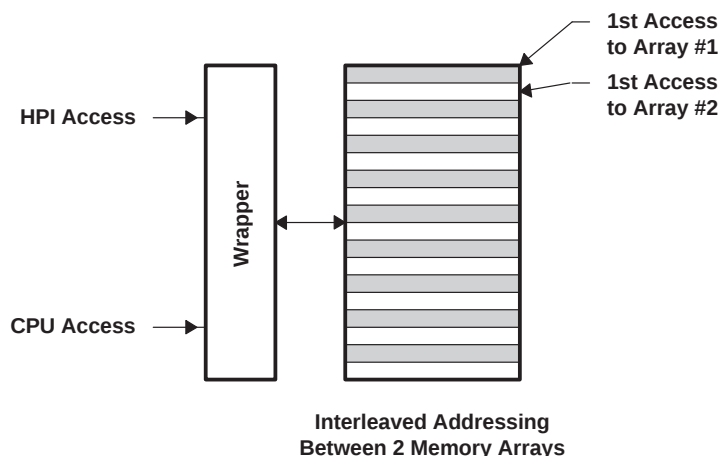
*Memory Array Clock Circuitry Not Initialized After Power-On Reset (Continued)***Figure 4. Interleaved Addressing**

The memory access failure also exists in shared memory. However, the memory architecture differs slightly for shared memory and may appear to fail in more than one address location. The multiple failures occur because the logical memory blocks consist of two physical memory arrays that are interleaved — even address locations in one array and odd address locations in the second array. In shared memory, the failure may appear to be in either or both the first access to the even address array and the first access to the odd address array.

In either case — local or shared memory — the memory access failure may or may not appear on every memory block. Due to its nature, the failure can be affected by voltage level and temperature. However, if systems are designed within the specified power supply voltage ranges, temperature limits are not exceeded, and the workaround is implemented, then there will not be subsequent failures.
