*RM57Lx Microcontroller*

**Silicon Revision B**

# Silicon Errata

Literature Number: SPNZ233B  
August 2015–Revised June 2018

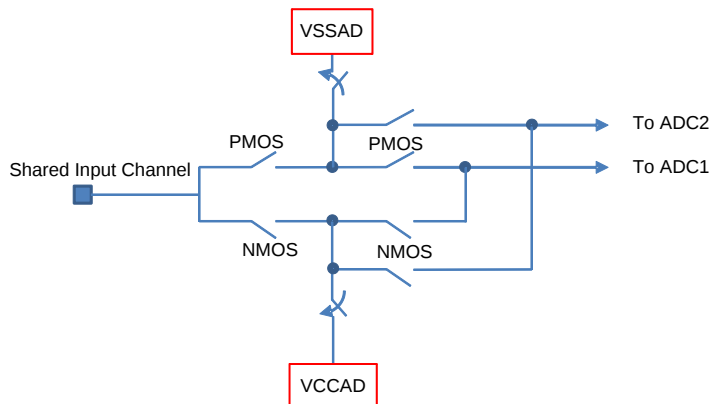
**Figure 2. Shared Input Channel in "Open" State**

The PMOS and NMOS switches are open indicating that this shared input channel is not currently being sampled either by ADC1 or by ADC2. Also, there are switches to VCCAD and VSSAD that are closed. If any current is injected into this analog input, any leakage through the open PMOS switch will be shunted to VSSAD. These switches to VSSAD and VCCAD are opened as soon as this shared input channel is being sampled by either ADC1 or ADC2.

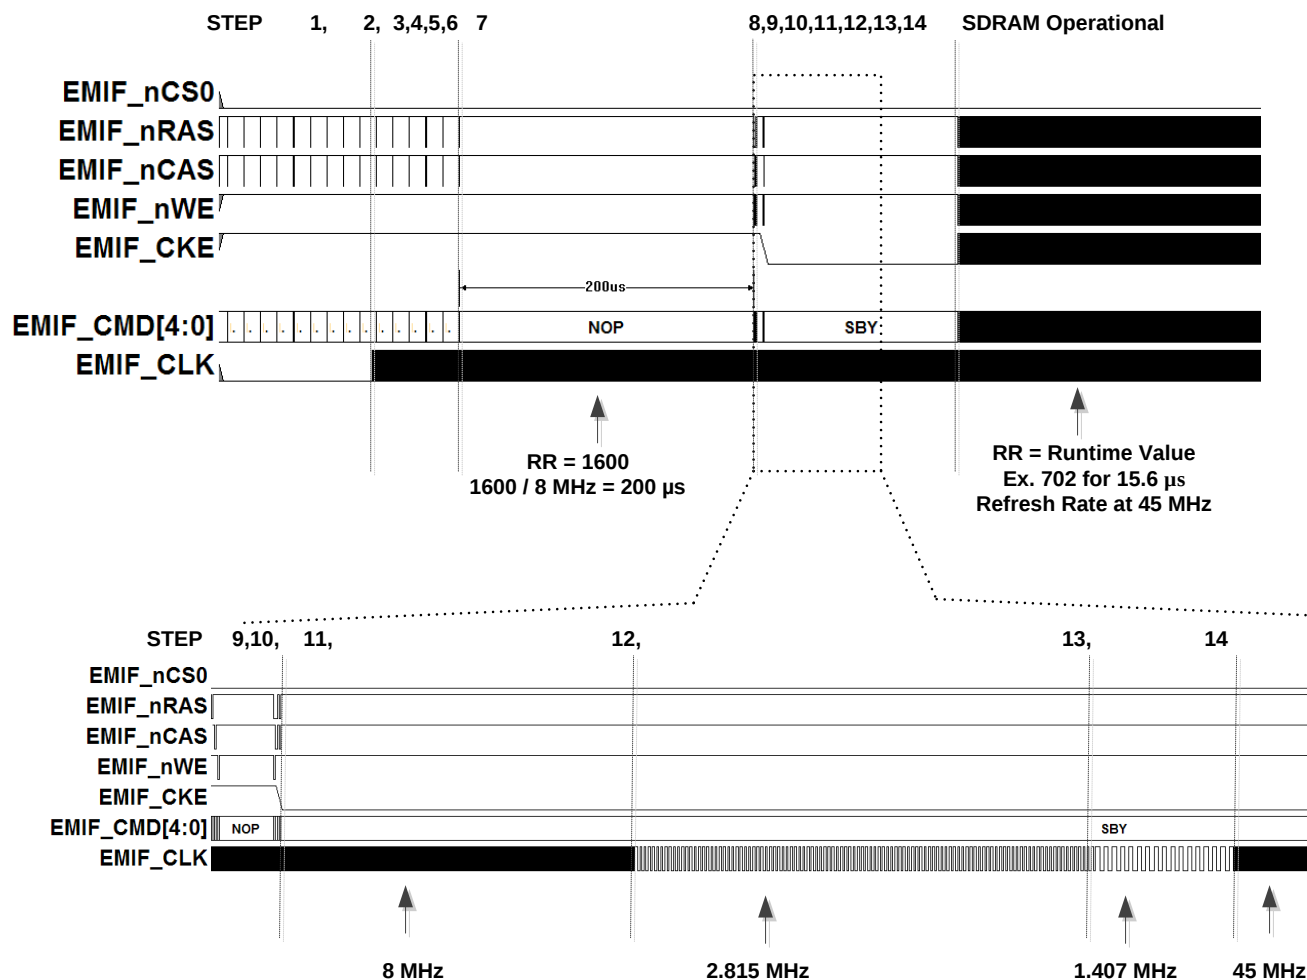
Figure 4. Correct SDRAM Initialization Procedure for Final EMIF Clock Frequency  $\geq 40$  MHz

[Figure 4](#) shows EMIF activity as the preceding device initialization sequence is performed, assuming an OSCIN frequency of 16.0 MHz and a PLL frequency of 180 MHz.

This list consists of only the steps that are related to proper SDRAM initialization; it is not a comprehensive list of device initialization steps. Many other steps in the device initialization can be performed before [Step 1](#) and between [Step 1](#) and [Step 2](#). However, [Step 2](#) through [Step 14](#) should be performed as a sequence without introducing any other initialization steps between them. Following this recommendation reduces the risk of unrelated EMIF activity (including activity on the asynchronous chip selects) during the critical time when the SDRAM is in the self-refresh (SBY) state and the EMIF clock is being switched.
