MSP430F5633 Device Erratasheet

The revision of the device can be identified by the revision letter on the [Package Markings](#) or by the [HW_ID](#) located inside the TLV structure of the device

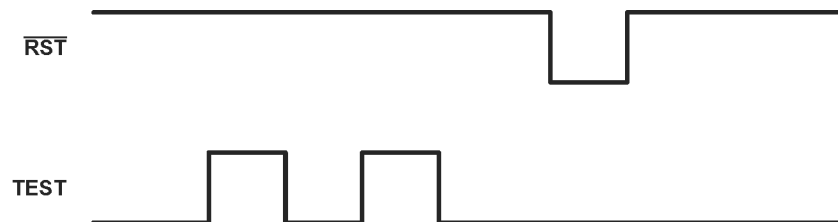
Workaround To exit the BSL one of the following methods must be used.

- A Power cycle
- or
- Toggle the TEST pin twice when nRST is high and after 50us pull nRST low.

Note: This toggling of TEST pins is not subject to timing constraints. The appropriate level transitions on TEST pin, followed by a RST pulse after 50us, are sufficient to trigger an exit from BSL mode.
